2015 Year-End Bioreactor Progress Report

The Buncombe County Solid Waste Management Facility is located in the mountains of western North Carolina, approximately nine miles north of the city of Asheville. The 557-acre solid waste management facility opened in 1997 with a Subtitle D landfill disposal area that comprises approximately 100 acres. Under the United States Environmental Protection Agency's Project XL, Buncombe County is operating a combined leachate recirculation and gas recovery system at its Subtitle D landfill. The purpose of the project is to determine if liquid addition has any adverse effects on alternative liner systems. The County is also monitoring the effects of liquids addition on waste density and settlement to determine if it is increasing the life of the landfill and gas generation for energy production. This project differs from other Project XL projects in that it is a full-scale project that is being operated over an extended period of time. This project was granted regulatory flexibility to apply water sources other than leachate to the waste, and to apply water sources to the waste in landfill cells with alternative liners. To date, only leachate has

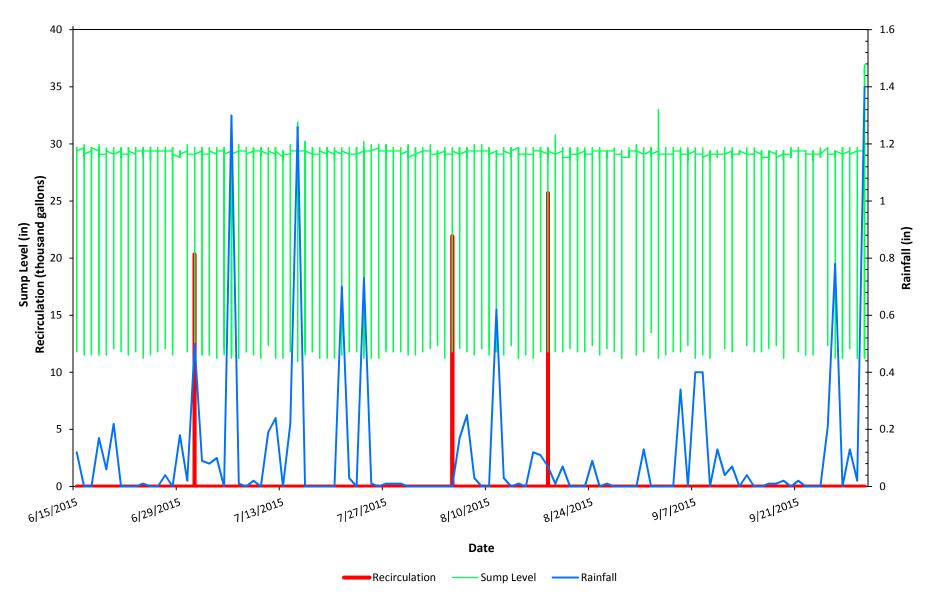
Figure 4-26 Cell 6 Sump Level, Recirculation Events, and Rainfall

Data has been collected from the Cell 6 pump datalogger to record the sump level. The Cell 6 sump pump is set to turn on at a level of 30 inches and off at a level of 12 inches. **Figure 4-26** shows a graph of the sump levels from July through September 2015 along with the recirculation events and daily rainfall. No recirculation events occurred after September 2015.

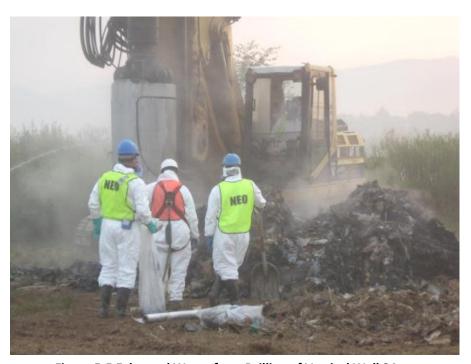
Figure 5-5 Exhumed Waste from Drilling of Vertical Well 24

The waste from these five boreholes was observed to be noticeably wetter than the waste for the other boreholes. Steam emanating from the waste of VW-24 was indicative of the elevated temperatures. The waste from this borehole appeared to be well decomposed.
