2015 Mid-Year Progress Report

USEPA PROJECT XL

Buncombe County Bioreactor Project

Buncombe County Solid Waste Management Facility

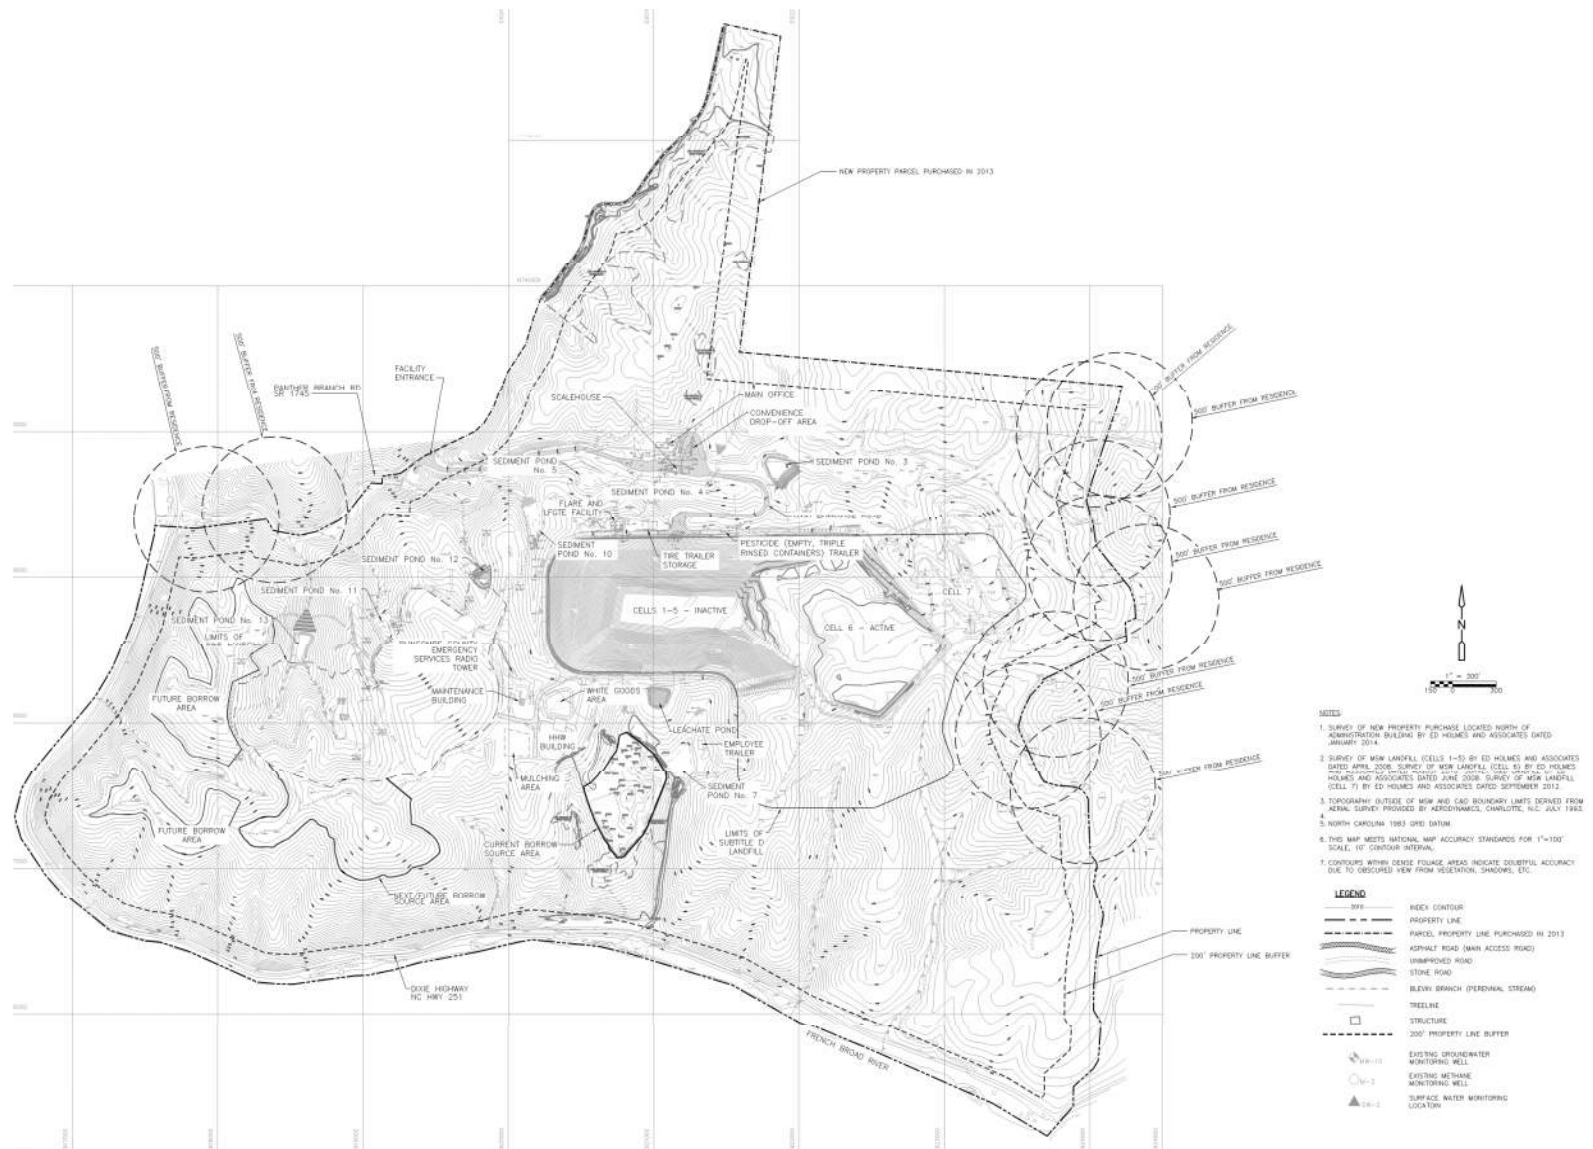
Figure 1-1 Buncombe County Solid Waste Management Facility

The Buncombe County Solid Waste Management Facility is located in the mountains of western North Carolina, approximately nine miles north of the City of Asheville. The 557-acre solid waste management facility (refer to **Figure 1-1**) opened in 1997 and comprises a Subtitle D landfill, construction and demolition (C&D) landfill, wood waste mulching facility, convenience center for residential drop-off, a household hazardous waste (HHW) facility, and a white goods and tires holding facility.

The Subtitle D landfill is 95 acres and consists of 10 disposal cells that are being constructed sequentially over the estimated 30+ year life of the facility. Cells 1 and 2 were constructed with a prescriptive RCRA Subtitle D liner system consisting of a 24" soil barrier layer with a maximum permeability of 1×10^{-7} cm/sec, a 60-mil high density polyethylene (HDPE) liner and a 24-inch rock drainage layer. Cells 3-6 were constructed with an alternative liner system that uses an 18-inch soil barrier layer with a maximum permeability of 1×10^{-5} cm/sec, a geosynthetic clay liner (GCL), a 60-mil HDPE liner and a 24" rock drainage layer.

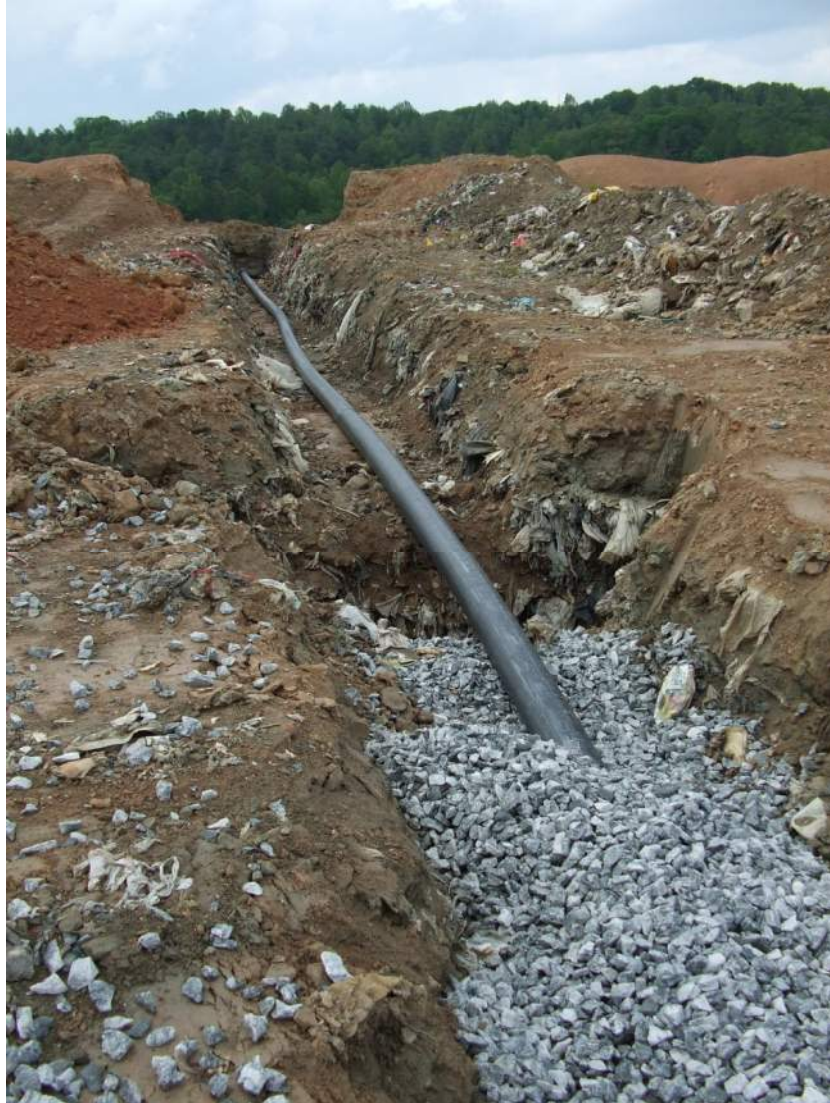
Figure 2-7 Horizontal Injection Trench Installation in Cell 6

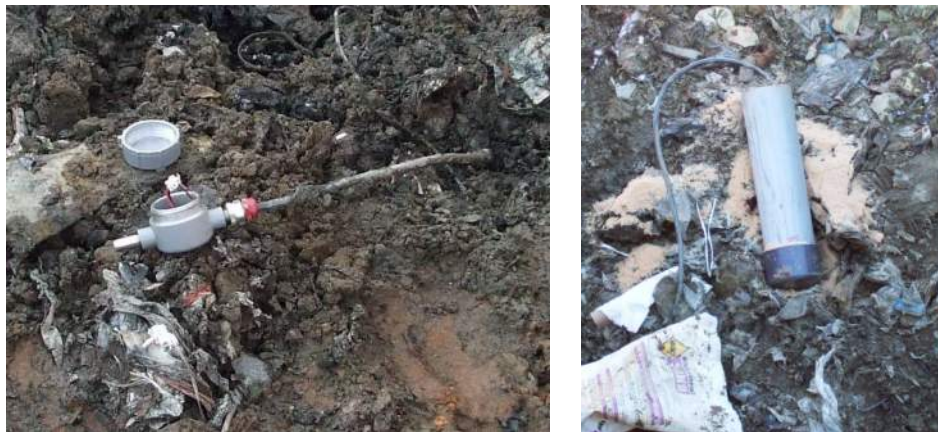
Figure 2-9 Installation of Thermocouples in Cell 6

Thermocouples were installed in six (6) locations around the Cell 6 Phase 1 HITs in July 2012 as shown in **Figure 2-8**. The thermocouples consist of a stainless steel temperature sensor with a lead cable as shown in **Figure 2-9**. These thermocouples were placed in 4-inch perforated PVC pipe packed with concrete sand. The cable end of the pipe was left open to allow cable movement during settlement. The sensors transmit temperature data to a datalogger installed adjacent to the Cell 6 pump station control panel that will be downloaded periodically. Temperature readings will be used to monitor decomposition as mesophilic bacteria typically range between 80 and 115°F. The sensors will be helpful in assessing the impacts of leachate temperature during injection. As ambient air temperatures drop in the winter, the leachate in the pond will get colder.

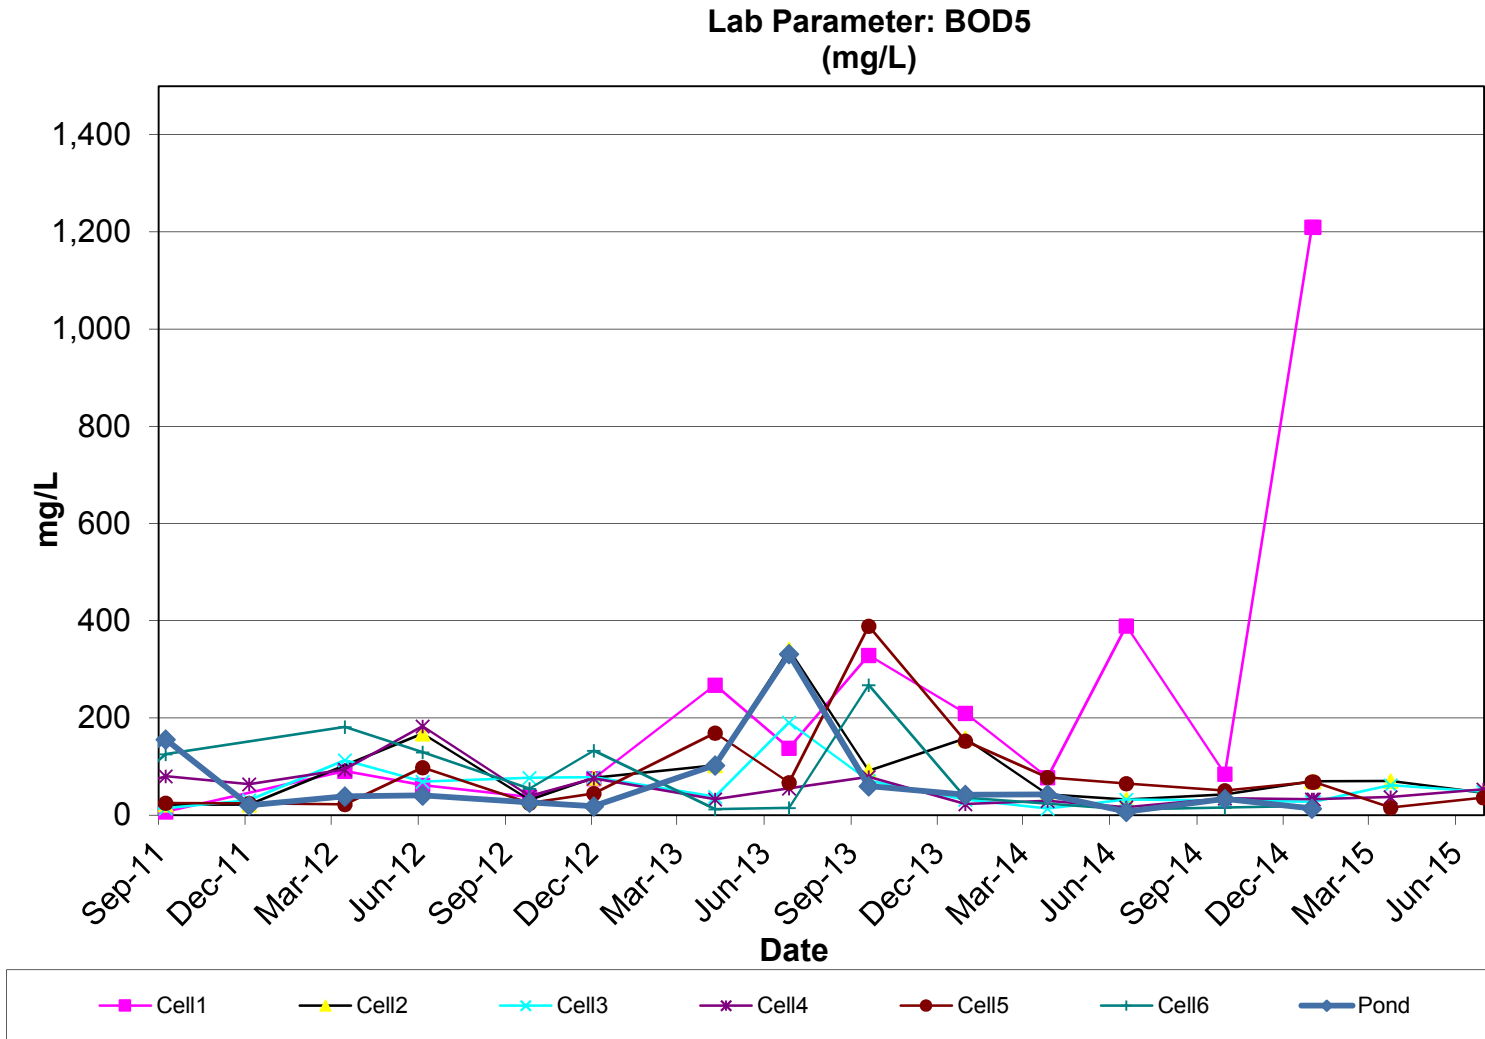
Figure 4-9 BOD5 of Leachate

*Note: No readings were taken in Cell 1 during the January-June 2015 period due to a clogged sampling port.

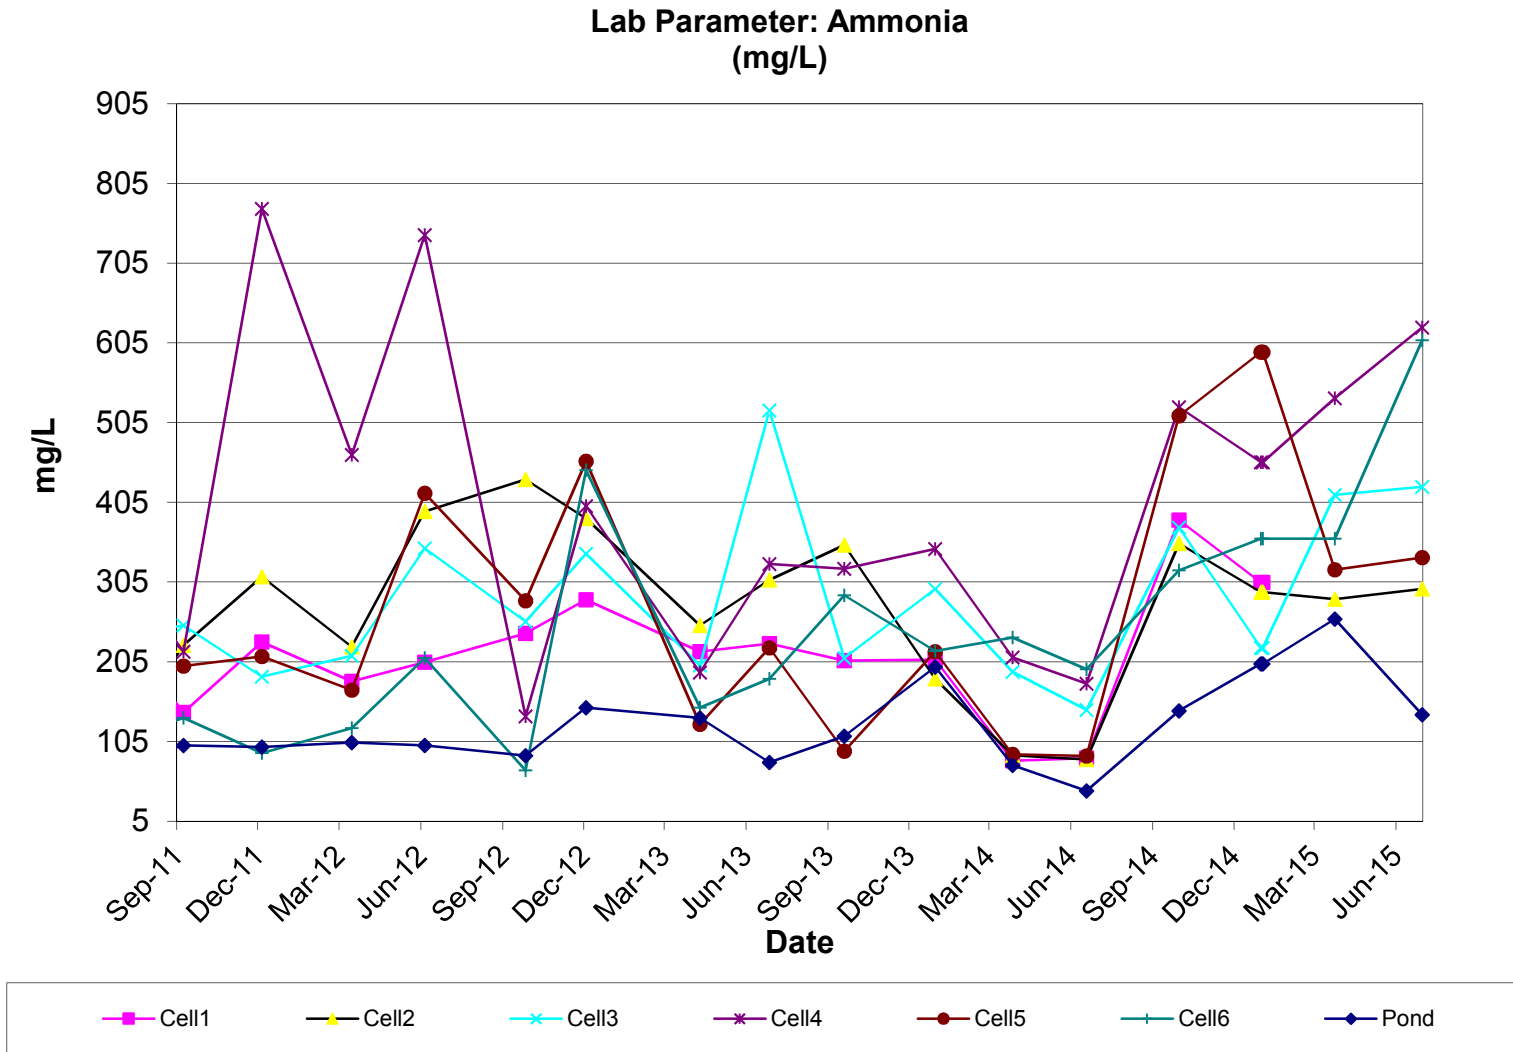
Figure 4-12 Ammonia of Leachate

*Note: No readings were taken in Cell 1 during the January-June 2015 period due to a clogged sampling port.

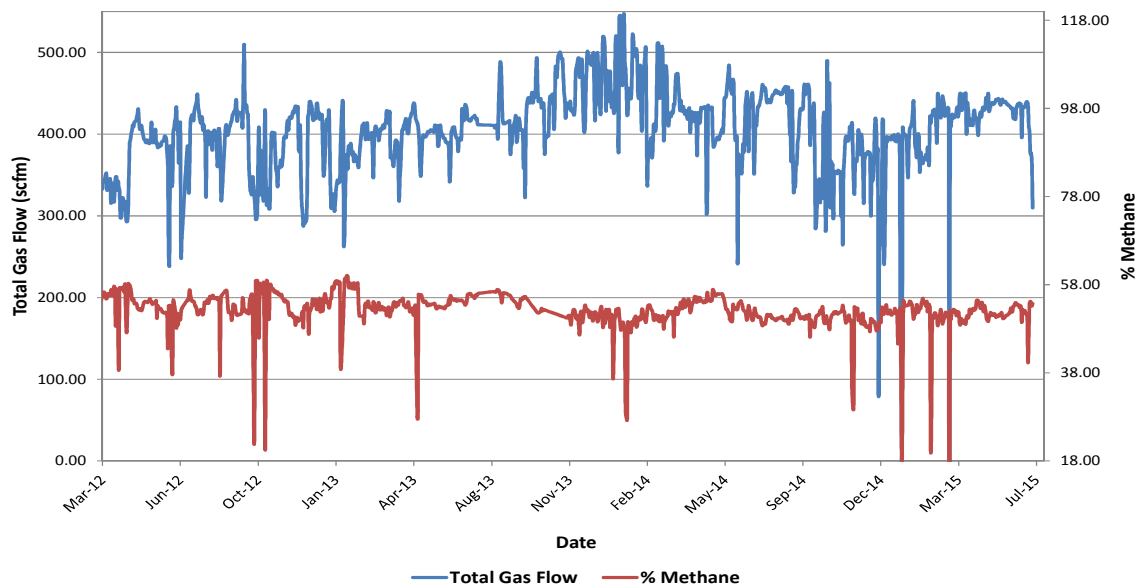
Figure 4-17 Total Gas Flow and Percent Methane at the LFGTE Facility

The total gas flow and methane percentage of the gas collected from the landfill is monitored continuously at the LFGTE facility as presented in **Figure 4-17**.

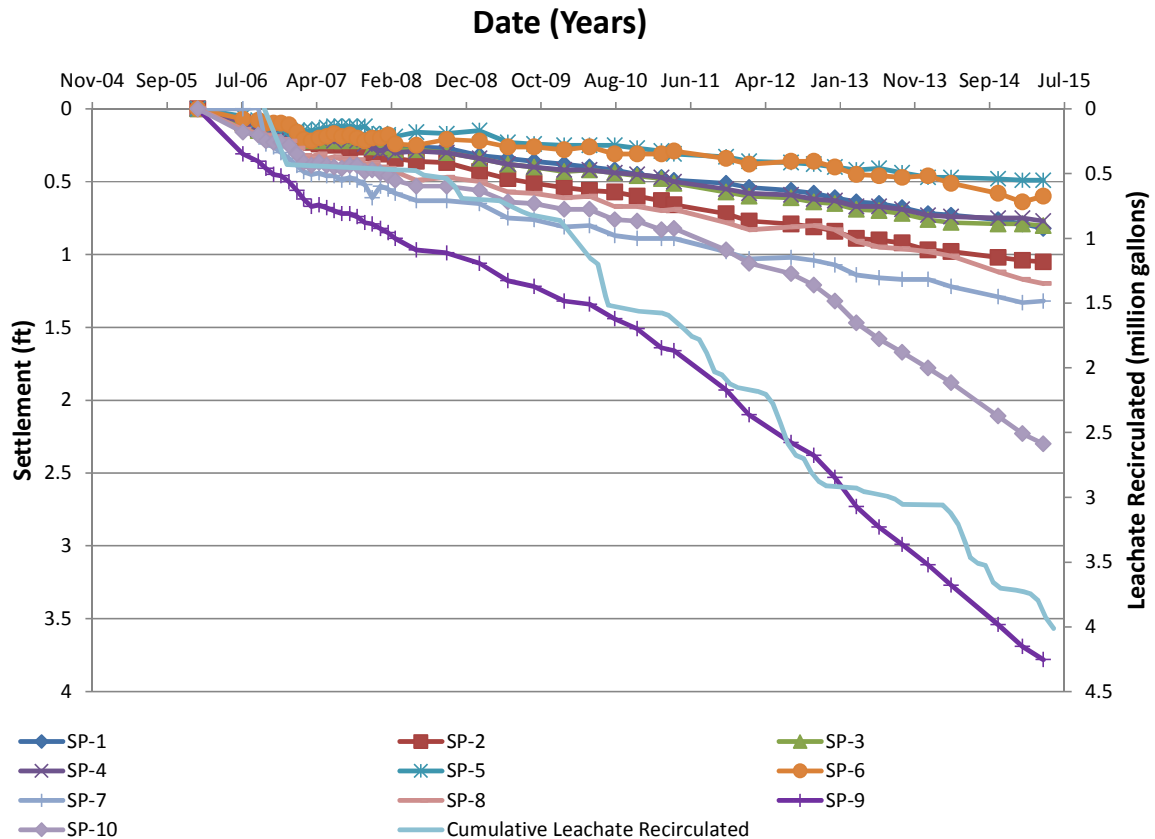
Figure 4-19 Cumulative Settlement

Figure 4-19 compares the measured settlement in the settlement plates from July 2006 through April 2015 to the quantity of leachate recirculated in Cells 1-6.

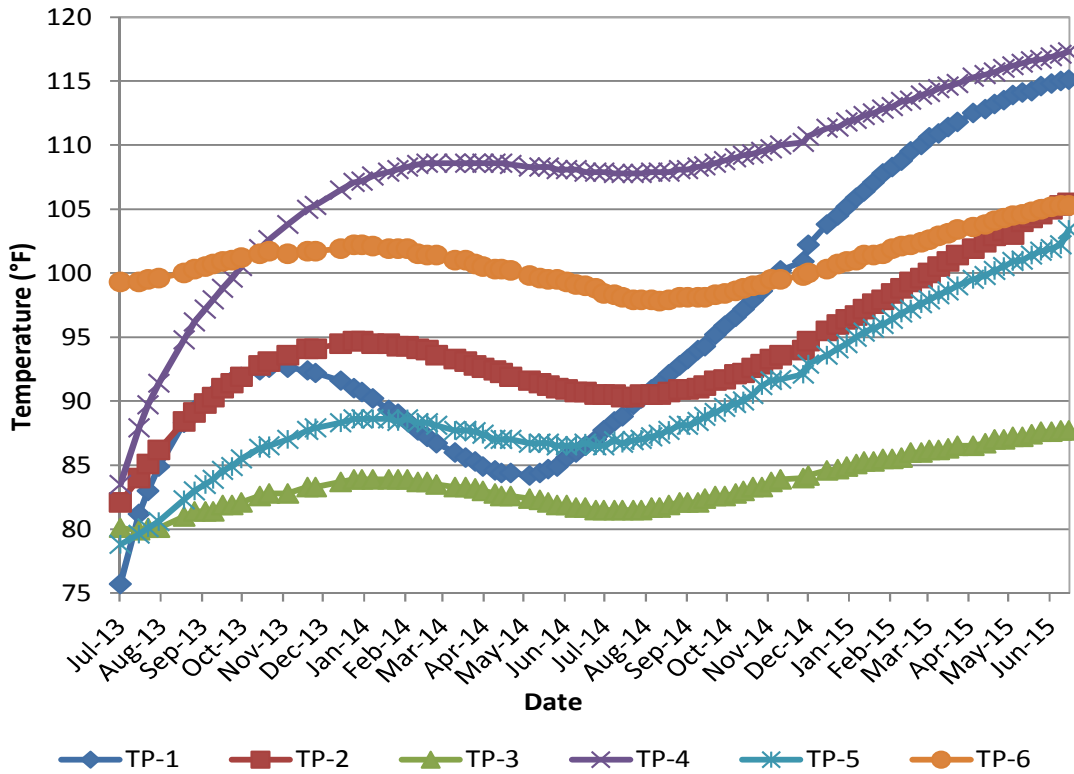
Figure 4-22 Waste Temperature Readings in Cell 6

The temperature of waste in Cell 6 is shown in **Figure 4-22**. Leachate recirculation in this cell began in June 2014.

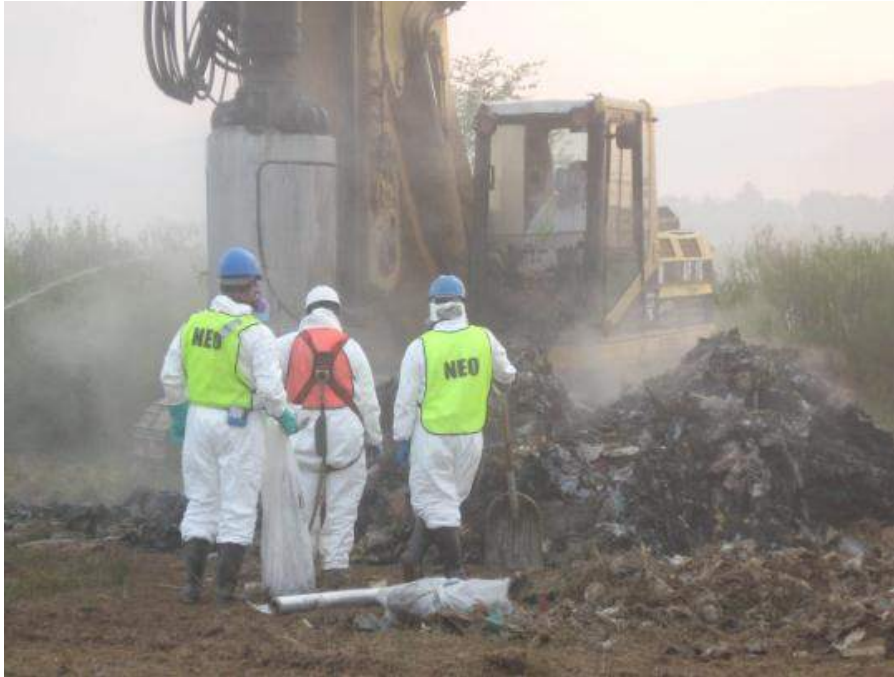
Figure 5-5 Exhumed Waste from Drilling of Vertical Well 24

The waste from these five boreholes was observed to be noticeably wetter than the waste for the other boreholes. Steam emanating from the waste of VW-24 was indicative of the elevated temperatures. The waste from this borehole appeared to be well decomposed.

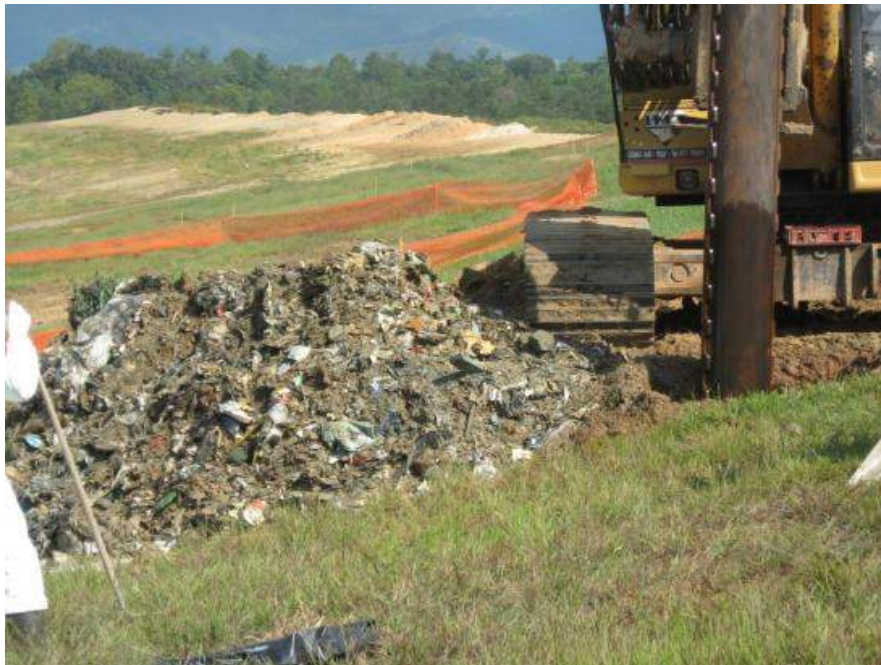
Figure 5-6 Exhumed Waste from Drilling of Vertical Well 13
