2016 Year-End Progress Report

# USEPA PROJECT XL

## Buncombe County Bioreactor Project

### Buncombe County Solid Waste Management Facility

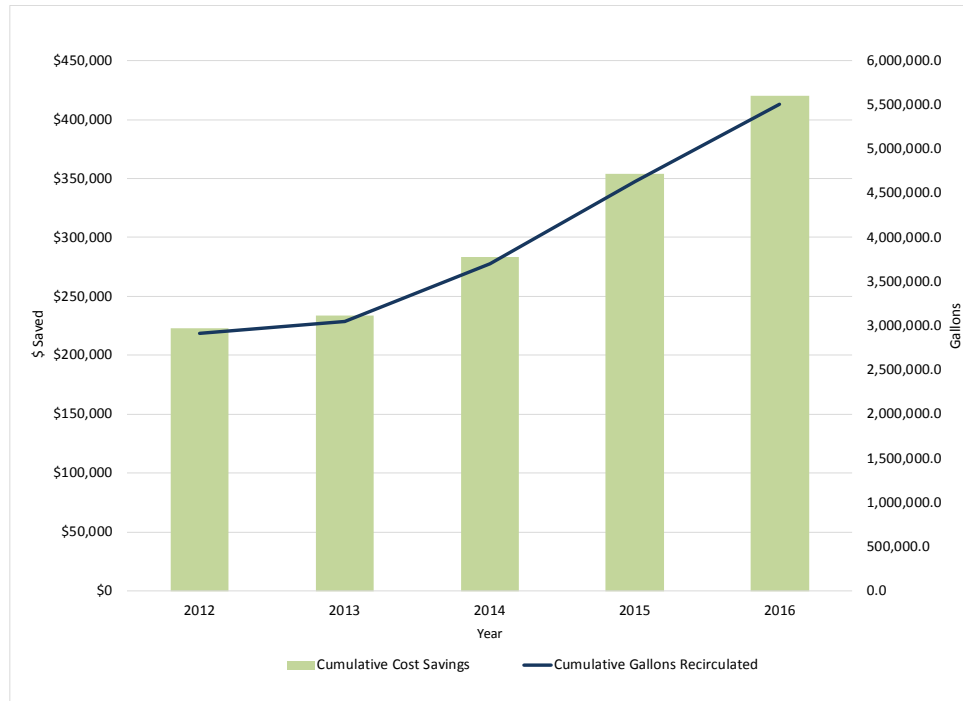
**Figure ES-1: Gallons Recirculated Compared with Truck Hauling Cost Savings**

Approximately 5.5 million gallons of leachate has been recirculated since the program began, resulting in 1,101 less truck trips to the wastewater treatment plant (WWTP). That has provided a savings of \$420,095.38 in avoided hauling costs as shown in **Figure ES-1** below. With the expansion of the leachate recirculation system into Cell 6, the largest cell of the landfill, the amount of leachate that can be recirculated is significantly increased. **Figure ES-2** shows the number of truck hauls per semi-annual period along with the recirculated leachate in equivalent truck hauls.

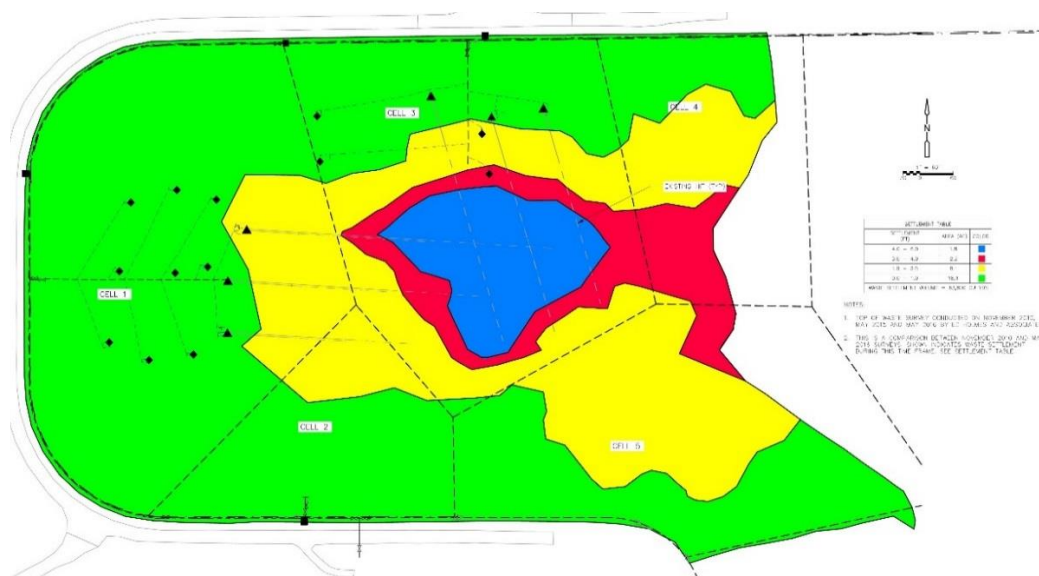
**Figure ES-3: Settlement in Cells 1 through 5 since November 2010**

Settlement plates installed in Cells 1-5 show an average settlement of 1.52 ft. from January 2006 to May 2016. Comparison of topographic surveys of Cells 1-5 taken in 2010 and 2016, show 0-1 ft. settlement on the slopes and 1-6 ft. settlement over the waste plateau as shown in **Figure ES-3**. The prominent settlement areas correspond with the locations of the recirculation trenches but also benefit from stormwater that is captured on the waste plateau. The settlement in Cells 1-5 is estimated to be approximately 51,000 cy which is equivalent to five months of capacity valued at nearly \$2 million.

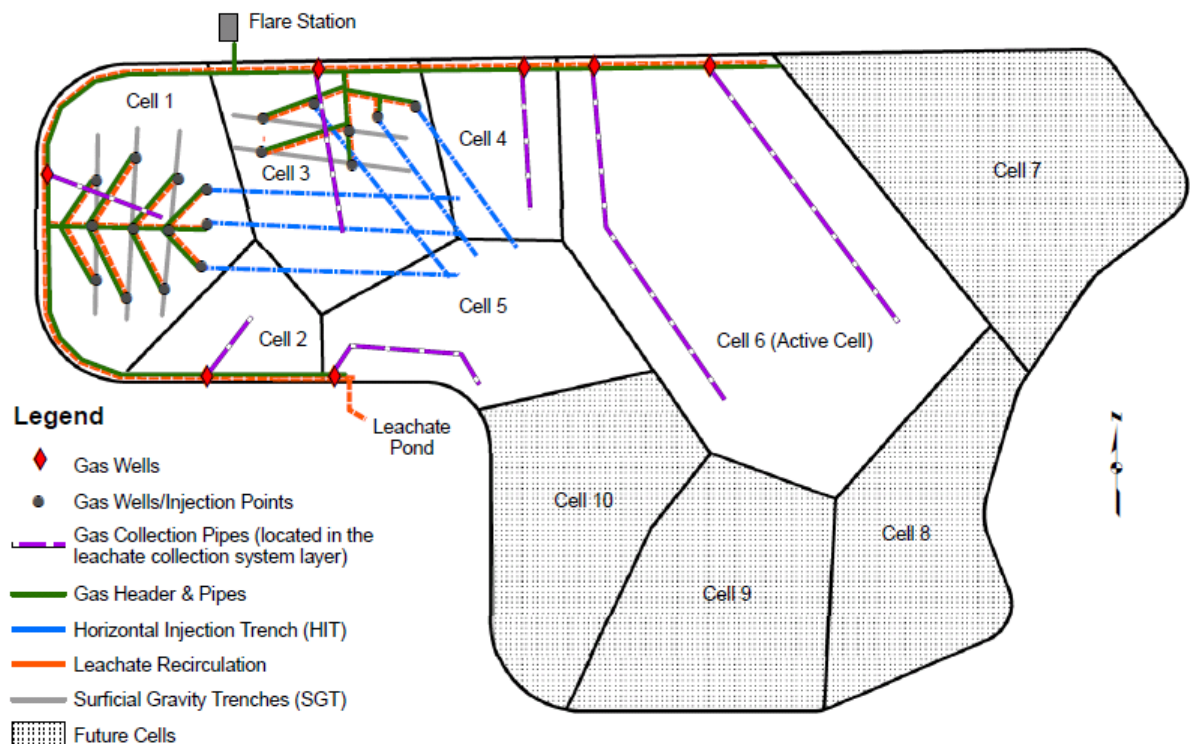
**Figure 2-1 Retrofit Bioreactor System**

Cells 1-5 was nearing capacity when the project began, prompting the need to install a retrofit system. The retrofit system is equipped to recirculate leachate using a combination of horizontal injection trenches (HIT) and surficial gravity trenches (SGT) as shown in **Figure 2-1**.

Six HIT were installed in the retrofit area. The first three HIT were installed in anticipation of the project being approved when the top of waste was at Elevation 2040. They extend approximately 400

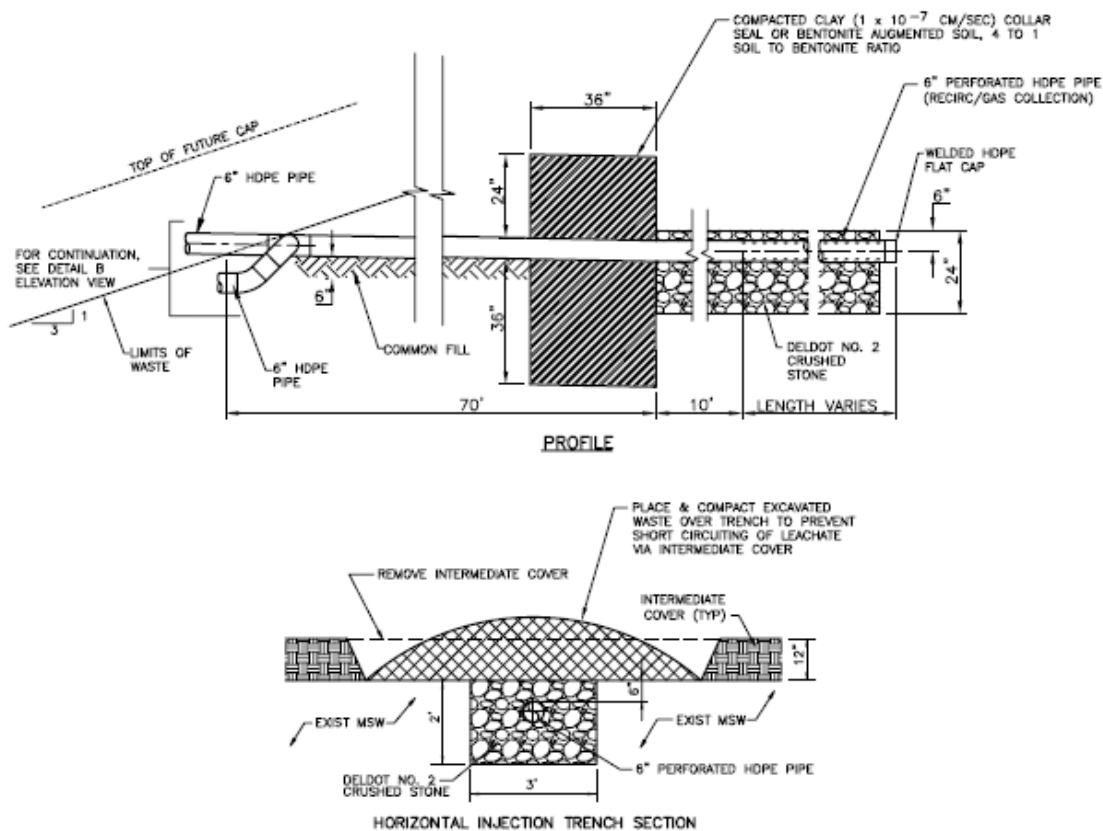
**Figure 2-2 Horizontal Injection Trench**

Construction details of the HIT and SGT are shown in **Figures 2-2** and **2-3**.

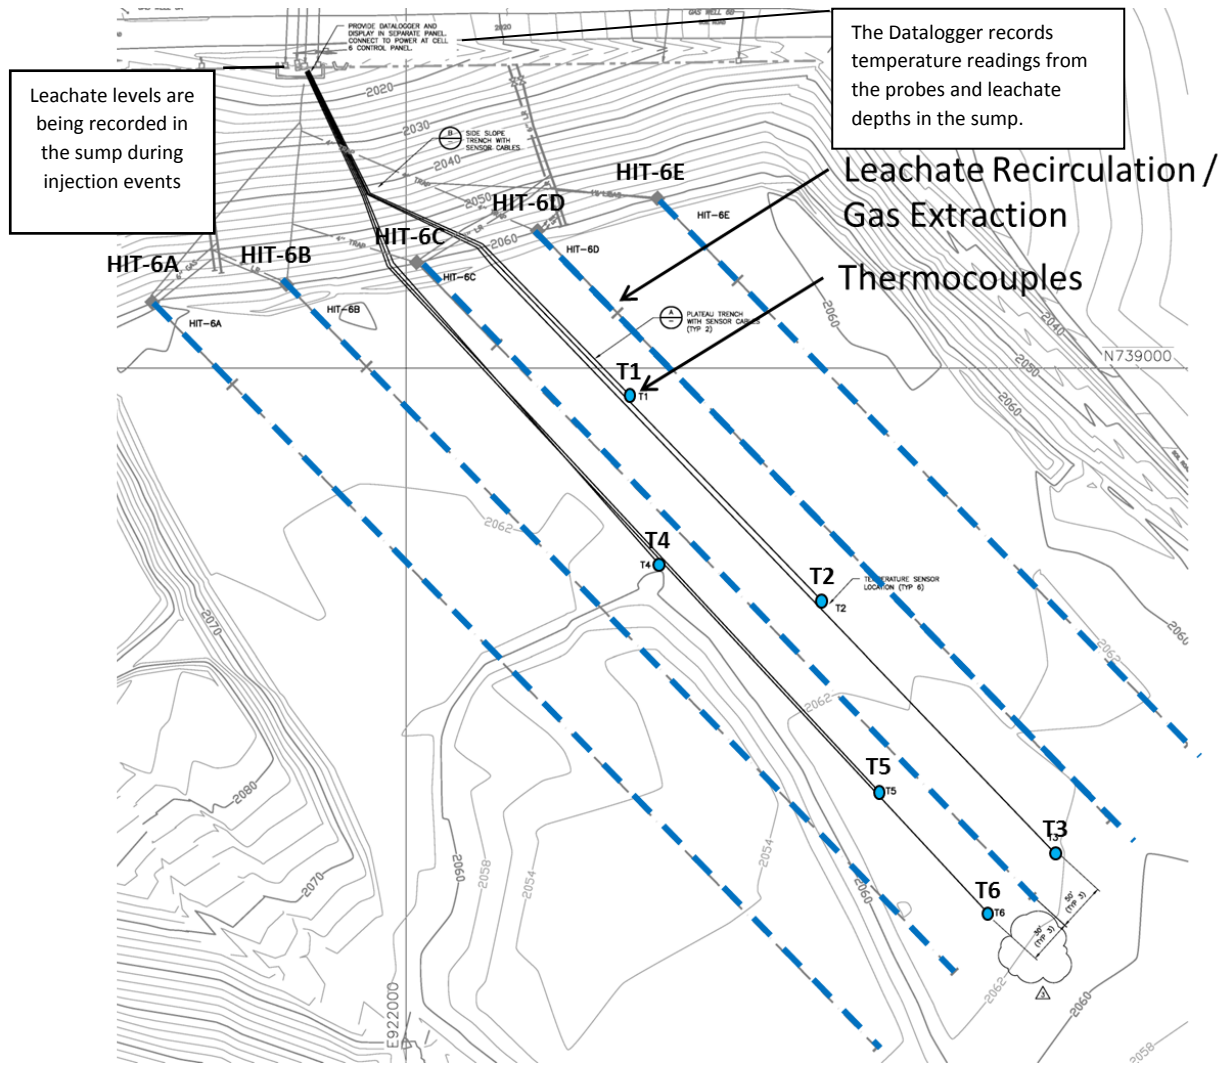
Figure 2-8 Temperature Sensors in Cell 6

Thermocouples were installed in six (6) locations around the Cell 6 Phase 1 HIT in July 2012 as shown in **Figure 2-8**. The thermocouples consist of a stainless steel temperature sensor with a lead cable as shown in **Figure 2-9**. The thermocouples were placed in 4-inch perforated PVC pipe packed with concrete sand. The cable end of the pipe was left open to allow cable movement during settlement. The sensors transmit temperature data to a datalogger installed adjacent to the Cell 6 pump station control panel that is downloaded monthly. Temperature readings are being used to monitor decomposition as active mesophilic bacteria typically results in a range between 80°F and 115°F. The sensors are also helpful in assessing the impacts of leachate temperature during injection. As ambient air temperatures drop in the winter, the leachate in the pond will get colder.

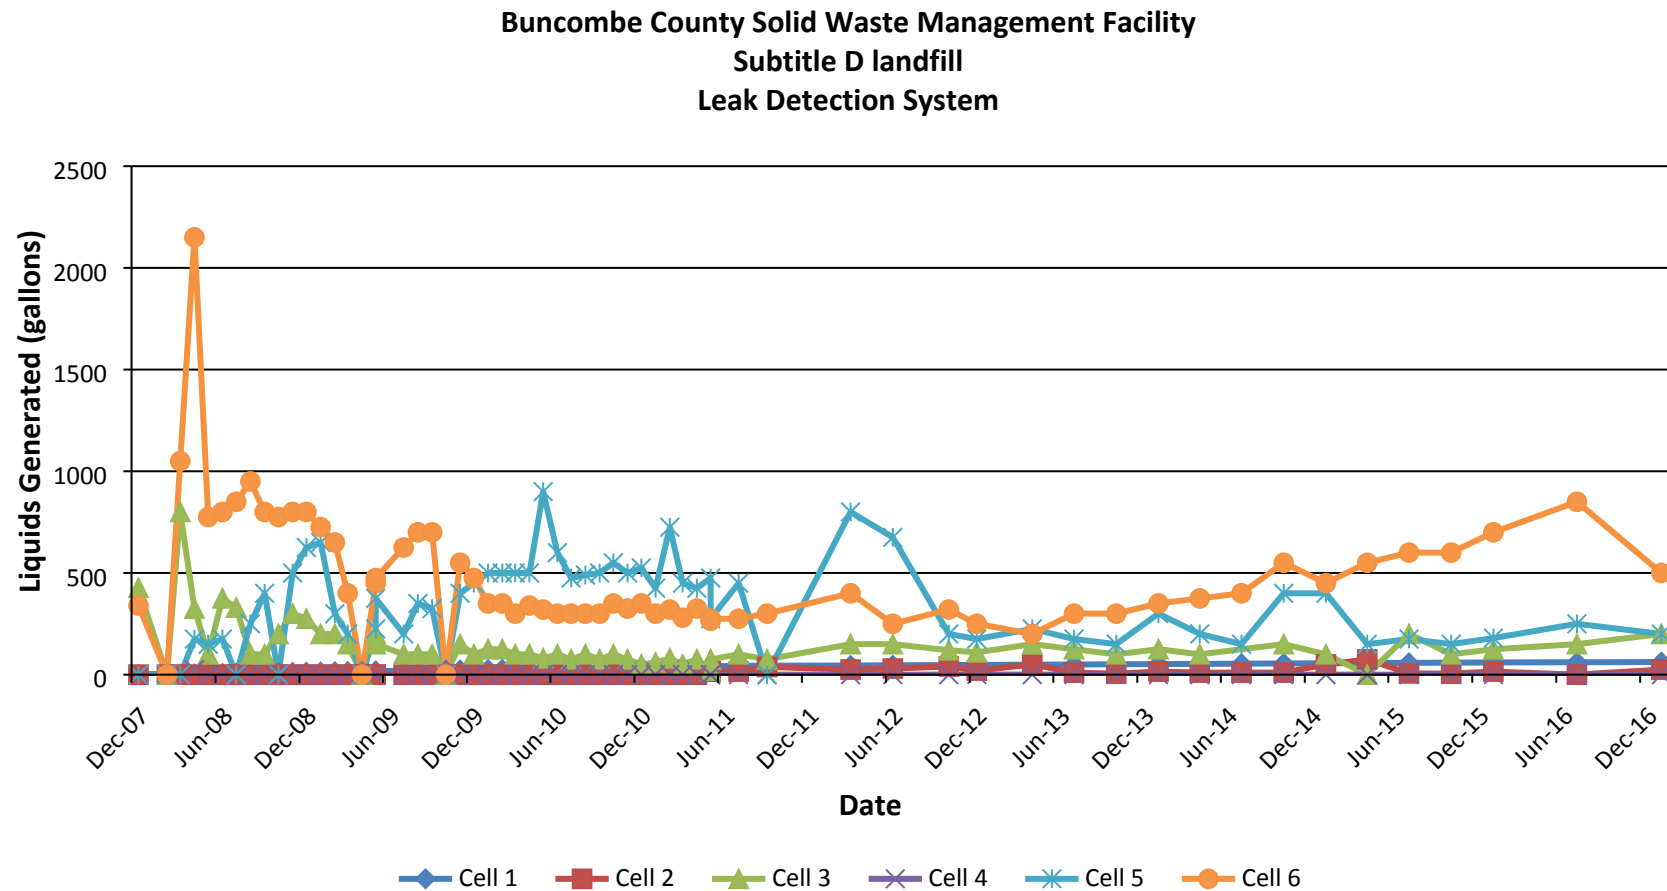
Figure 4-1 Semi-Annual Leak Detection Volumes

**Figure 4-1** shows the monthly quantities of liquid collected from the LDZ. **Figures 4-2** through **4-7** show qualitative data from testing of the liquid. The parameters are pH, conductance, ORP, BOD5, COD and ammonia.

**Table 4-1** shows the annual quantity of liquid collected from the leak detection zone (LDZ). Liquids have been observed in the Cell 1LDZ but the project team is unable to measure the quantity due to the remote location of the discharge. A method to measure quantity from Cell 1 was discussed during the 2016 stakeholders meeting and is presented in Section 6.

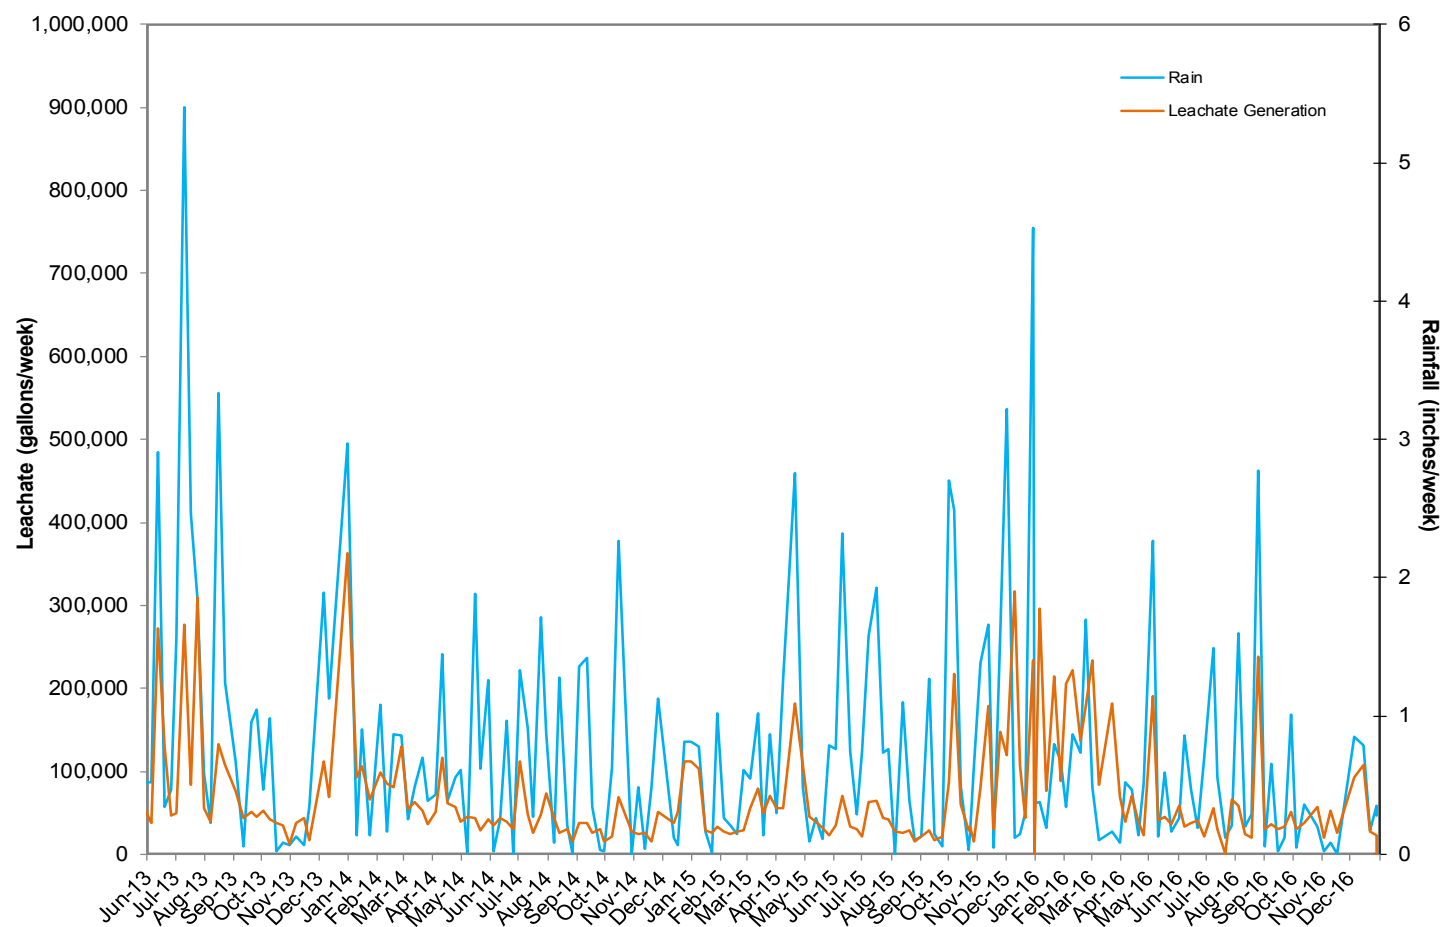
**Figure 4-8 Leachate Generation vs. Rainfall**

1. Leachate generation value low due to broken air compressor resulting in less condensate discharge.

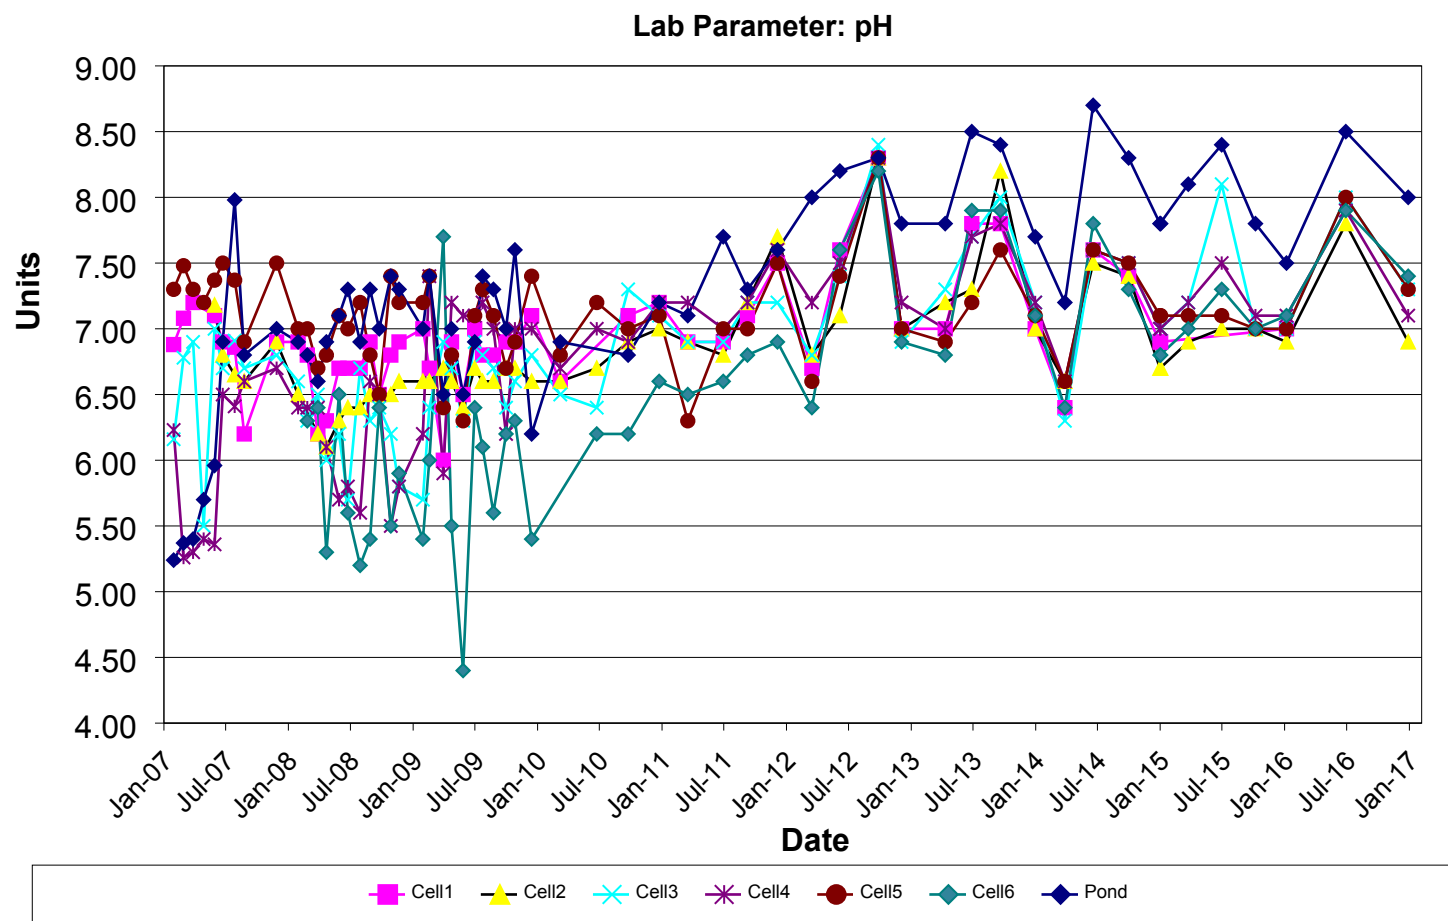
**Figure 4-13 pH of Leachate**

\*Note: No readings were taken in Cell 1 during the January-December 2015 period due to a clogged sampling port.

It was also observed that the pH of the leachate in the pond was higher than the leachate in the cells as shown in Figure 4-13. However, the pH trend for the pond follows the leachate pH trend for the cells. It is thought that the concrete liner could possibly contribute to the higher pH in the pond. The liquid in the LDZ of the pond is mostly groundwater based on a comparison of conductance.

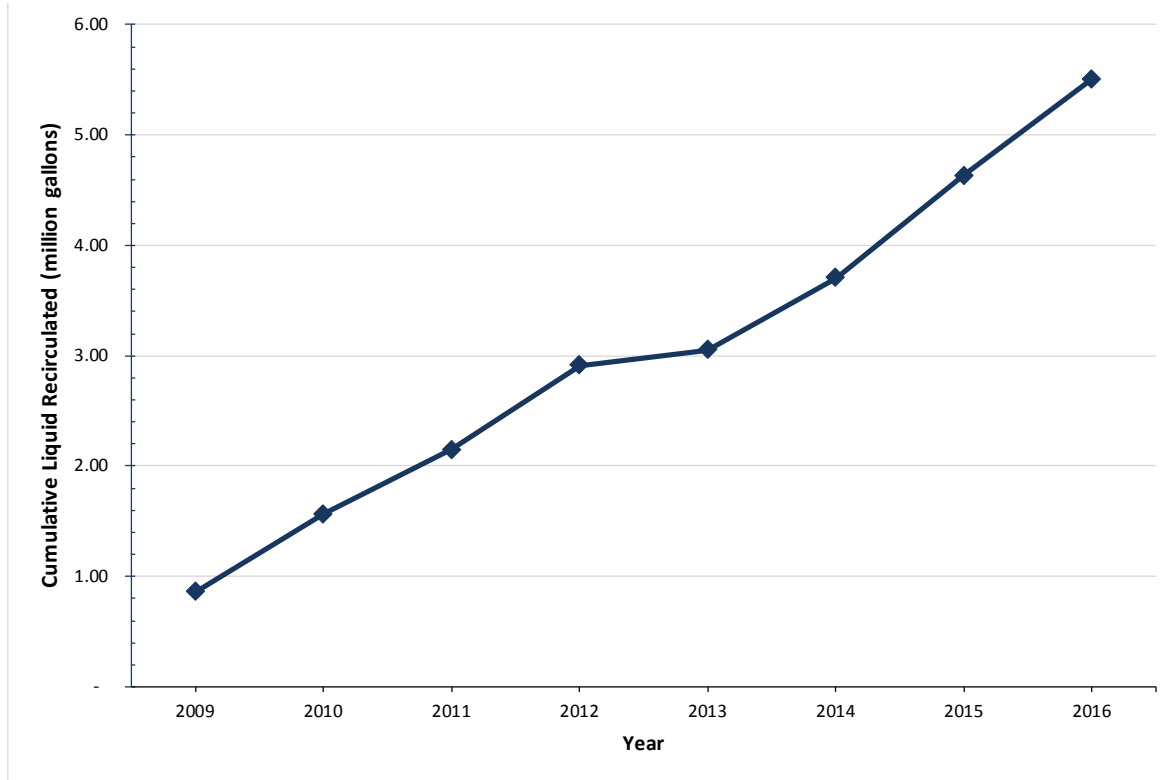
**Figure 4-16 Cumulative Volume of Leachate Recirculated**

**Figure 4-16** shows the cumulative quantity of leachate recirculated from 2006 through 2016. Approximately 5.5 million gallons of leachate have been recirculated. The annual leachate recirculated is presented in **Table 4-3**.

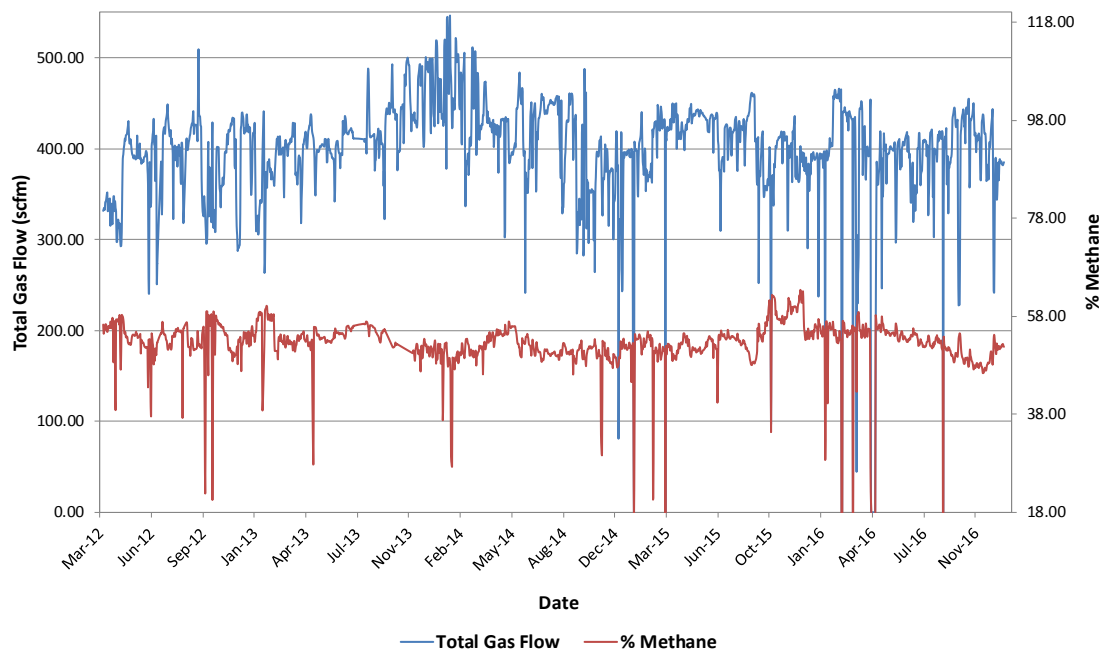
**Figure 4-17 Total Gas Flow and Percent Methane at the LFGTE Facility**

The total gas flow and methane percentage of the gas collected from the landfill is monitored continuously at the LFGTE facility as presented in **Figure 4-17**.

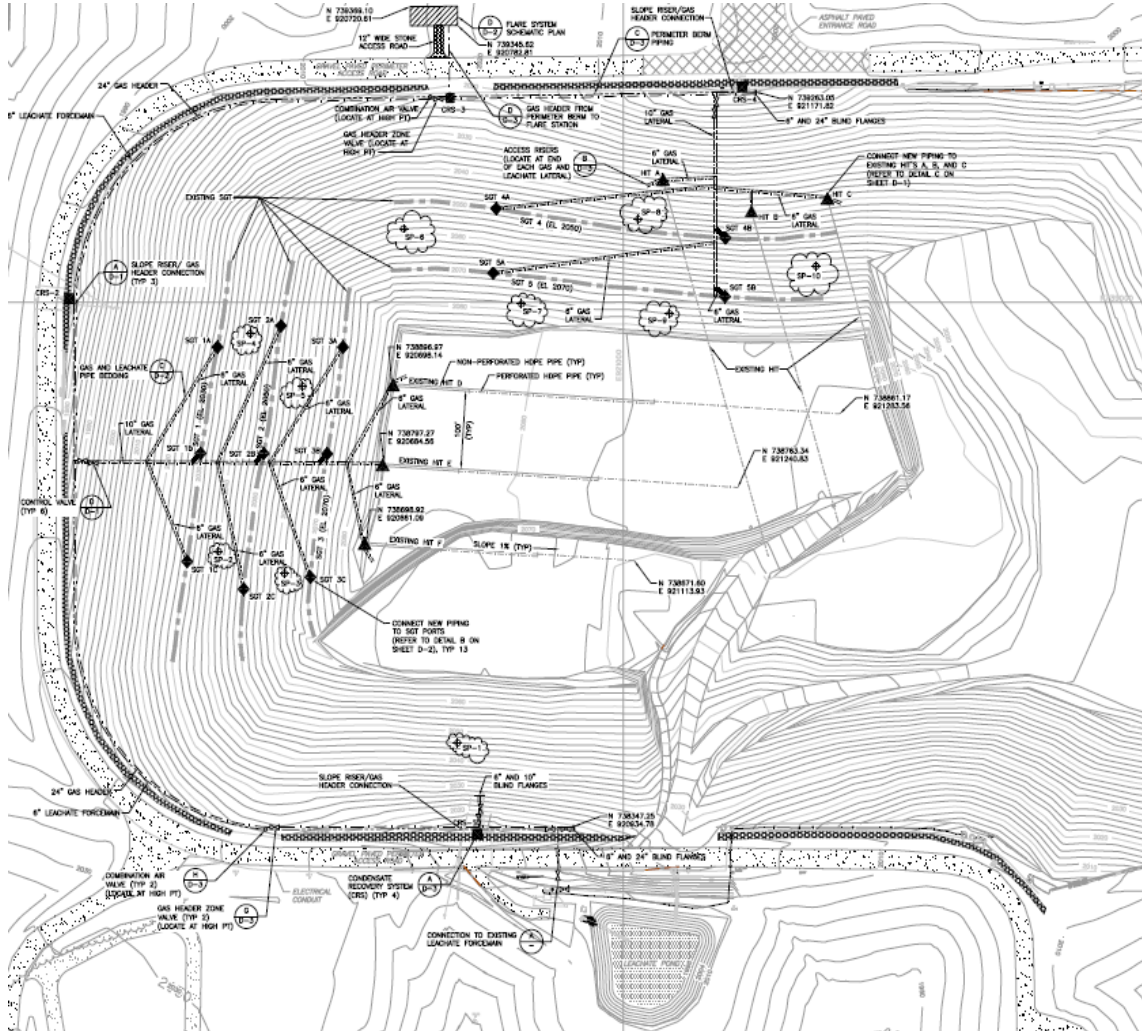
**Figure 4-18 Settlement Plates in Cells 1-5**  
(Plate locations are shown circled with cloud outline.)

The location of the ten (10) settlement plates installed within the retrofit area is shown in **Figure 4-18**.

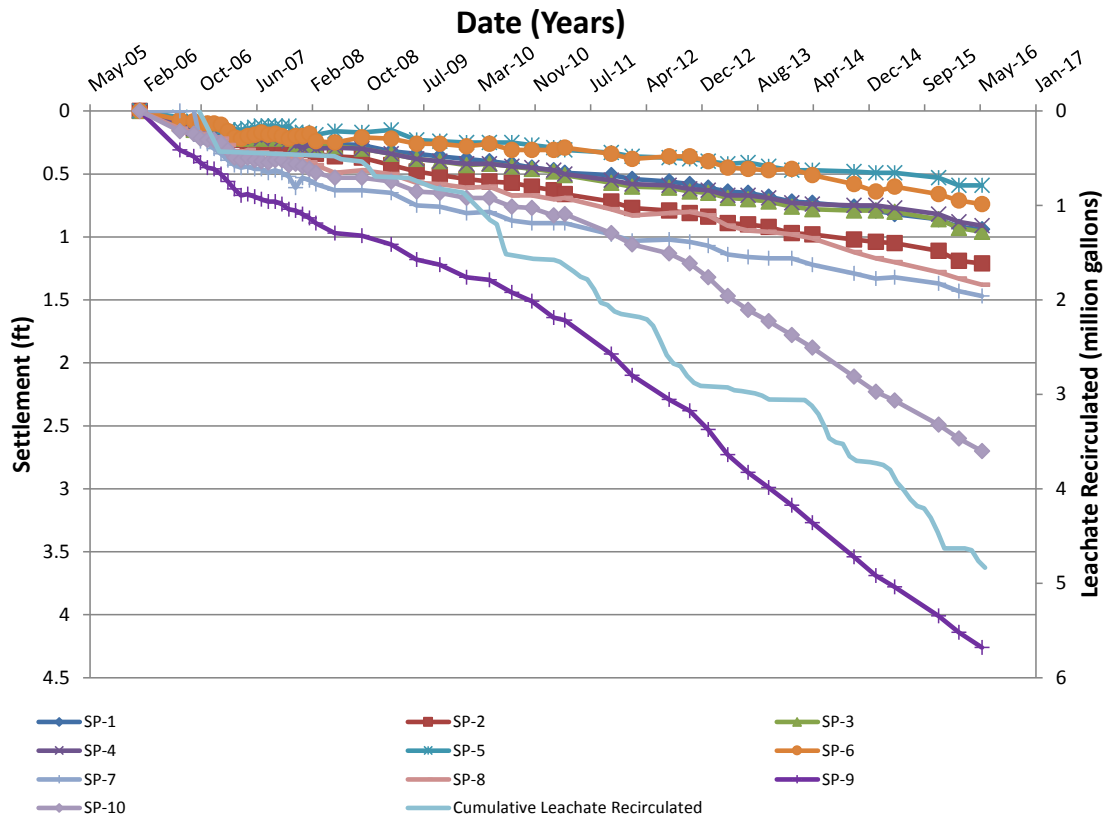
**Figure 4-19 Cumulative Settlement**

**Figure 4-19** compares the measured settlement in the settlement plates from July 2006 through May 2016 to the quantity of leachate recirculated in Cells 1-6.

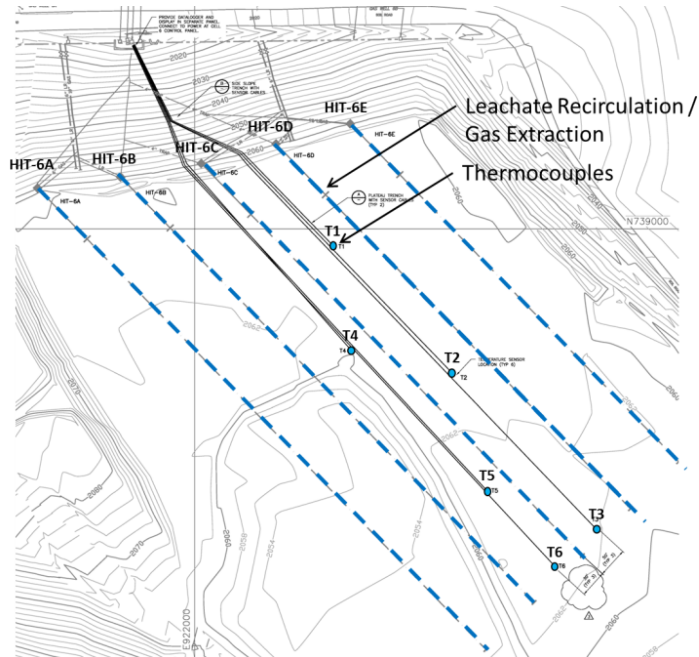
**Figure 4-21 Temperature Sensors in Cell 6**

Thermocouples were installed in six (6) locations around Cell 6 HIT in assessing the impacts of leachate temperature during injection as shown in **Figure 4-21**.

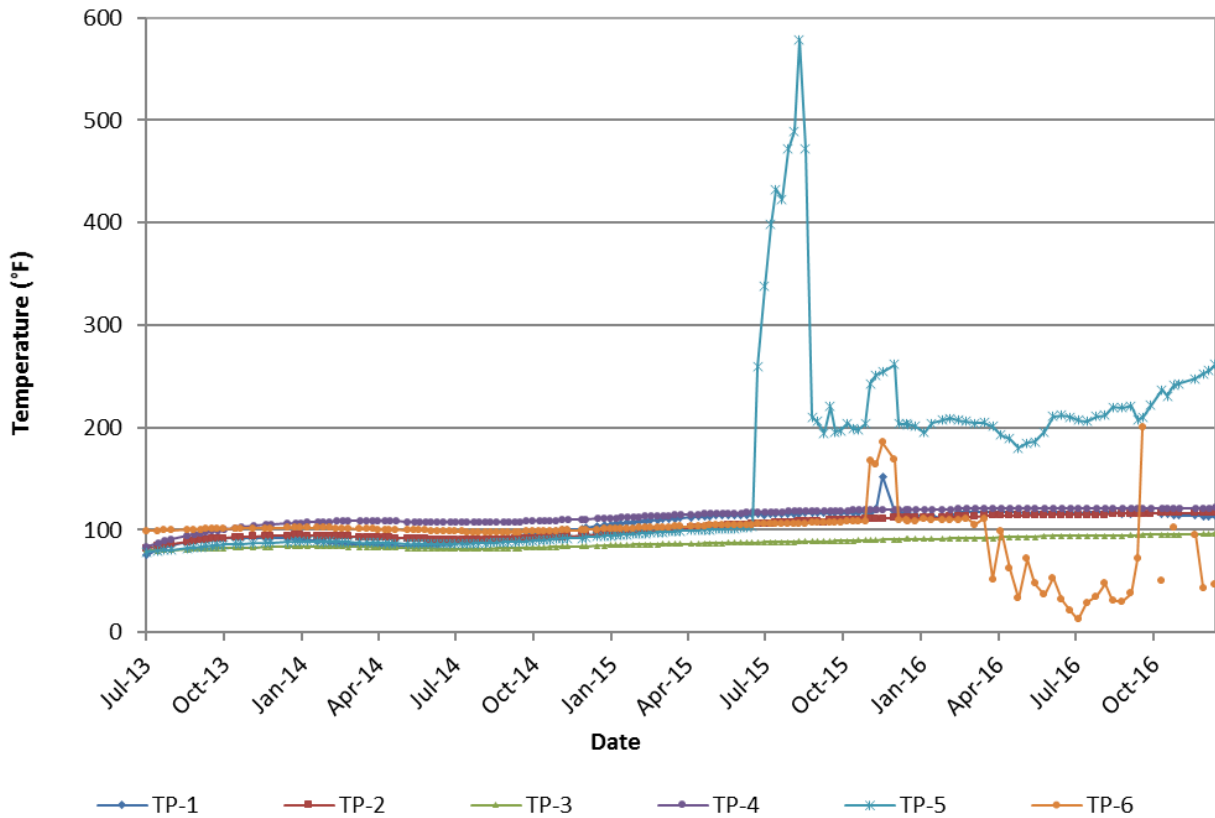
**Figure 4-22 Waste Temperature Readings in Cell 6**

The temperature of waste in Cell 6 is shown in **Figure 4-22**. Thermocouple T6 seems to have failed as of April 2016 as evidenced by erratic jumps from negative to positive temperatures in under a minute. Leachate recirculation in this cell began in June 2014.

\*Thermocouple TP-6 has failed as of April 2016.

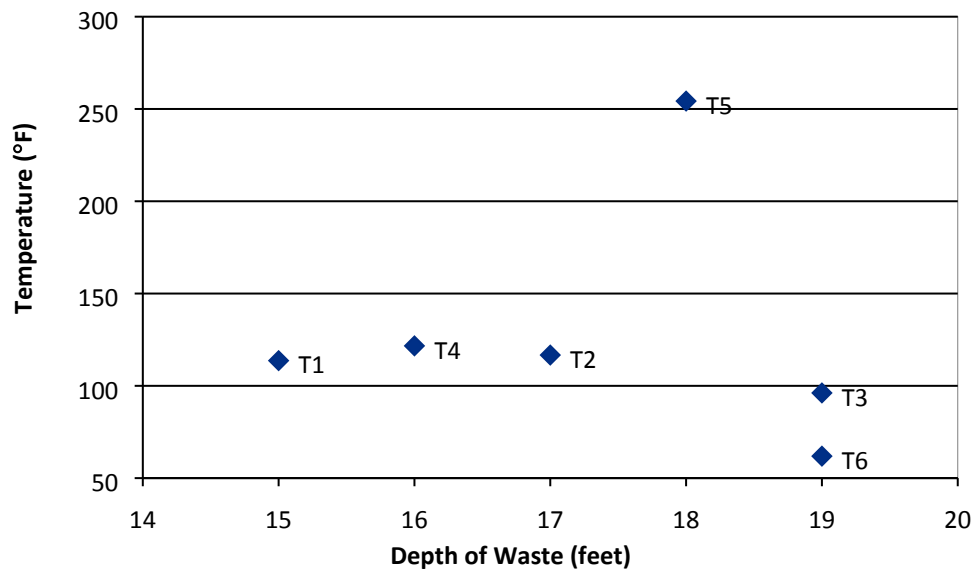
**Figure 4-23 Temperature of Waste at Various Depths in Cell 6**

The temperature of waste in Cell 6 compared with the depth of waste is shown in **Figure 4-23**.

(Note: Waste Depths from January 2016 Topographic Survey and Temperature Reading from December 2016)

\*Thermocouple T6 has failed as of April 2016.

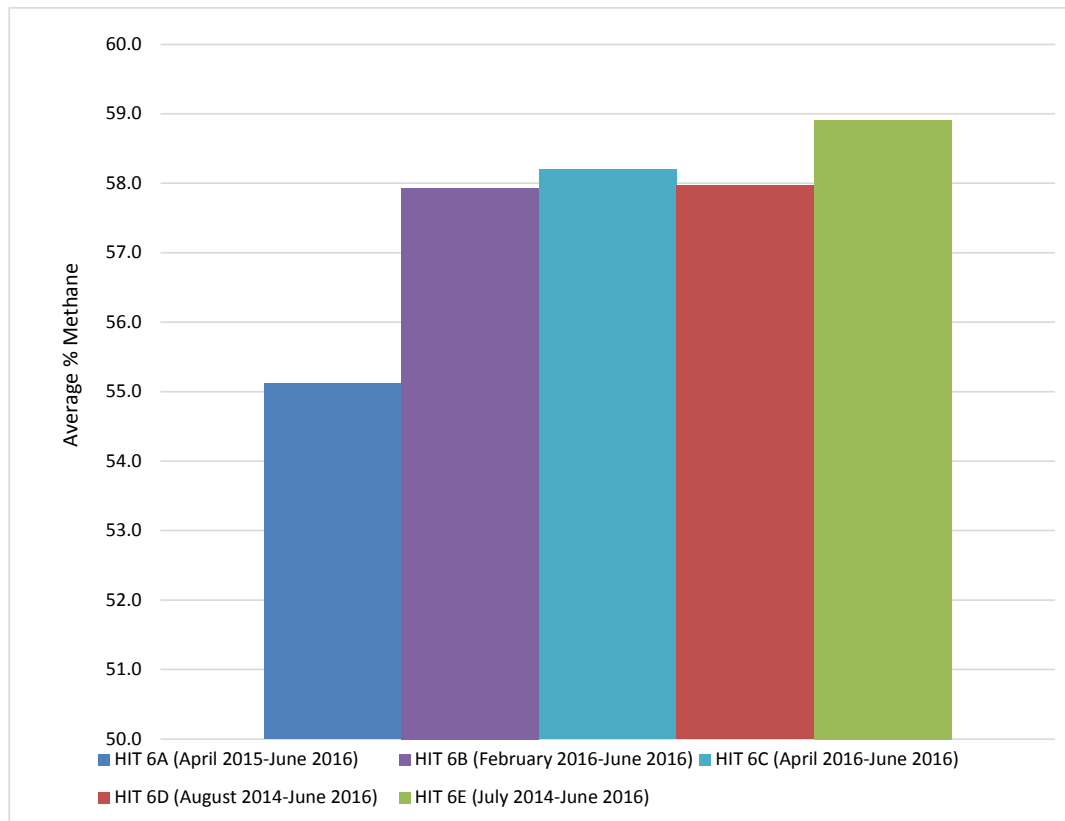
**Figure 4-24 Average Percent Methane in HITs 6A, 6B, 6C, 6D, and 6E**

Landfill gas is being collected from HITs 6A, 6D, and 6E and monitoring data has been collected since mid-2014. As no recirculation was done in HITs 6B and 6C during the January-June 2016 period due to weather conditions, landfill gas was collected from these as well. No data has been collected since June 2016. **Figure 4-24** shows the percent methane in each of these HITs and **Figure 4-25** shows the flow rate in standard cubic feet per minute (SCFM).

Landfill gas monitoring data has been collected since mid-2014 for HIT 6D and 6E and since early 2015 for HIT 6A as reported in Section 4.8. The landfill gas collection from the HITs has been successful. Methane contents are between 58% and 59% and the wells have steady flow rates. Therefore, it is recommended that landfill gas continue to be collected from the HITs that are not being used for recirculation and even in the ones being used for recirculation after they are dry.

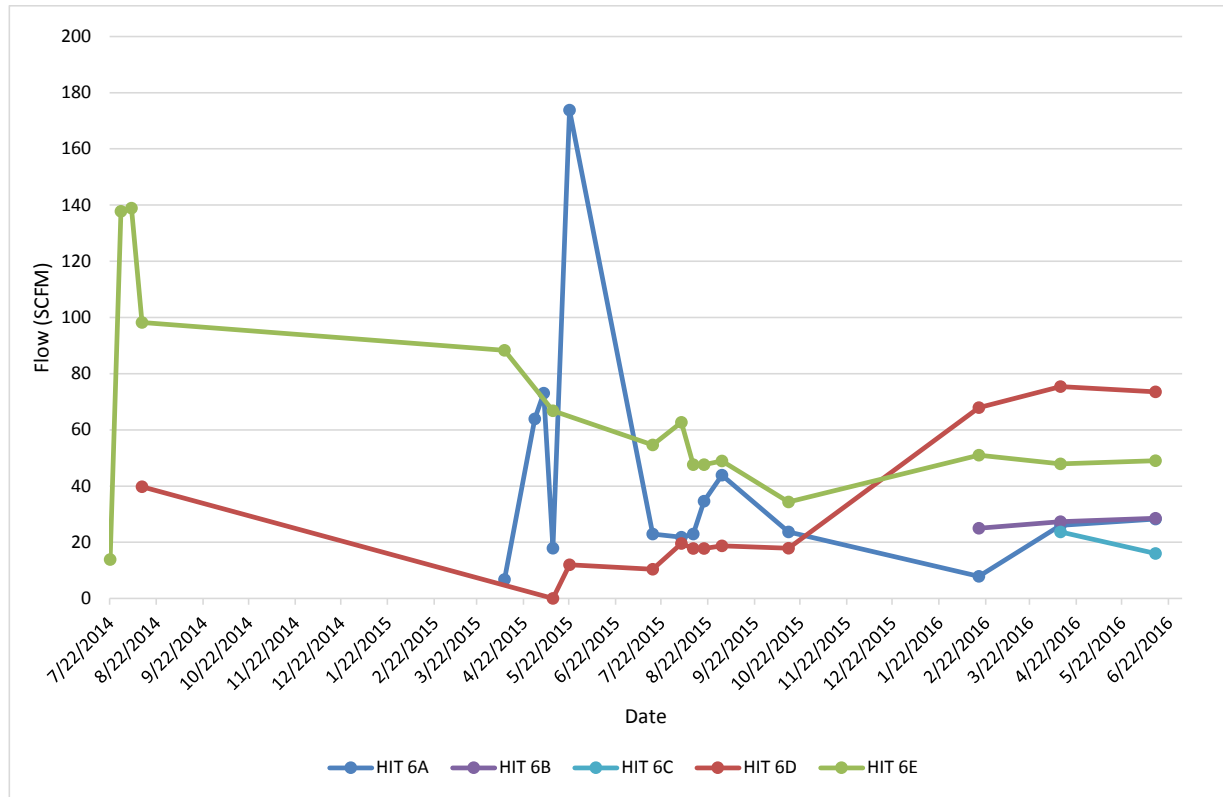
**Figure 4-25 Flow Rate in HITs 6A, 6B, 6C, 6D, and 6E**

(\*Flows were calculated using the differential pressure, vacuum, and orifice plate size for the HITs.)

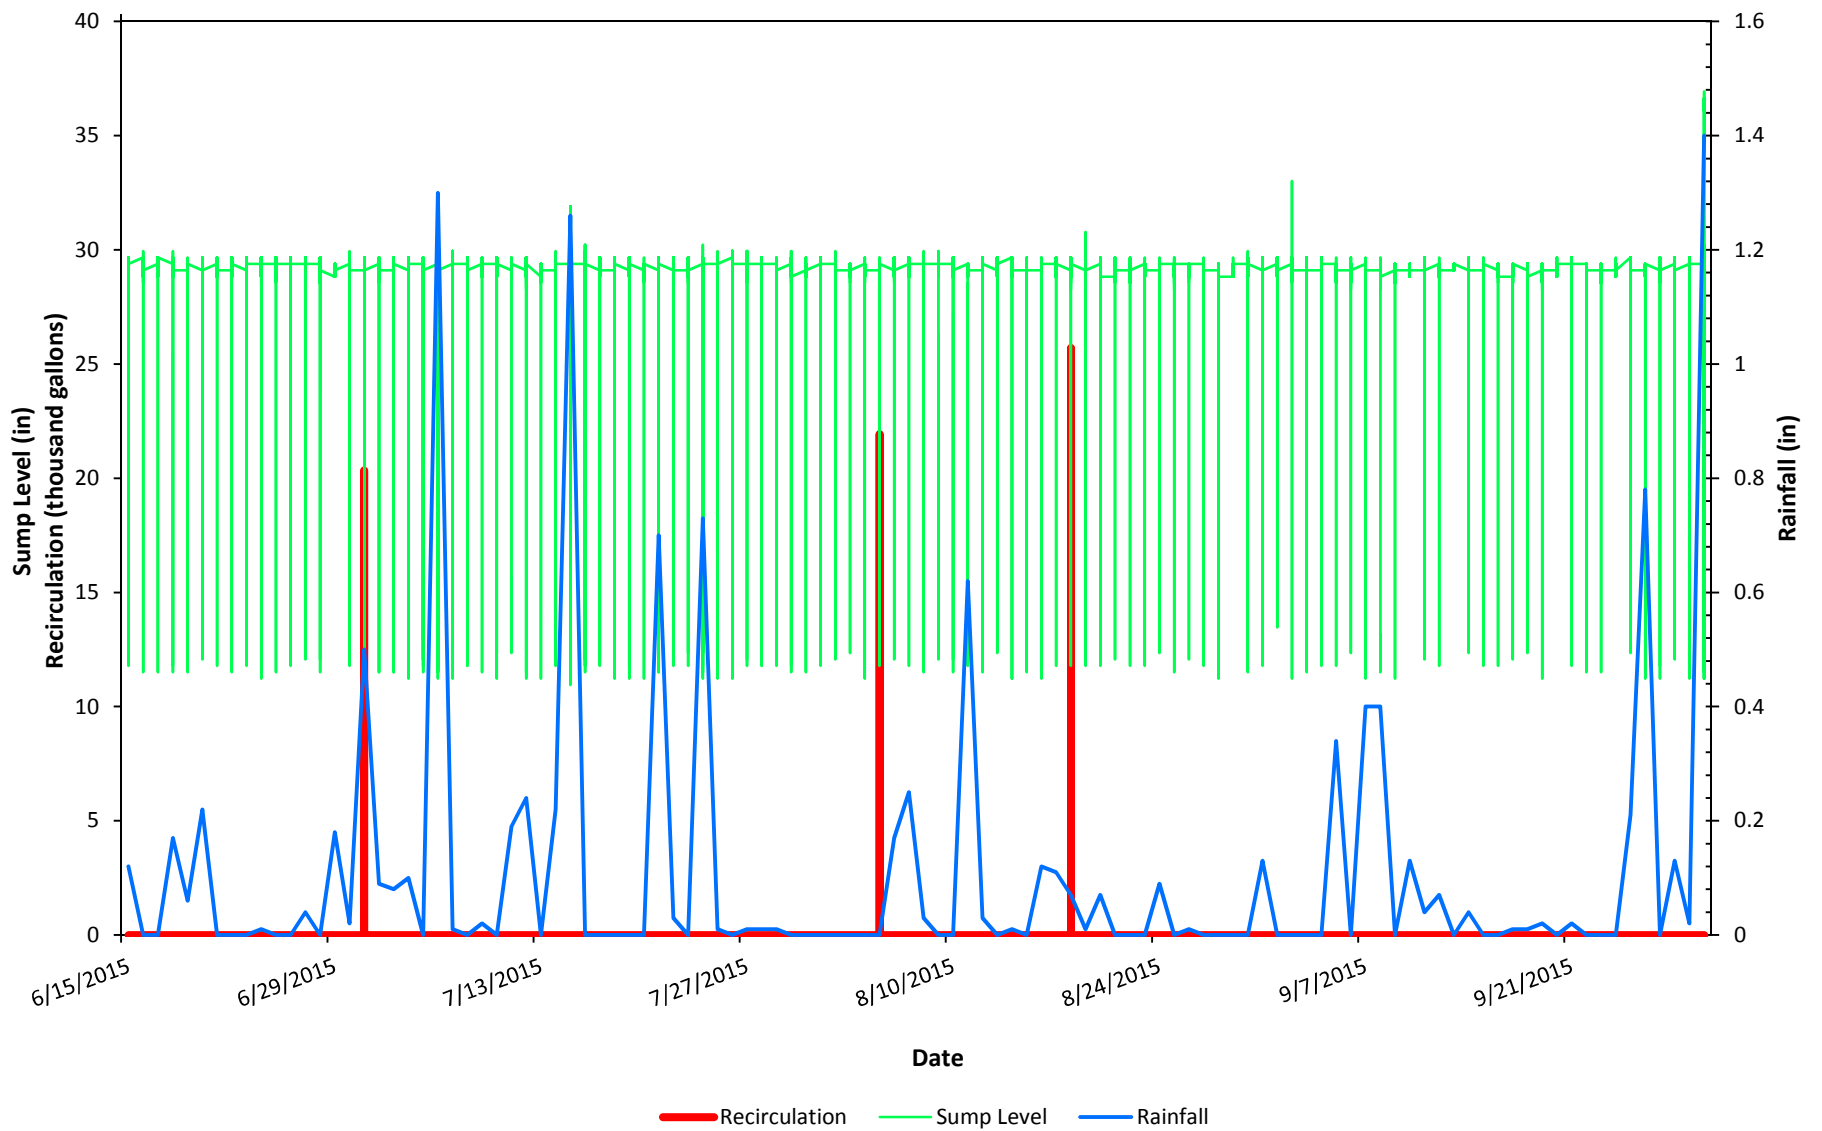
**Figure 4-26 Cell 6 Sump Level, Recirculation Events, and Rainfall**

Data has been collected from the Cell 6 pump datalogger to record the sump level. The Cell 6 sump pump is set to turn on at a level of 30 inches and off at a level of 12 inches. **Figure 4-26** shows a graph of the sump levels from June through September 2015 along with the recirculation events and daily rainfall. As no recirculation was done in Cell 6 during the January through June 2016 period, there is no update to this graph from the 2015 year-end report. The datalogger data was corrupt for the June through December 2016 period, and the figure was not able to be updated.

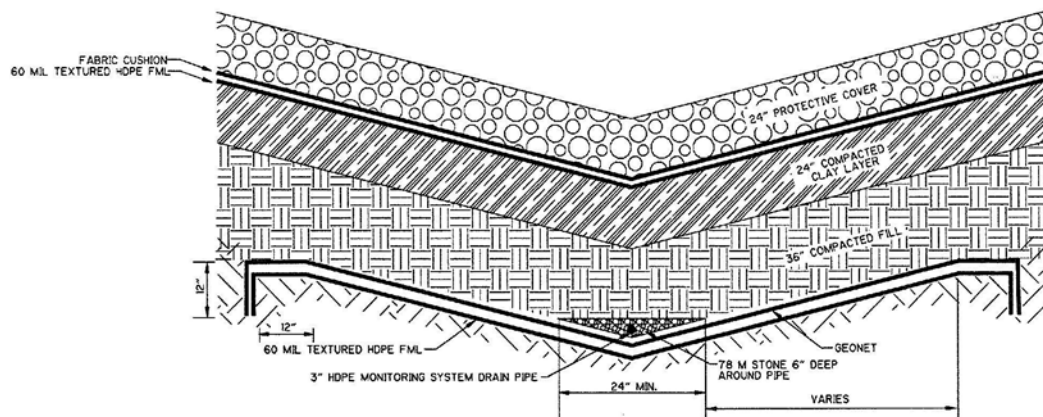
**Figure 5-1 Leak Detection Zone in Cells 1-6 and Leachate Pond**

The landfill cells and leachate pond are equipped with leak detection zones (LDZ) located beneath the leachate collection system sumps. The LDZ, as shown in **Figure 5-1**, are approximately 1 acre in size and consist of a 60 mil HDPE geomembrane and a 24-inch rock drainage layer located 3-ft below the subgrade of the liner system. The geomembrane is sloped to direct liquid to a collection pipe located directly below the leachate sumps. For Cells 3-6, liquid captured in the LDZ is pumped out through vertical stand pipes located along the perimeter berm. Cells 1 and 2 drain liquid through gravity pipes that protrude from the outer slope of the landfill perimeter access road. The drain pipes are equipped with gate valves that the operator opens to check for liquid. Quantity data is not recorded for Cell 1 as it appears to be impacted by a steady supply of groundwater from an underground spring. Further

Liquid present in the LDZ could be leachate that has leaked through the base liner system, groundwater or a combination of both. As shown in **Figure 5-1**, the LDZ are open on the sides and therefore are subject to potential groundwater infiltration. This is particularly evident in Cell 1 where it appears that the LDZ is being impacted by an underground spring based on the amount of flow witnessed during sampling events and the high quality of the water. Comparison of test data between the LDZ, leachate and groundwater was made in an effort to determine the source of the liquid.

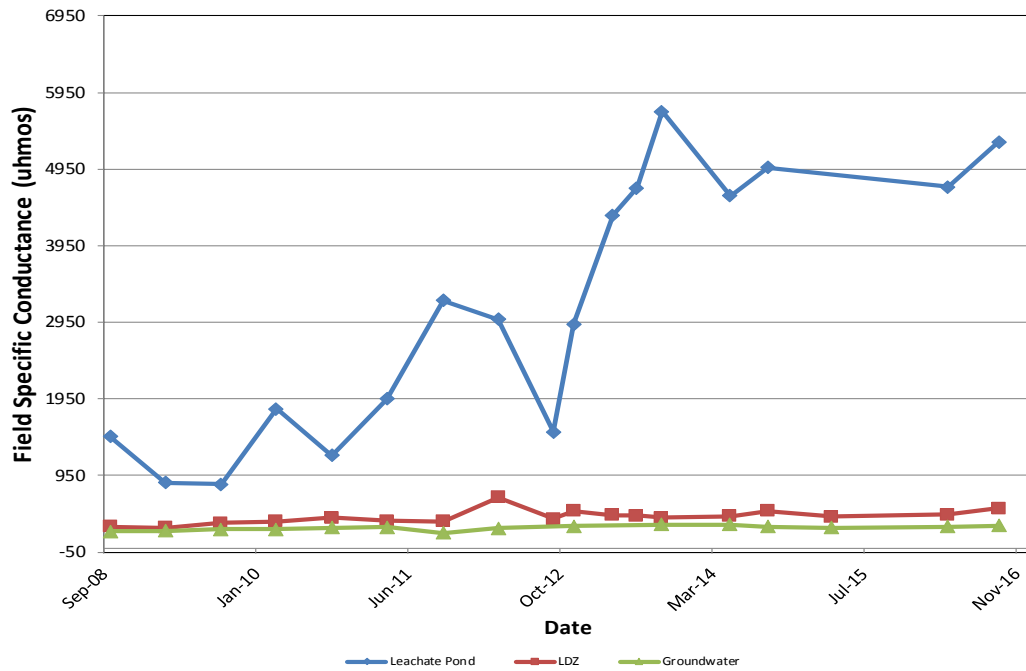
**Figure 5-2 Conductance of Leachate, LDZ, and GW Samples**  
(Values are averages of testing results for the six cells and all GW monitoring wells)

The conductance levels of leachate are much higher than the samples tested for the Cell 1 LDZ. The conductance of leachate is in the range of 800-15,000  $\mu\text{mho}/\text{cm}$  compared to 200-800  $\mu\text{mho}/\text{cm}$  for the LDZ. The LDZ conductance is similar to the levels tested from groundwater well samples in the area as shown in **Figure 5-2**.

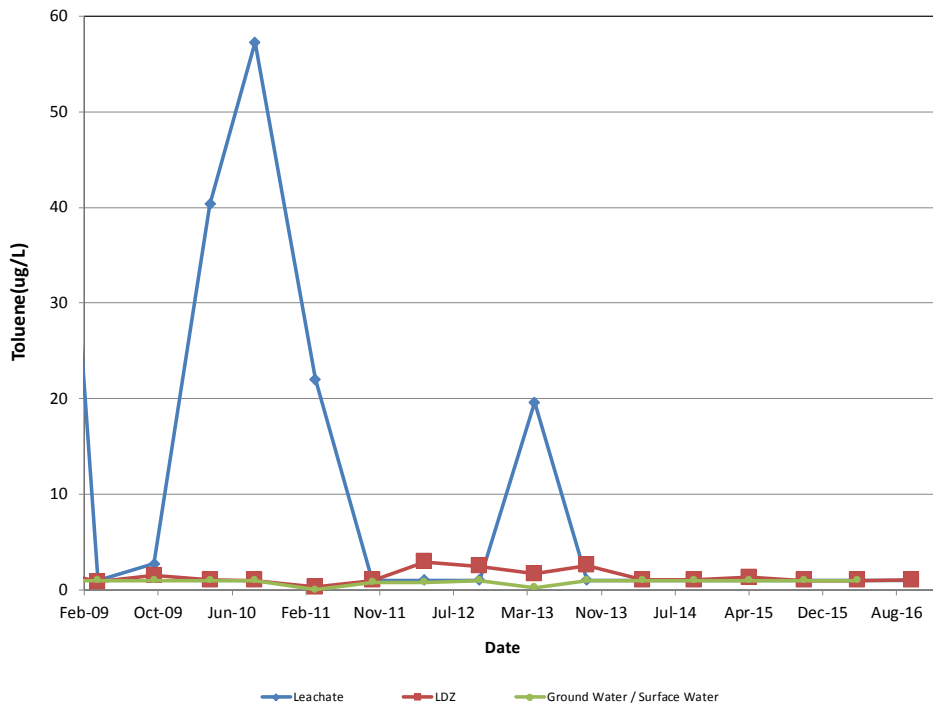
**Figure 5-3 Toluene of Leachate, LDZ and GW/SW Samples**  
(Values are averages of testing results for the six cells and all GW/SW monitoring wells)

Toluene, which is often present in leachate, was found to be much lower in the LDZ samples, which correlate closely with groundwater testing results as shown in **Figure 5-3**.
