2016 Year-End Progress Report

# USEPA PROJECT XL

## Buncombe County Bioreactor Project

### Buncombe County Solid Waste Management Facility

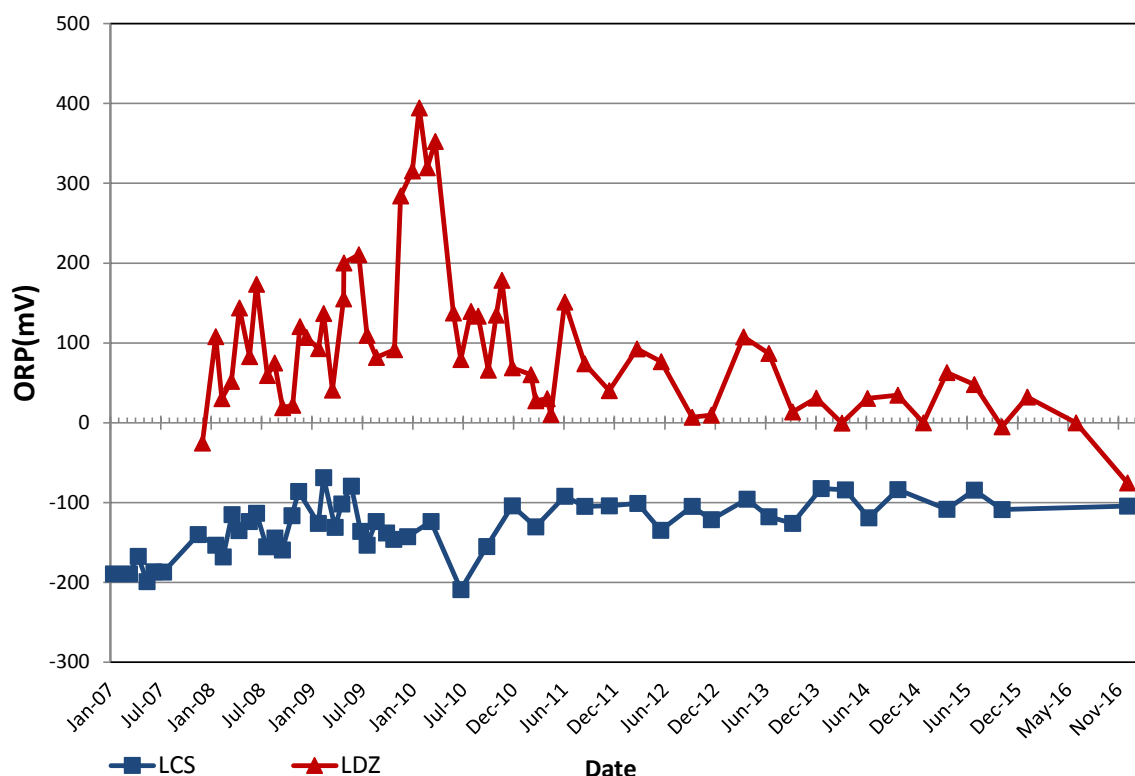
**Figure 5-4 ORP of LCS and LDZ**  
(Values are averages of testing results for the six Cells)

**Figure 5-4** shows the ORP values for the leachate and LDZ samples for all cells. Comparison of ORP values also shows a strong distinction between leachate and the liquid sampled from the LDZ. The ORP values for leachate are all negative while all but two of the LDZ samples produced positive values. A negative value is indicative of anaerobic conditions as would be expected for landfill leachate. Thus, the positive readings for the LDZ samples support the conclusion that the leachate is not a significant component of the LDZ liquid.

\*No readings were taken between January-June 2016 as the meter was being repaired.

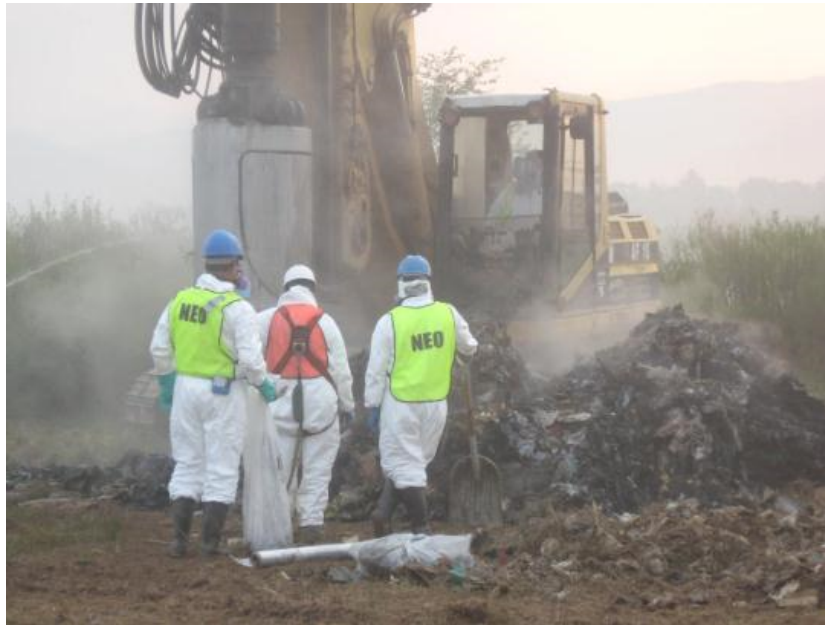
**Figure 5-5 Exhumed Waste from Drilling of Vertical Well 24**

The waste from these five boreholes was observed to be noticeably wetter than the waste for the other boreholes. Steam emanating from the waste of VW-24 was indicative of the elevated temperatures. The waste from this borehole appeared to be well decomposed.

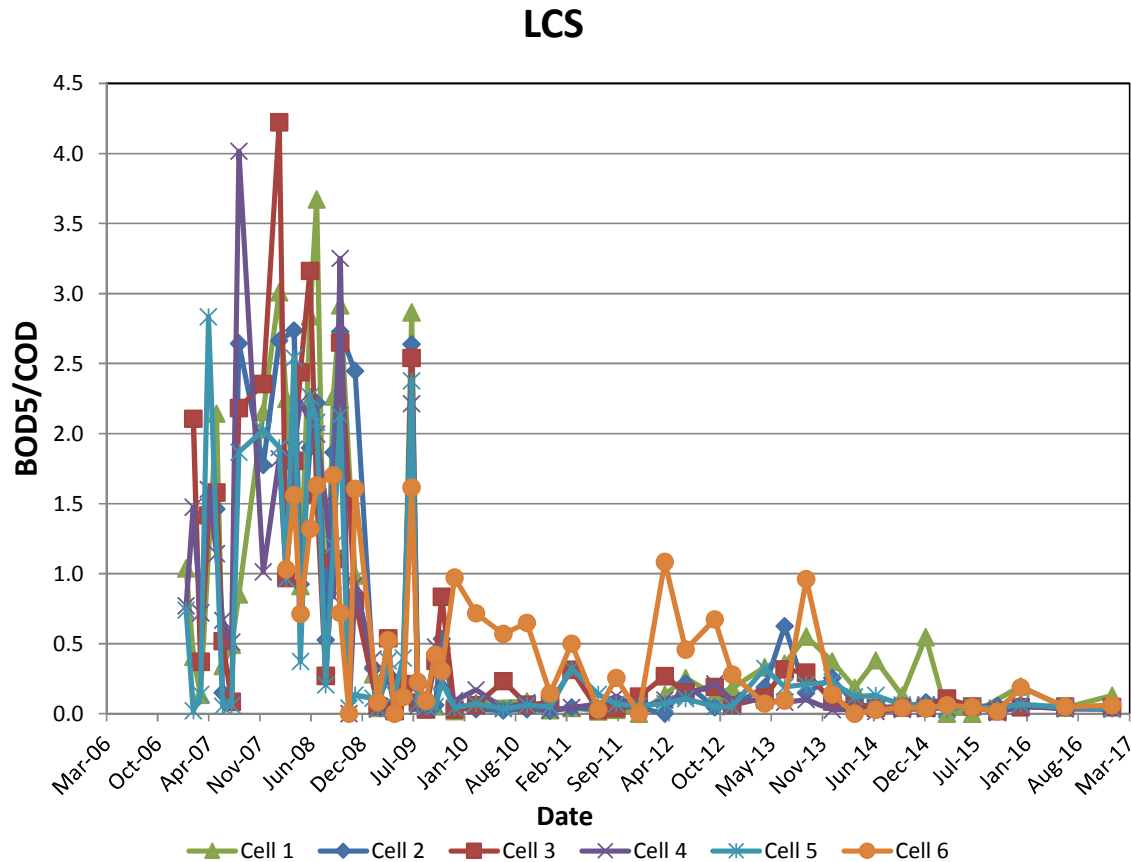
**Figure 5-7 BOD5/COD Ratio of LCS in Cells 1-6**

The BOD<sub>5</sub>/COD ratio of the landfill leachate has dropped steadily since 2007 indicating that stabilization of the organic waste fraction is occurring as shown in **Figure 5-7**.

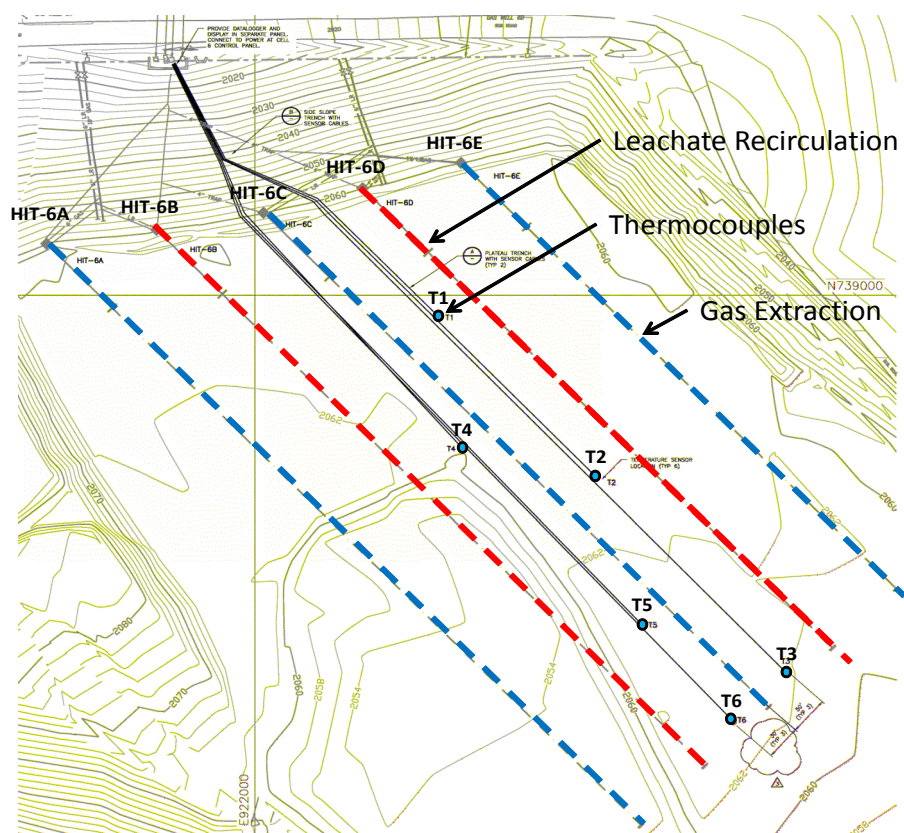
Figure 6-1 An Option Discussed at the Stakeholders' Meeting for Cell 6 HIT Operation

1. Consider adding a vertical gas well intersecting the HITs.
2. Consider installing temperature probes inside the HITs.
3. Consider utilizing waste heat from the LFGTE system to heat leachate for year-long leachate recirculation.

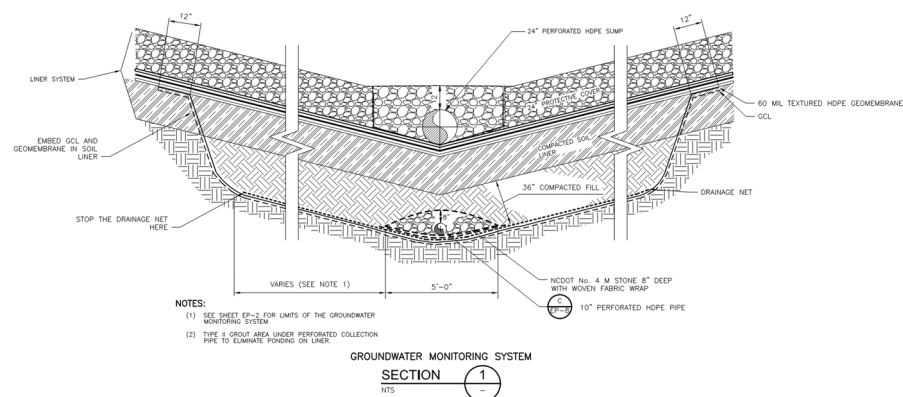
Figure 7-1: Revised LDZ Design

For Cells 7-10, it is recommended that the design of the LDZ be revised to eliminate the 3-foot separation between the LDZ and the bottom of the base liner system, as this will greatly reduce the potential for groundwater infiltration. This is shown in **Figure 7-1**.
