2017 Year-End Progress Report

# USEPA PROJECT XL

## Buncombe County Bioreactor Project

### Buncombe County Solid Waste Management Facility

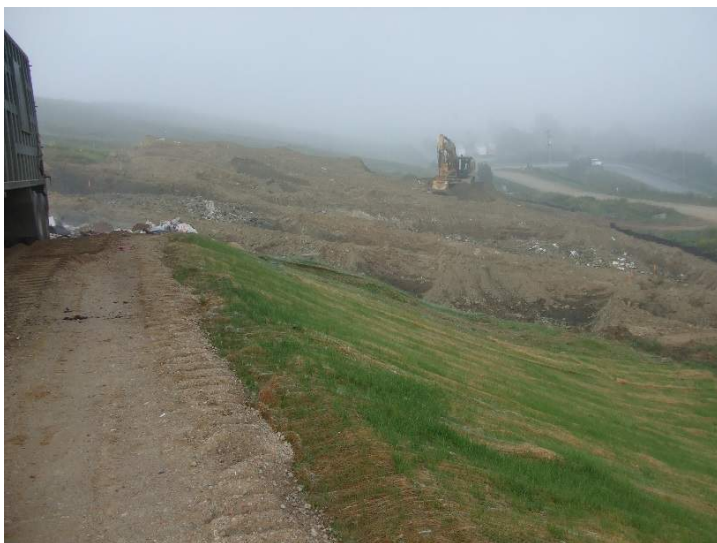
**Figure ES-1: Sideslope Waste Placement**

Buncombe County has received approval to steepen the slopes in Cells 1-6 and all future cells from 4H:1V sideslopes to 3H:1V sideslopes. This will allow airspace to be recaptured due to settlement from the bioreactor. Work began on September 19, 2017 on filling the sideslopes. Buncombe County is placing 90-percent of the incoming commercial tonnage on the sideslopes. During the filling process, recirculation has been halted in Cells 1-6. Progress photos are shown in **Figures ES-1** through **ES-4**.

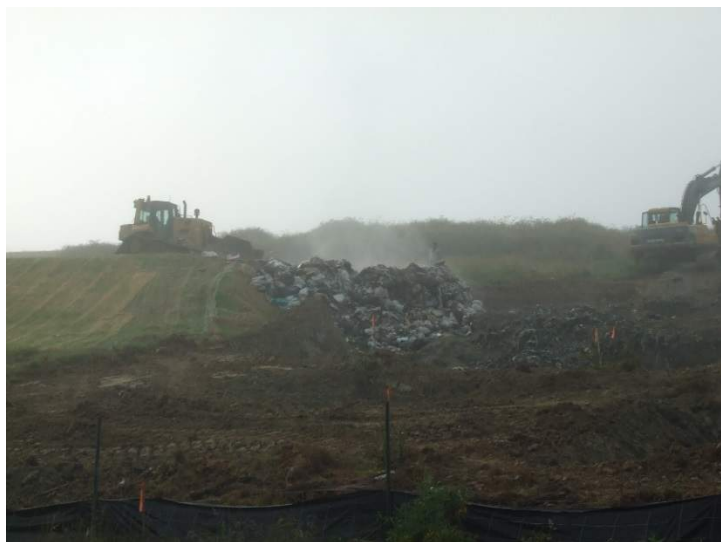
**Figure ES-2: Sideslope Waste Placement**

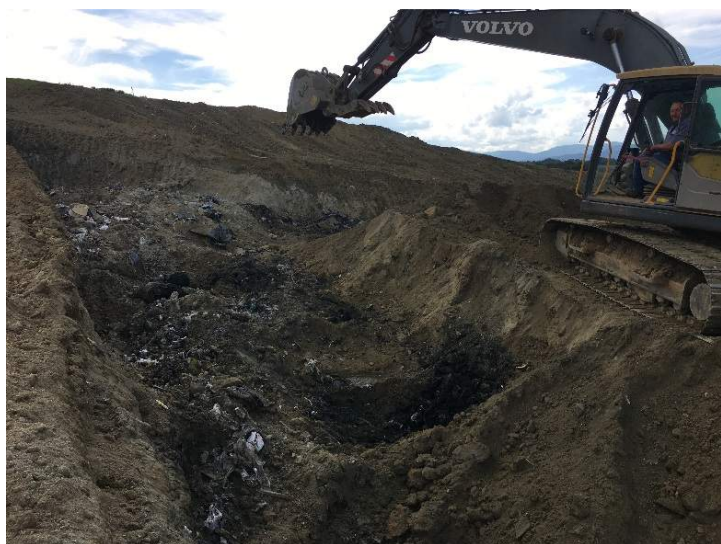
**Figure ES-3: Excavation Around Gas/Leachate Line**

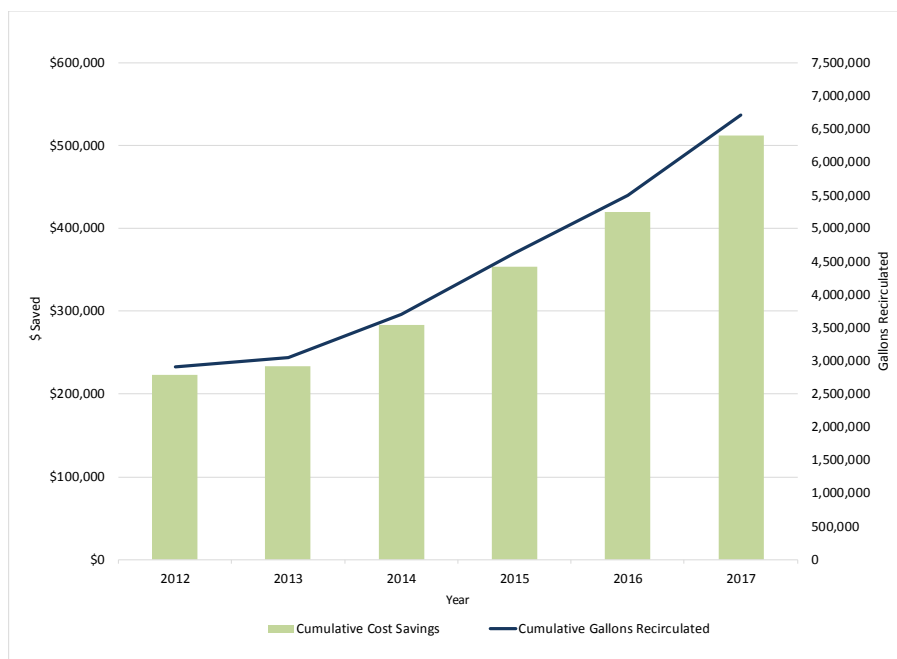
Approximately 6.7 million gallons of leachate has been recirculated since the program began, resulting in 1,342 less truck trips to the wastewater treatment plant (WWTP). That has provided a savings of \$511,674.17 in avoided hauling costs as shown in **Figure ES-5** below. With the expansion of the leachate recirculation system into Cell 6, the largest cell of the landfill, the amount of leachate that can be recirculated is significantly increased.

**Figure ES-5: Gallons Recirculated Compared with Truck Hauling Cost Savings**

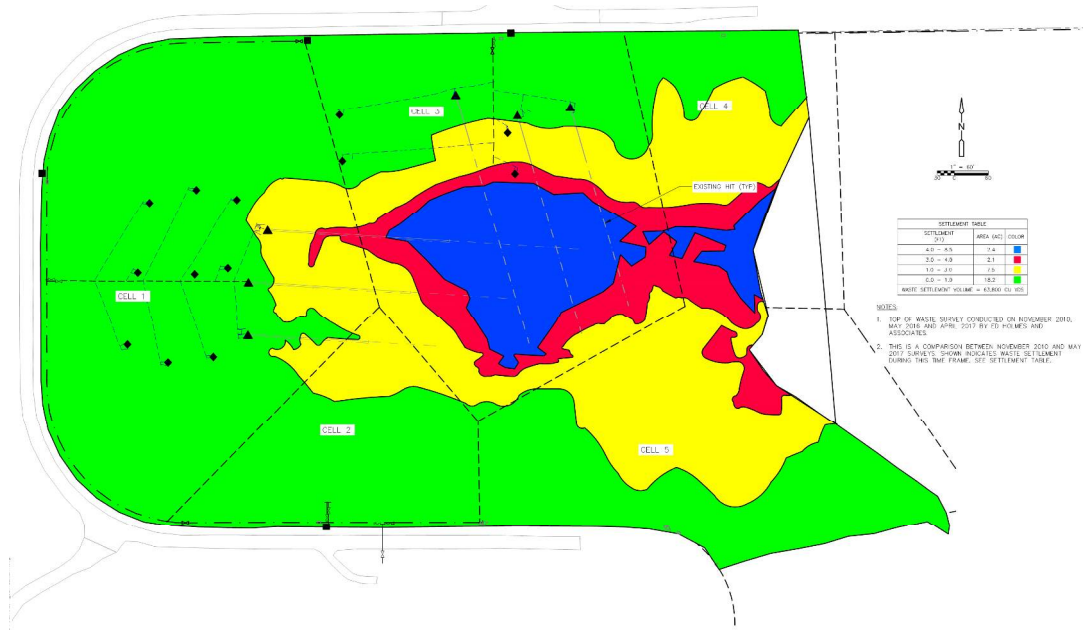
Settlement plates installed in Cells 1-5 show an average settlement of 1.72 ft. from January 2006 to July 2017. Comparison of topographic surveys of Cells 1-5 taken in 2010 and 2016, show 0-1 ft. settlement on the slopes and 1-8.5 ft. settlement over the waste plateau as shown in **Figure ES-6** (see also Figure 4-20). The prominent settlement areas correspond with the locations of the recirculation trenches but also benefit from stormwater that is captured on the waste plateau. The settlement in Cells 1-5 is estimated to be approximately 51,000 cy which is equivalent to five months of capacity valued at nearly \$2 million.

**Figure ES-6: Settlement in Cells 1 through 5 since November 2010**

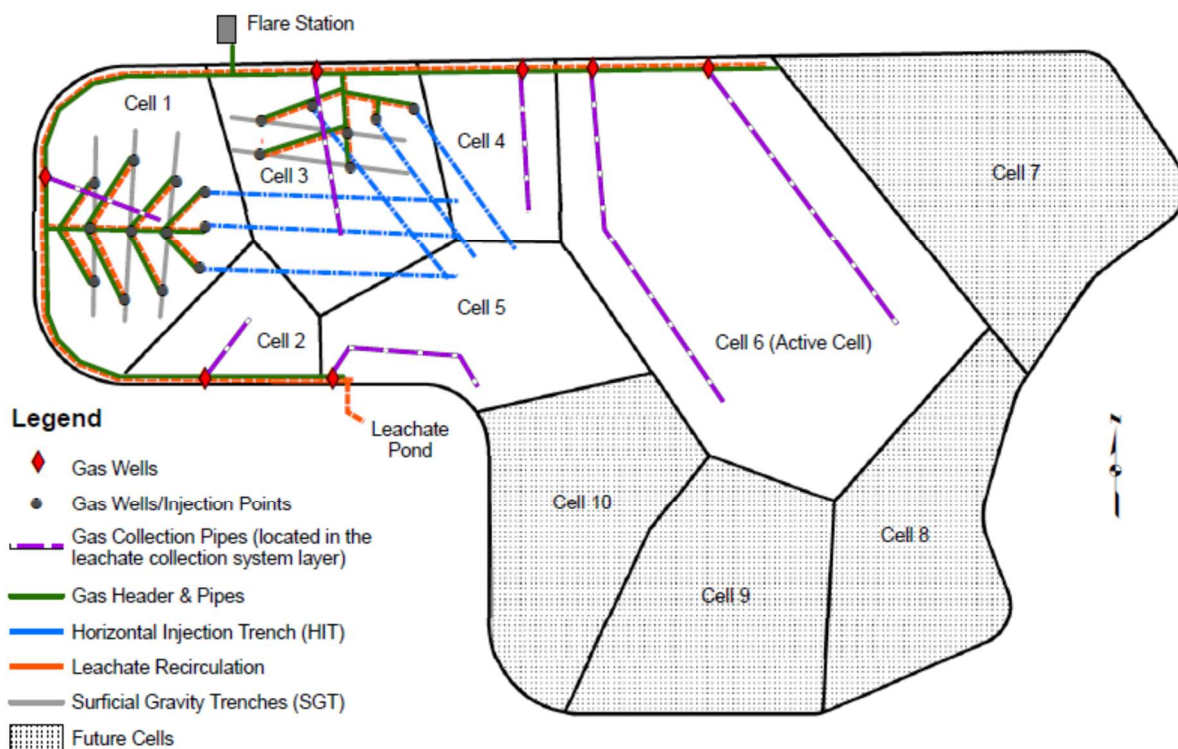
Cells 1-5 was nearing capacity when the project began, prompting the need to install a retrofit system. The retrofit system is equipped to recirculate leachate using a combination of horizontal injection trenches (HIT) and surficial gravity trenches (SGT) as shown in **Figure 2-1**.

Figure 2-1 Retrofit Bioreactor System

Six HIT were installed in the retrofit area. The first three HIT were installed in anticipation of the project being approved when the top of waste was at Elevation 2040. They extend approximately 400 ft. south into the waste mass and are spaced 100 ft. apart. Three more HIT were installed at Elevation 2080 using the same spacing and extend approximately 800 ft. east in the waste. Due to the longer length of these HIT, two pipes were used in each of the trenches to provide more uniform distribution of leachate. This is achieved by using a short pipe that wets the first 400 ft. of the trench and a long pipe that wets the latter half of the trench.

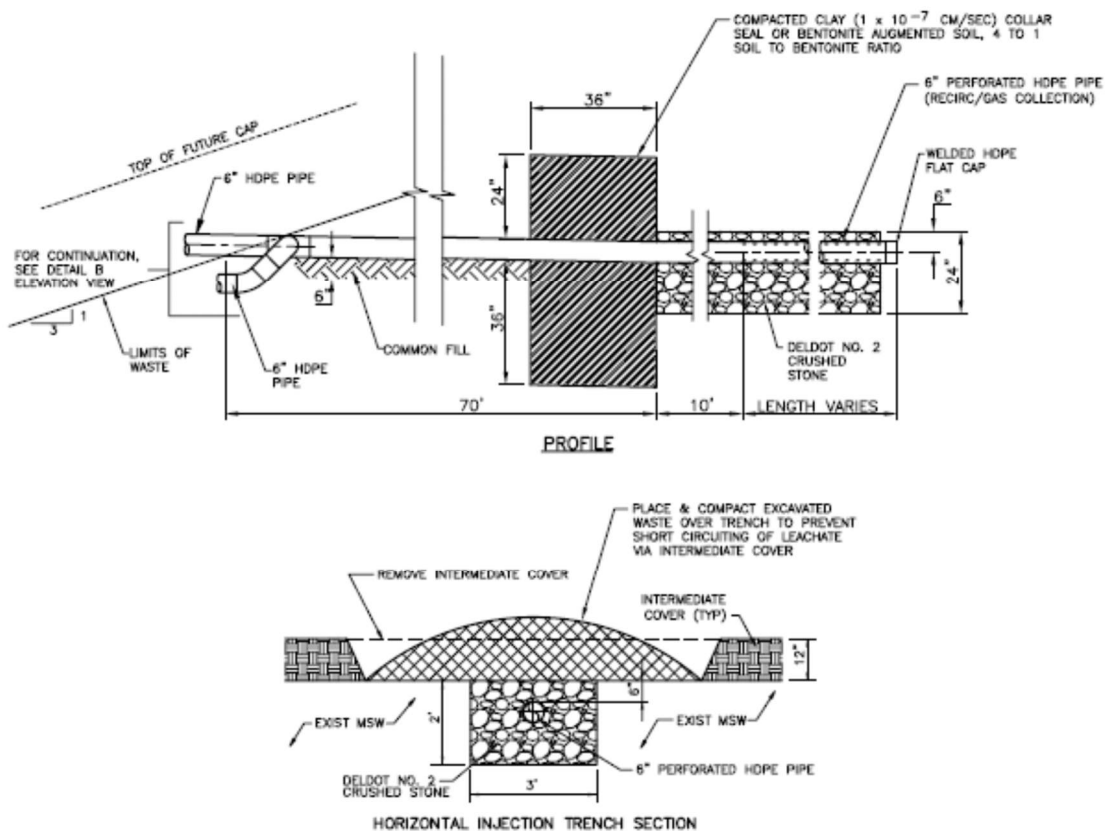
Construction details of the HIT and SGT are shown in **Figures 2-2 and 2-3**.

**Figure 2-2 Horizontal Injection Trench**

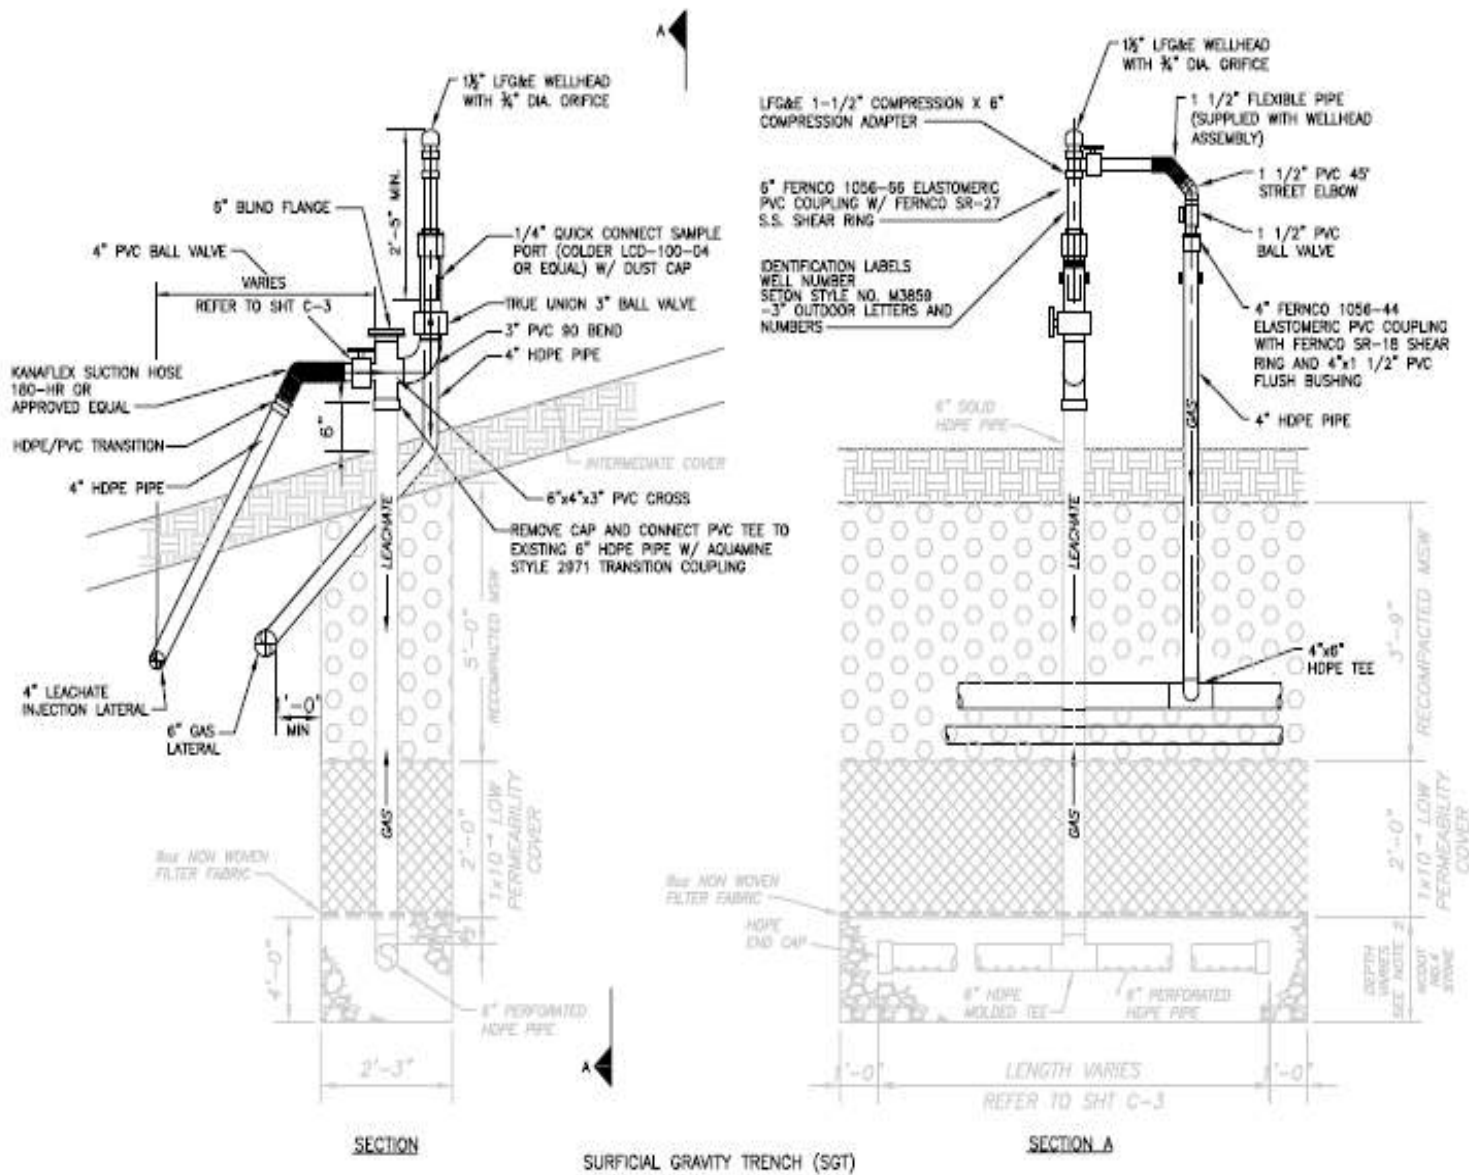
Figure 2-3 Surficial Gravity Trench Detail

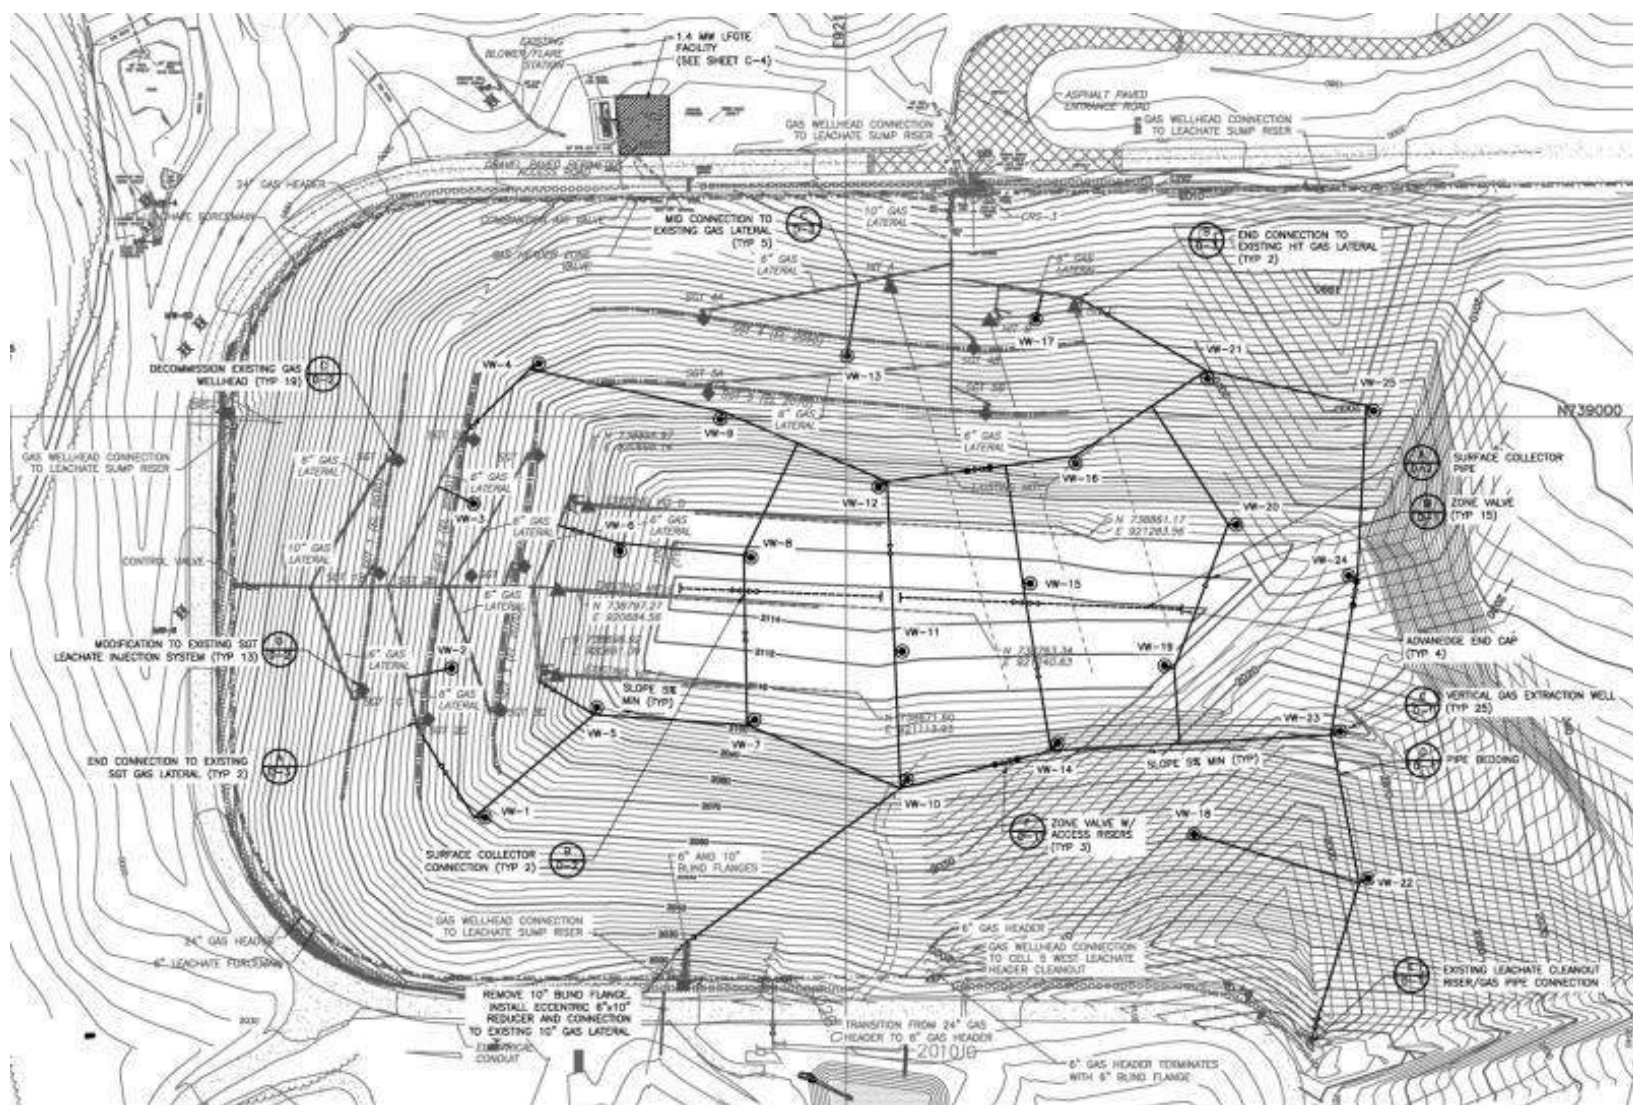
**Figure 2-4 Vertical Gas Well Collection System in the Retrofit Area**

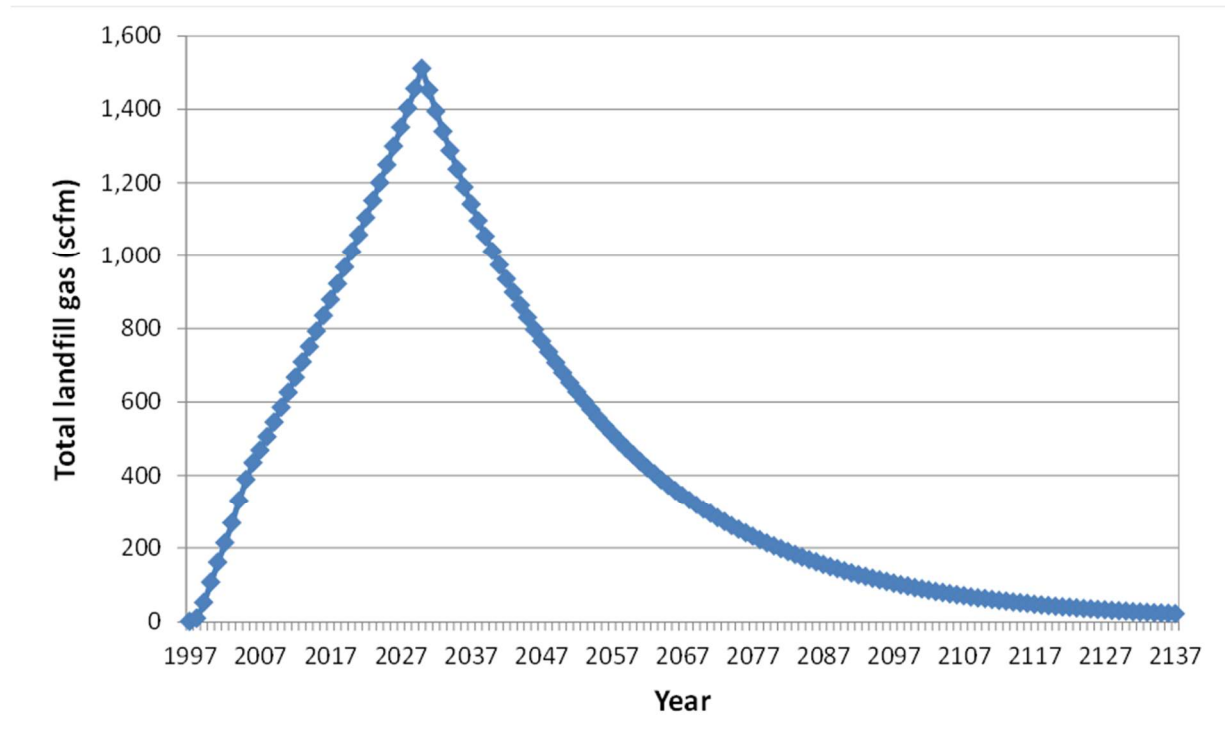
Figure 2-5 Landfill Gas Projections Using Land GEM Model

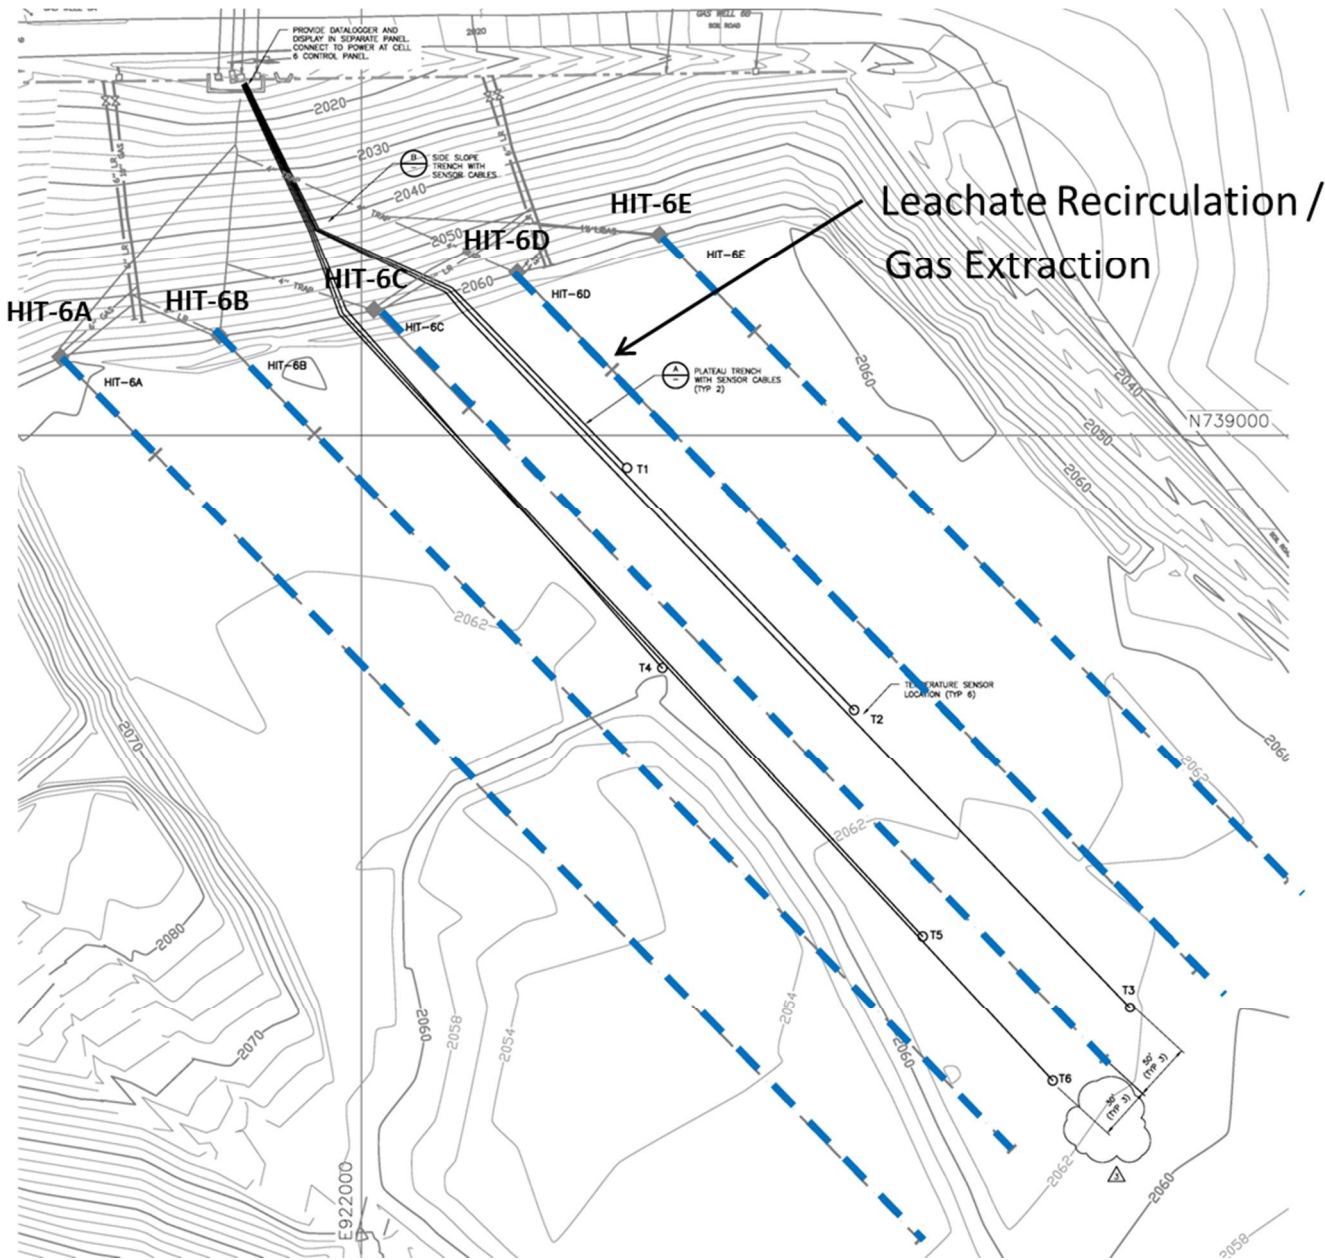
Figure 2-6 Build-As-You-Go Bioreactor System

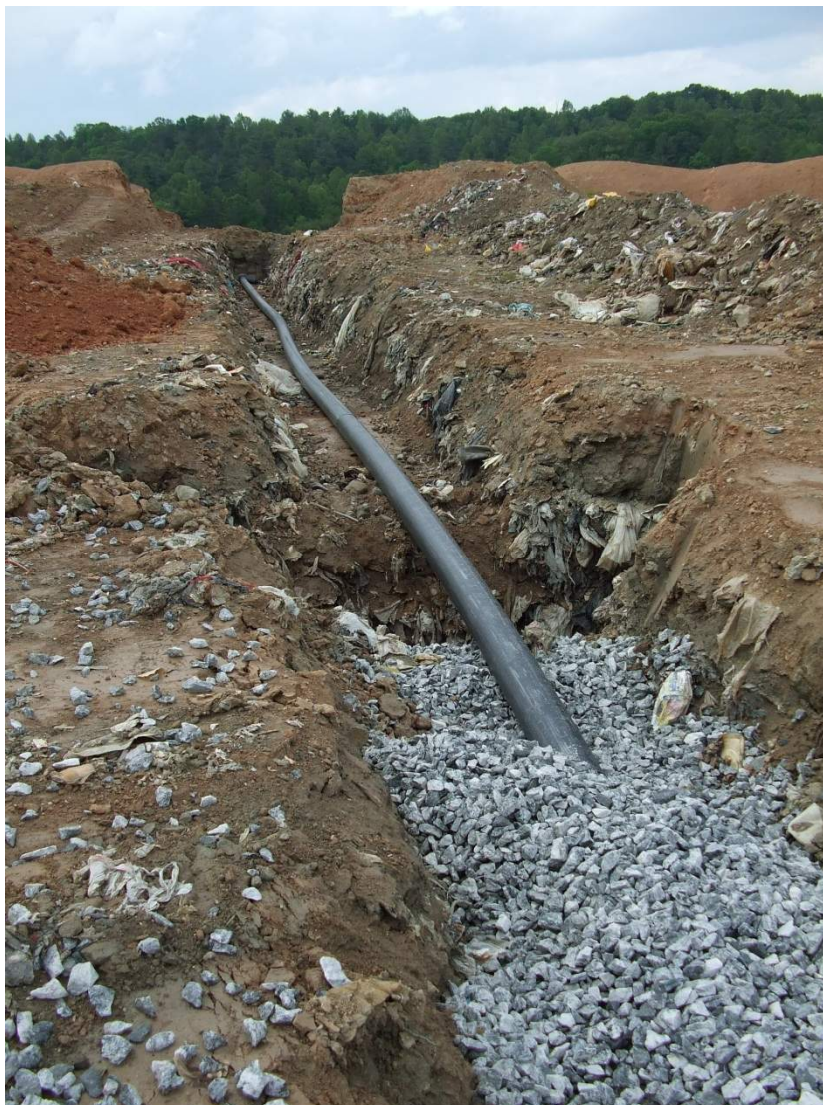
**Figure 2-7 Horizontal Injection Trench Installation in Cell 6**

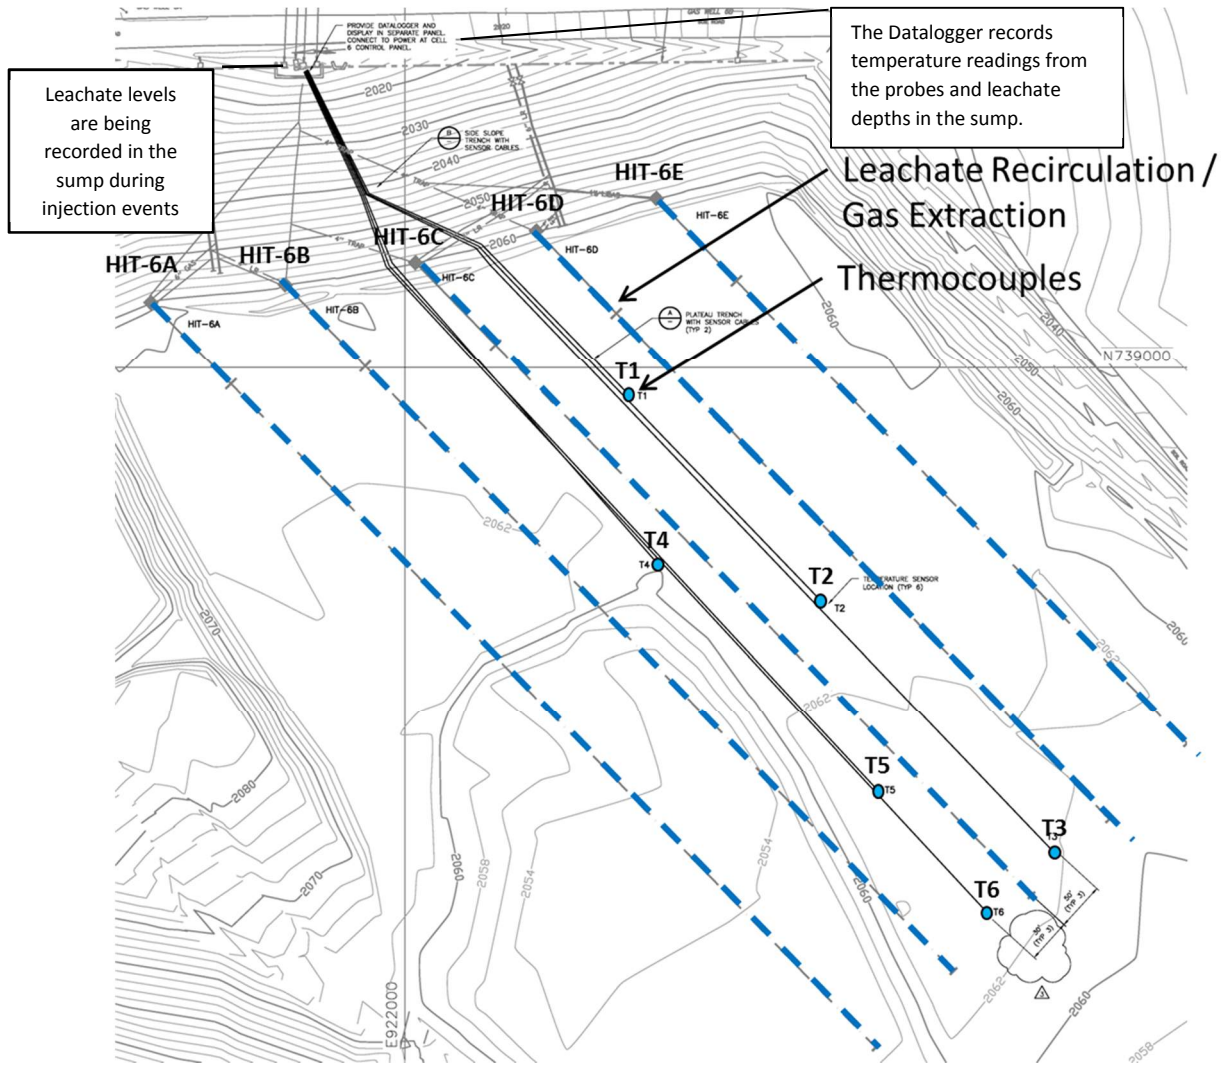
Thermocouples were installed in six (6) locations around the Cell 6 Phase 1 HIT in July 2012 as shown in **Figure 2-8**. The thermocouples consist of a stainless-steel temperature sensor with a lead cable as shown in **Figure 2-9**. The thermocouples were placed in 4-inch perforated PVC pipe packed with concrete sand. The cable end of the pipe was left open to allow cable movement during settlement. The sensors transmit temperature data to a datalogger installed adjacent to the Cell 6 pump station control panel that is downloaded monthly. Temperature readings are being used to monitor decomposition as active mesophilic bacteria typically results in a range between 80°F and 115°F. The sensors are also helpful in assessing the impacts of leachate temperature during injection. As ambient air temperatures drop in the winter, the leachate in the pond will get colder.

Figure 2-8 Temperature Sensors in Cell 6

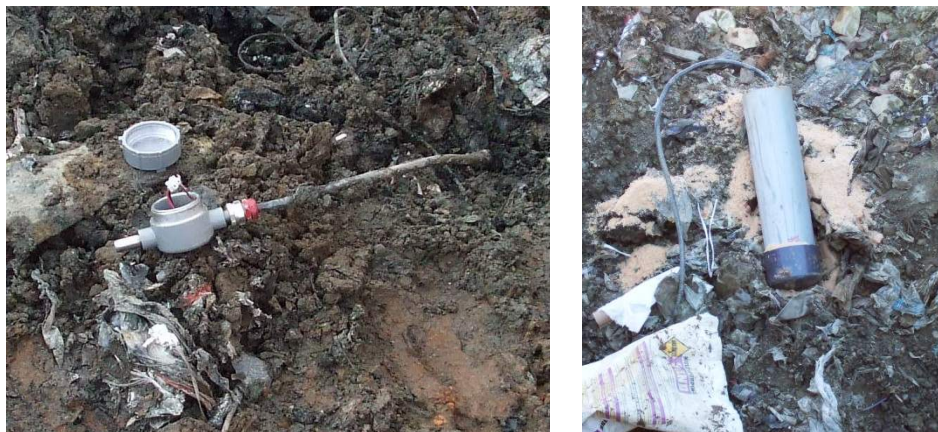
Figure 2-9 Installation of Thermocouples in Cell 6

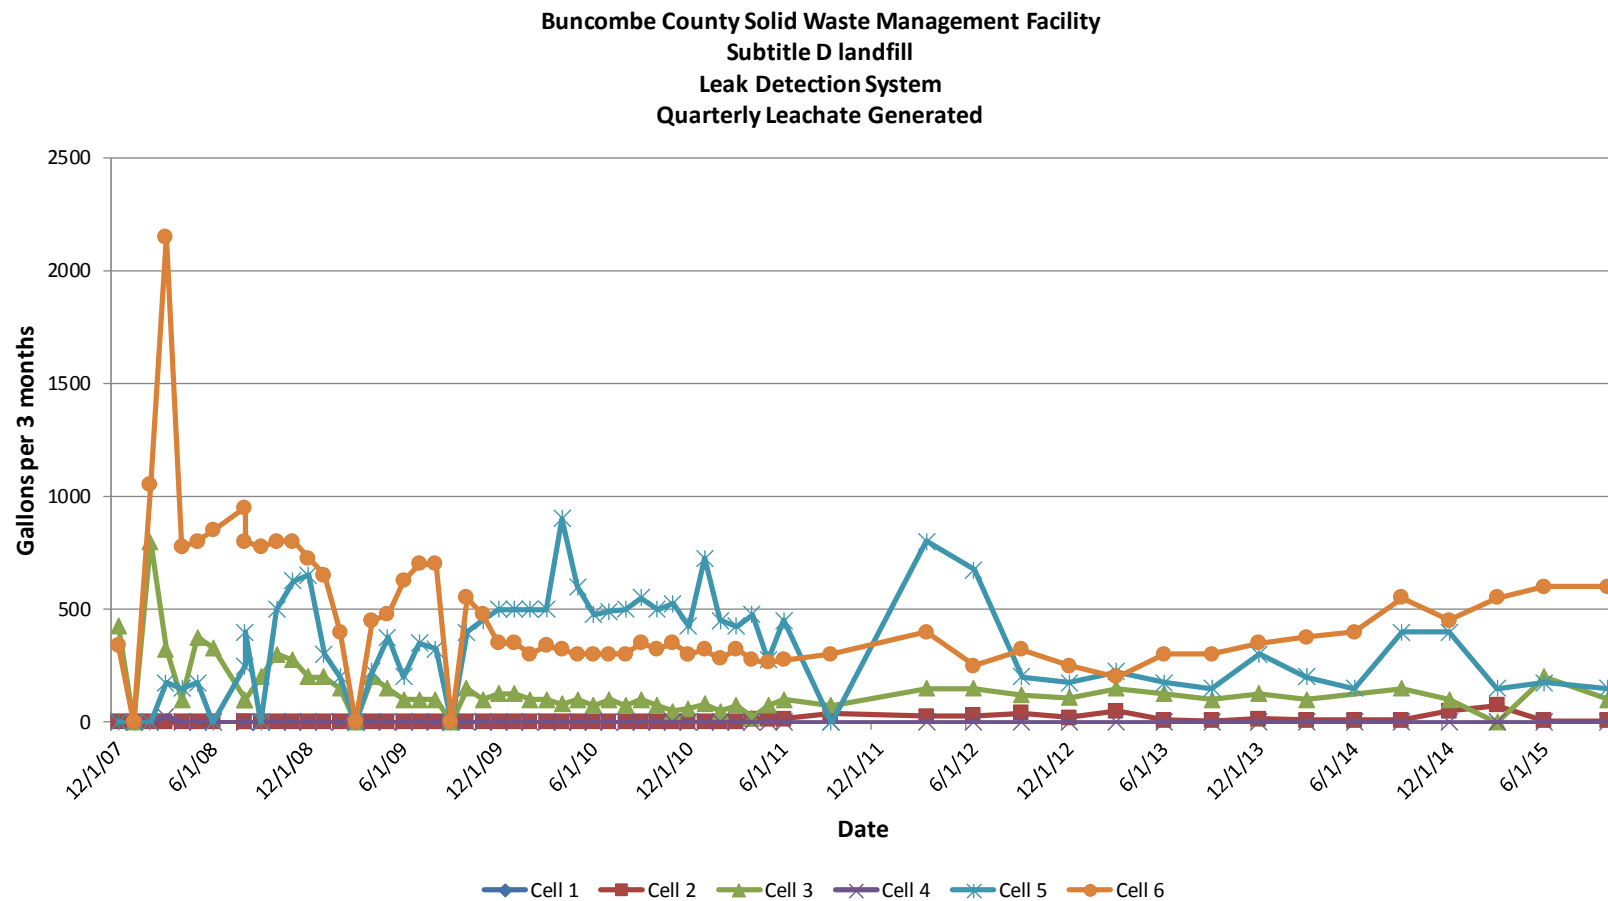
**Figures 4-1(a) and 4-1(b)** shows the quarterly and semi-annual quantities, respectively, of liquid collected from the LDZ. **Figures 4-2 through 4-7** show qualitative data from testing of the liquid. The parameters are pH, conductance, ORP, BOD5, COD and ammonia.

**Figure 4-1a Quarterly Leak Detection Volumes (2007-2015)**

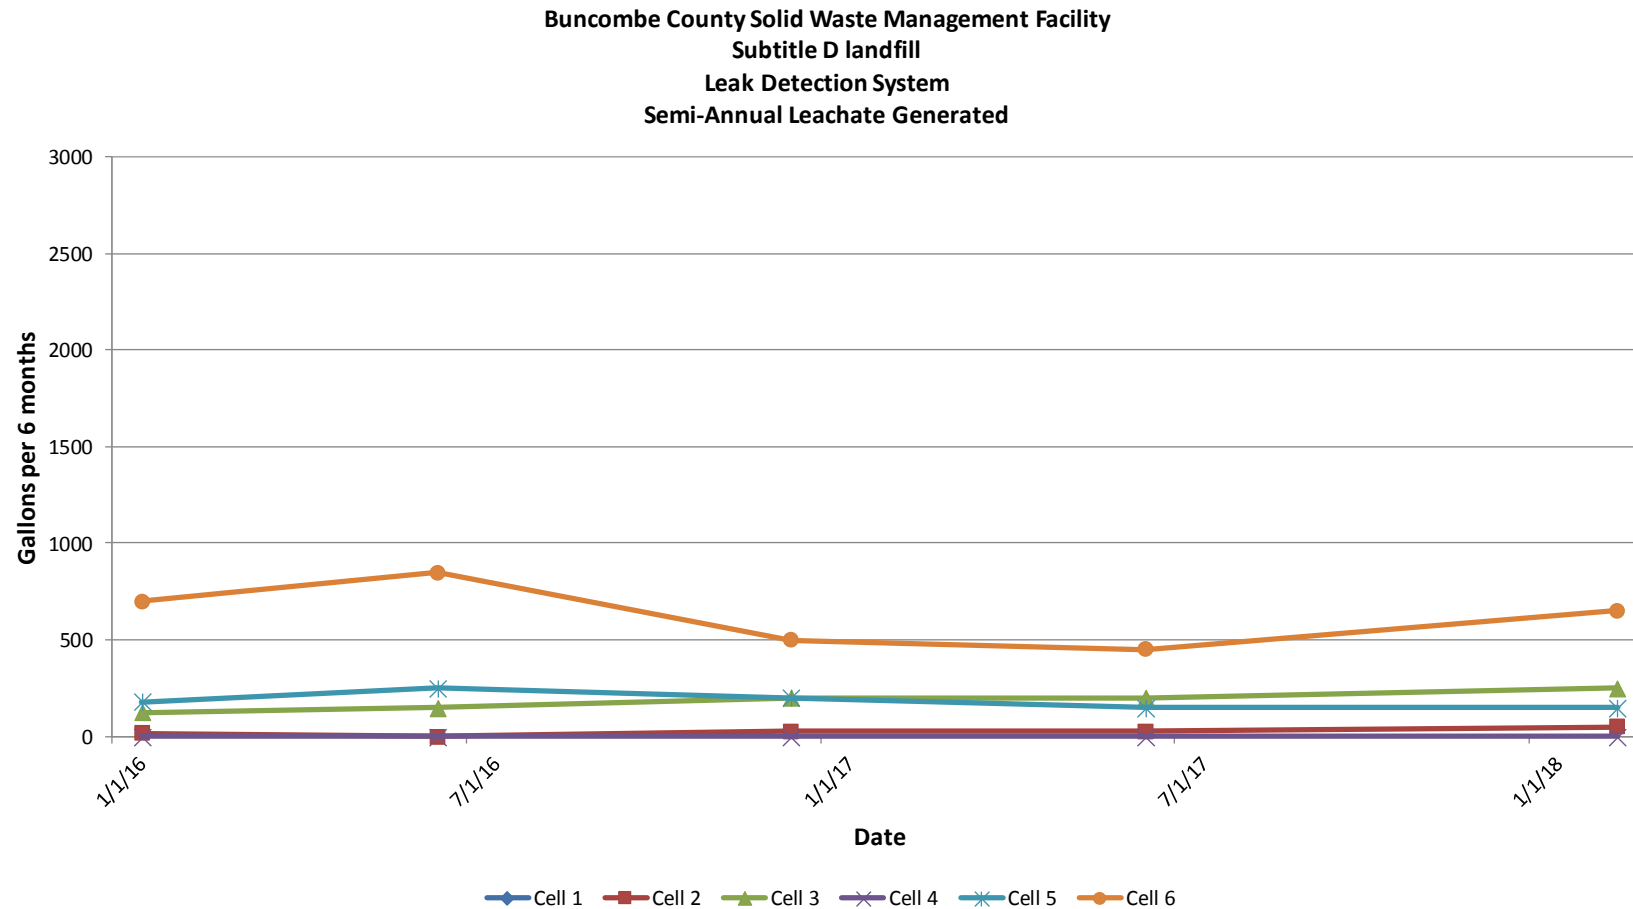
**Figure 4-1b Semi-Annual Leak Detection Volumes (2016-present)**

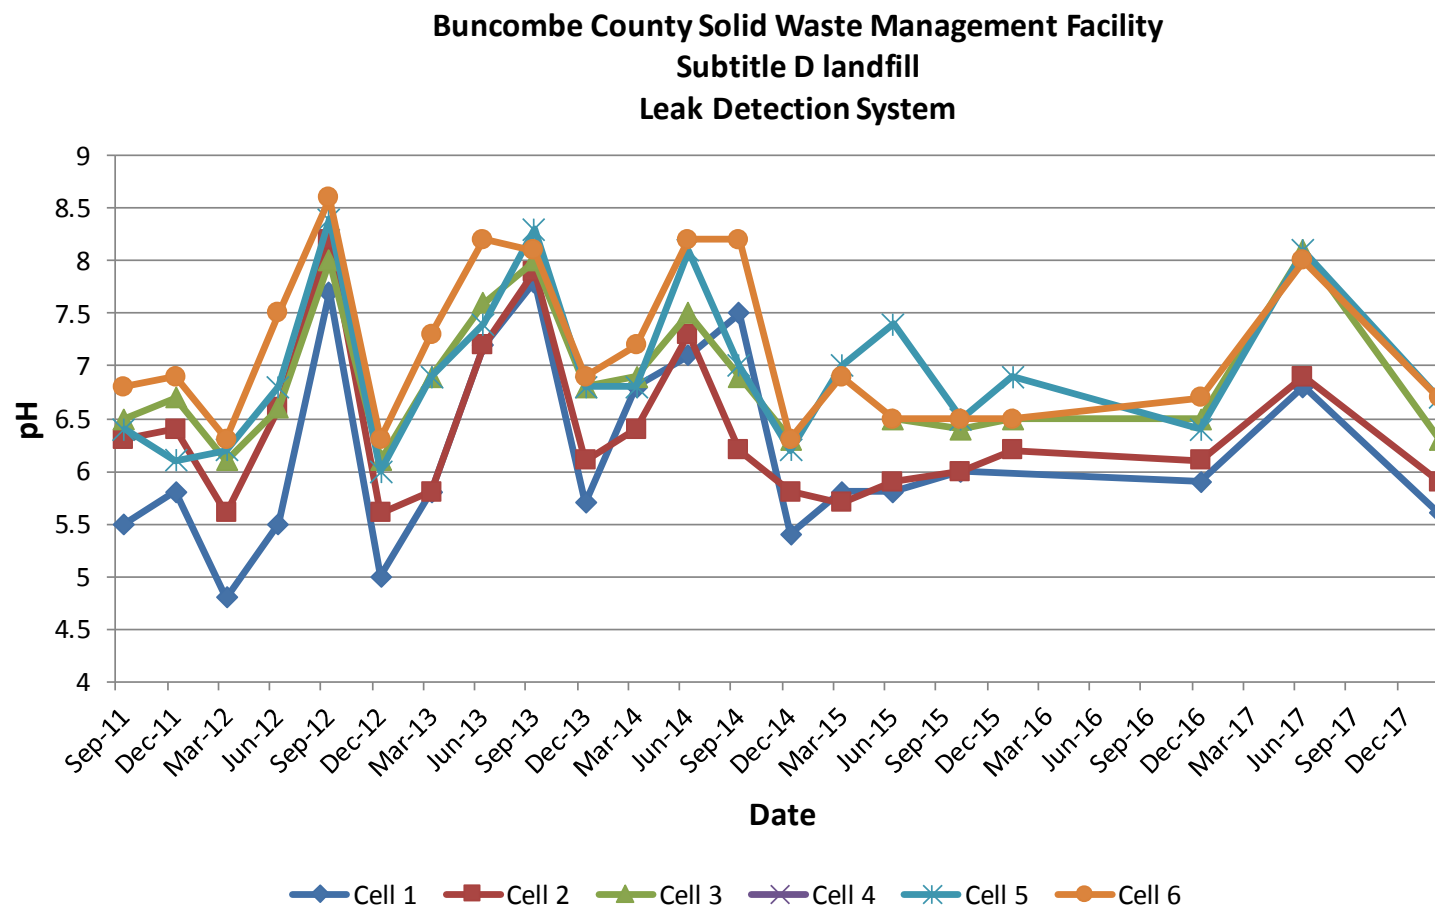
**Figure 4-2 pH**

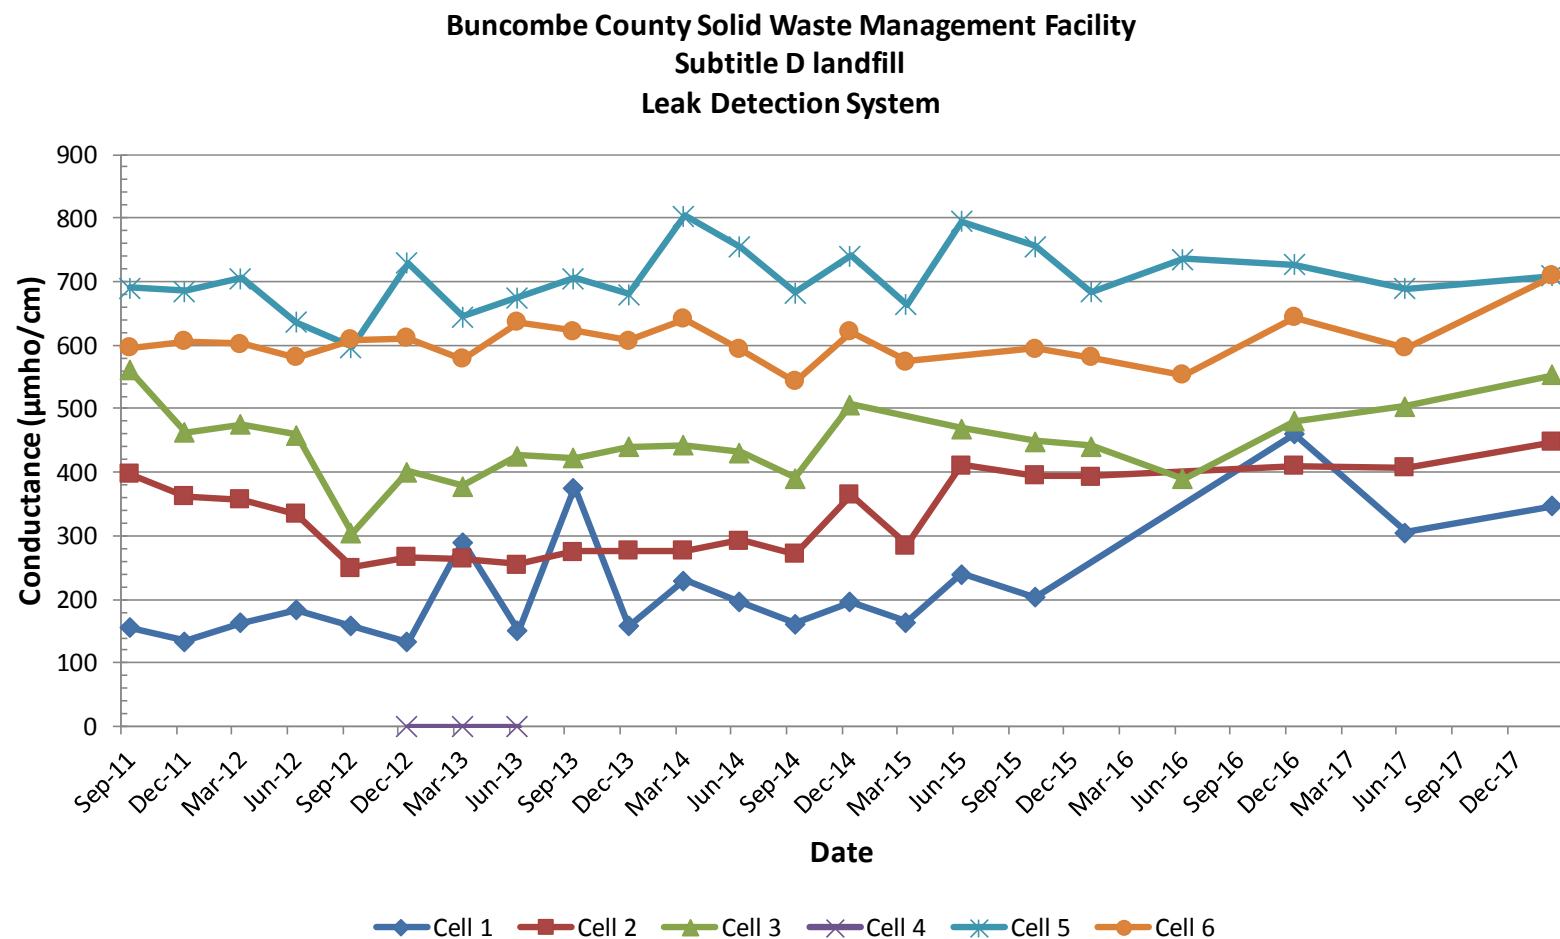
**Figure 4-3 Specific Conductance**

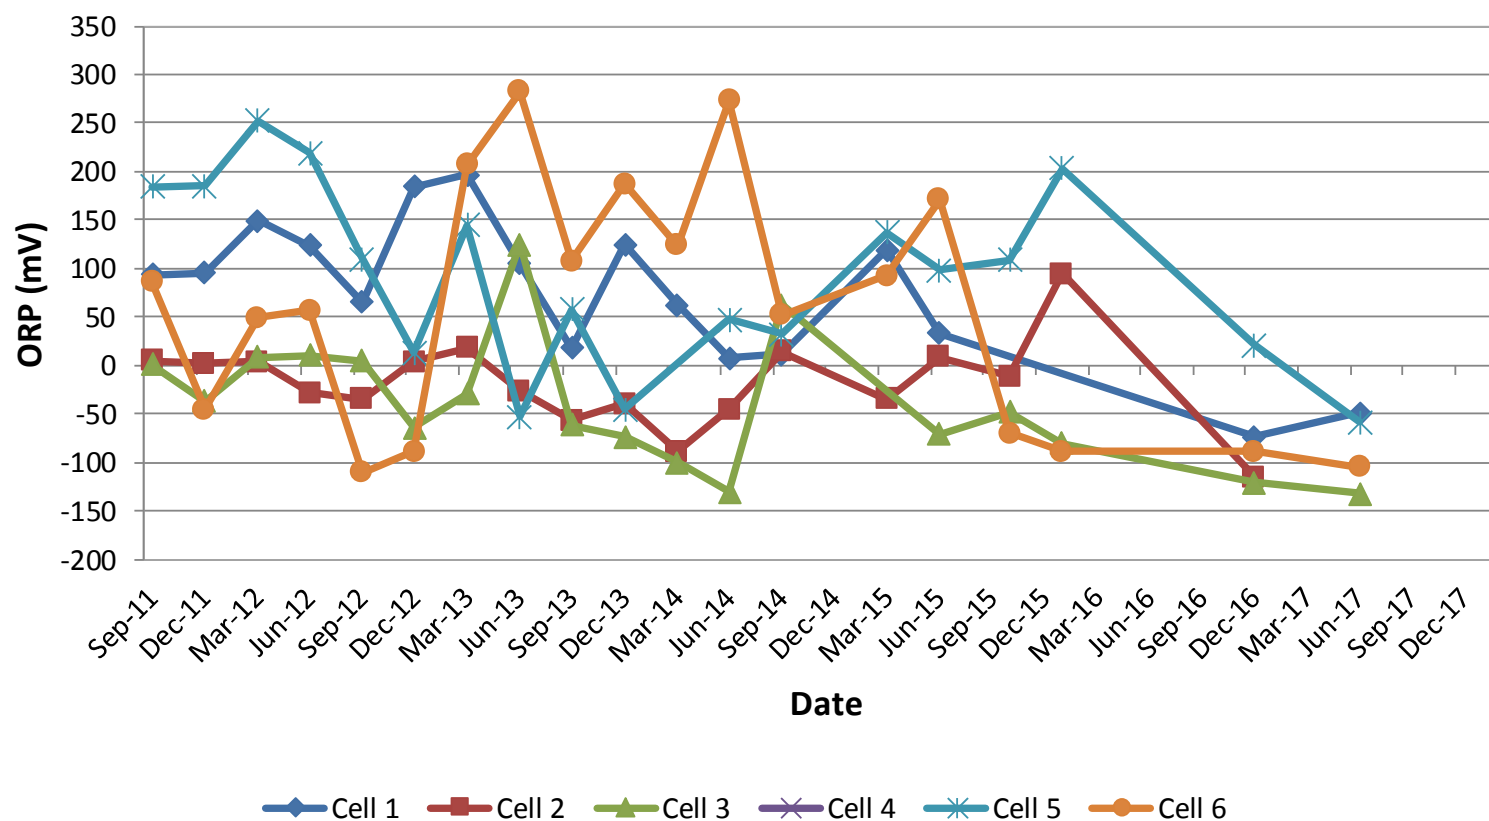
**Figure 4-4 Oxidation Reduction Potential**

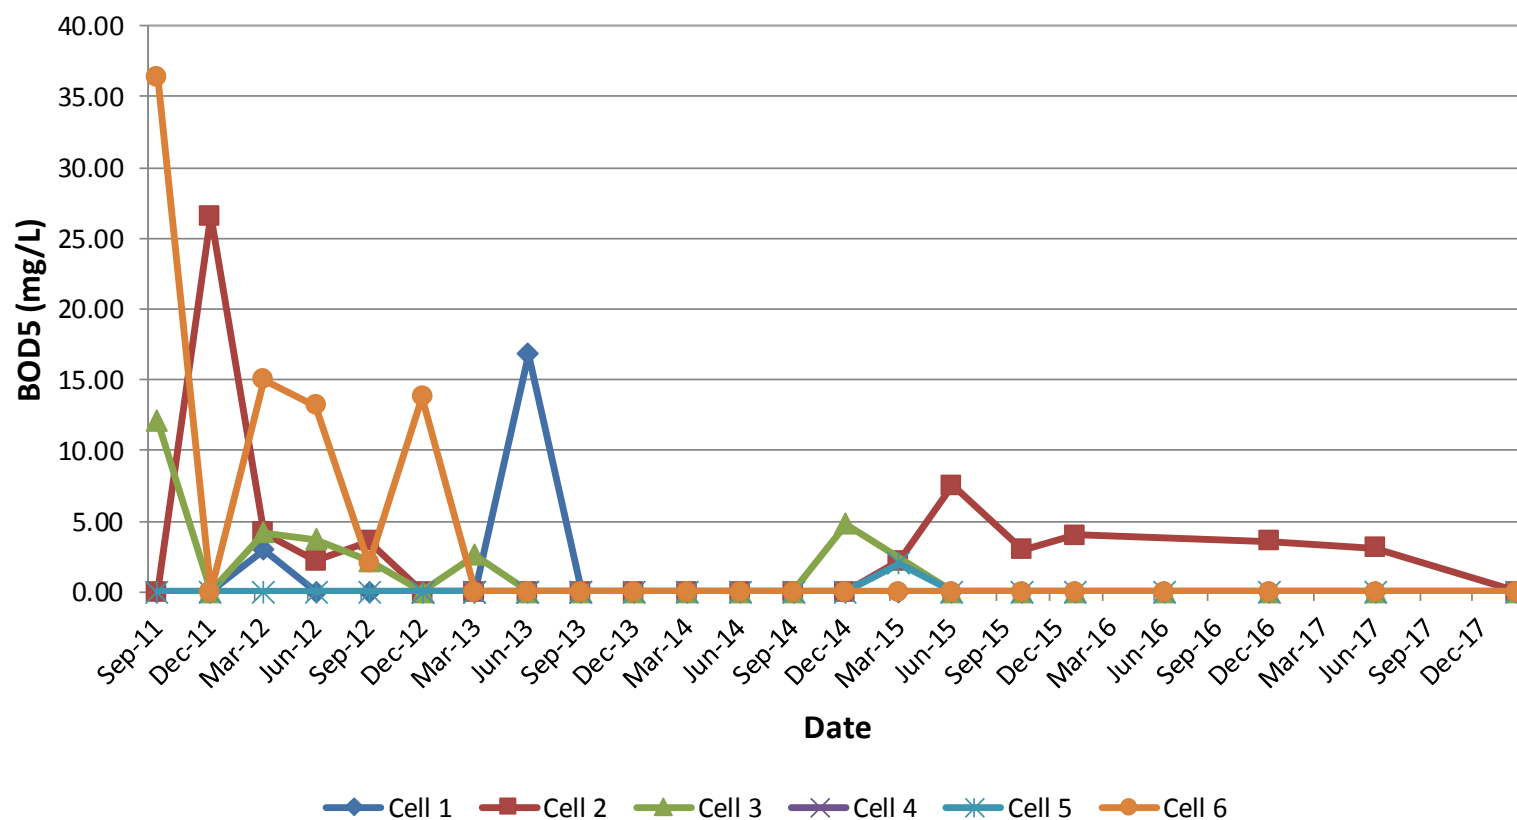
**Figure 4-5 BOD5**
