2017 Year-End Progress Report

# USEPA PROJECT XL

## Buncombe County Bioreactor Project

### Buncombe County Solid Waste Management Facility

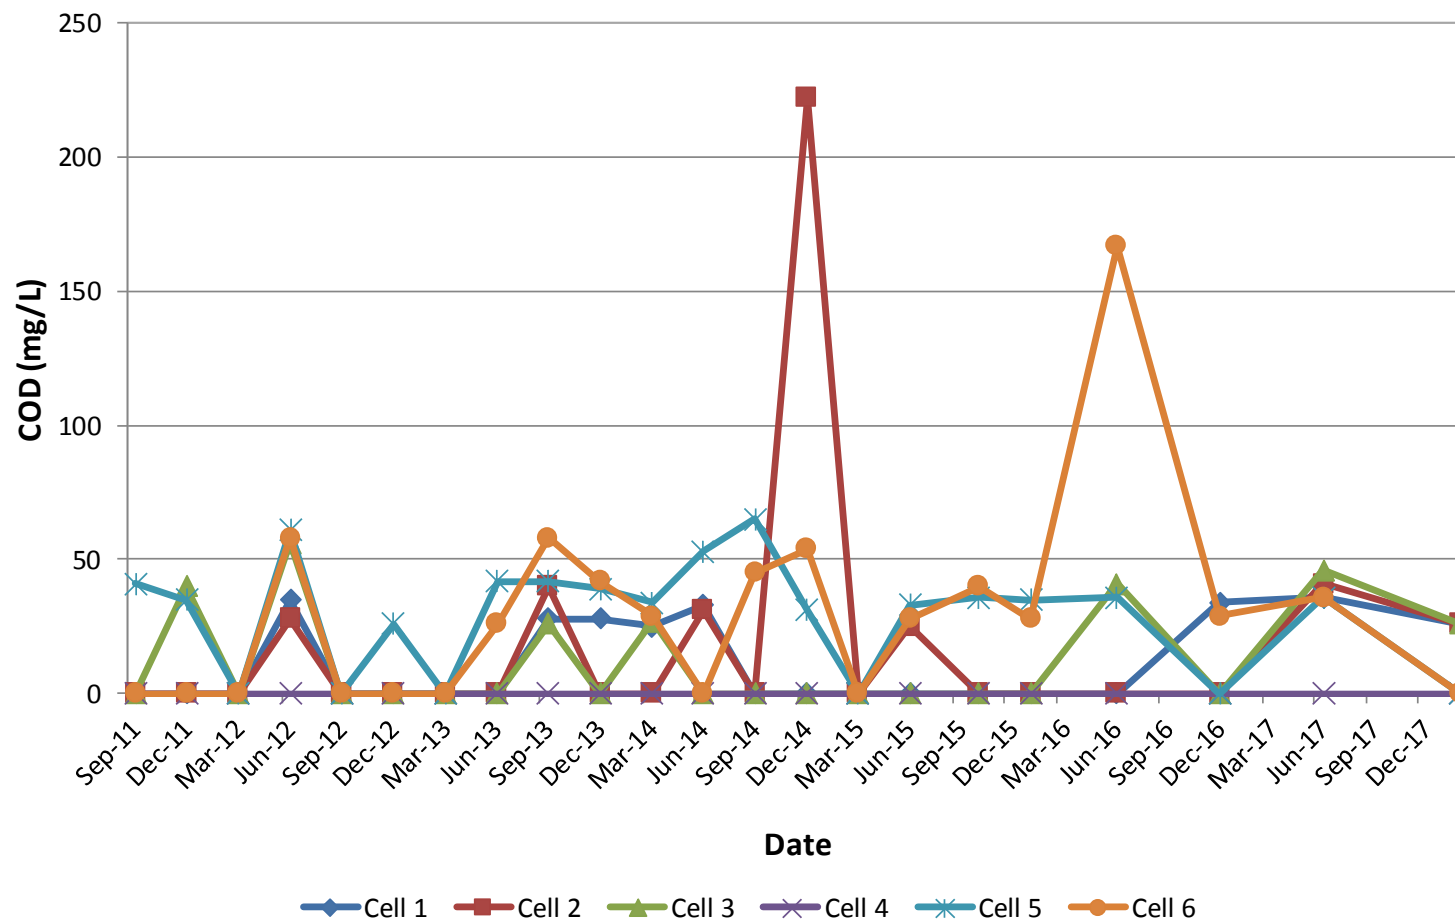
**Figures 4-1(a) and 4-1(b)** shows the quarterly and semi-annual quantities, respectively, of liquid collected from the LDZ. **Figures 4-2 through 4-7** show qualitative data from testing of the liquid. The parameters are pH, conductance, ORP, BOD5, COD and ammonia.

**Figure 4-6 COD**

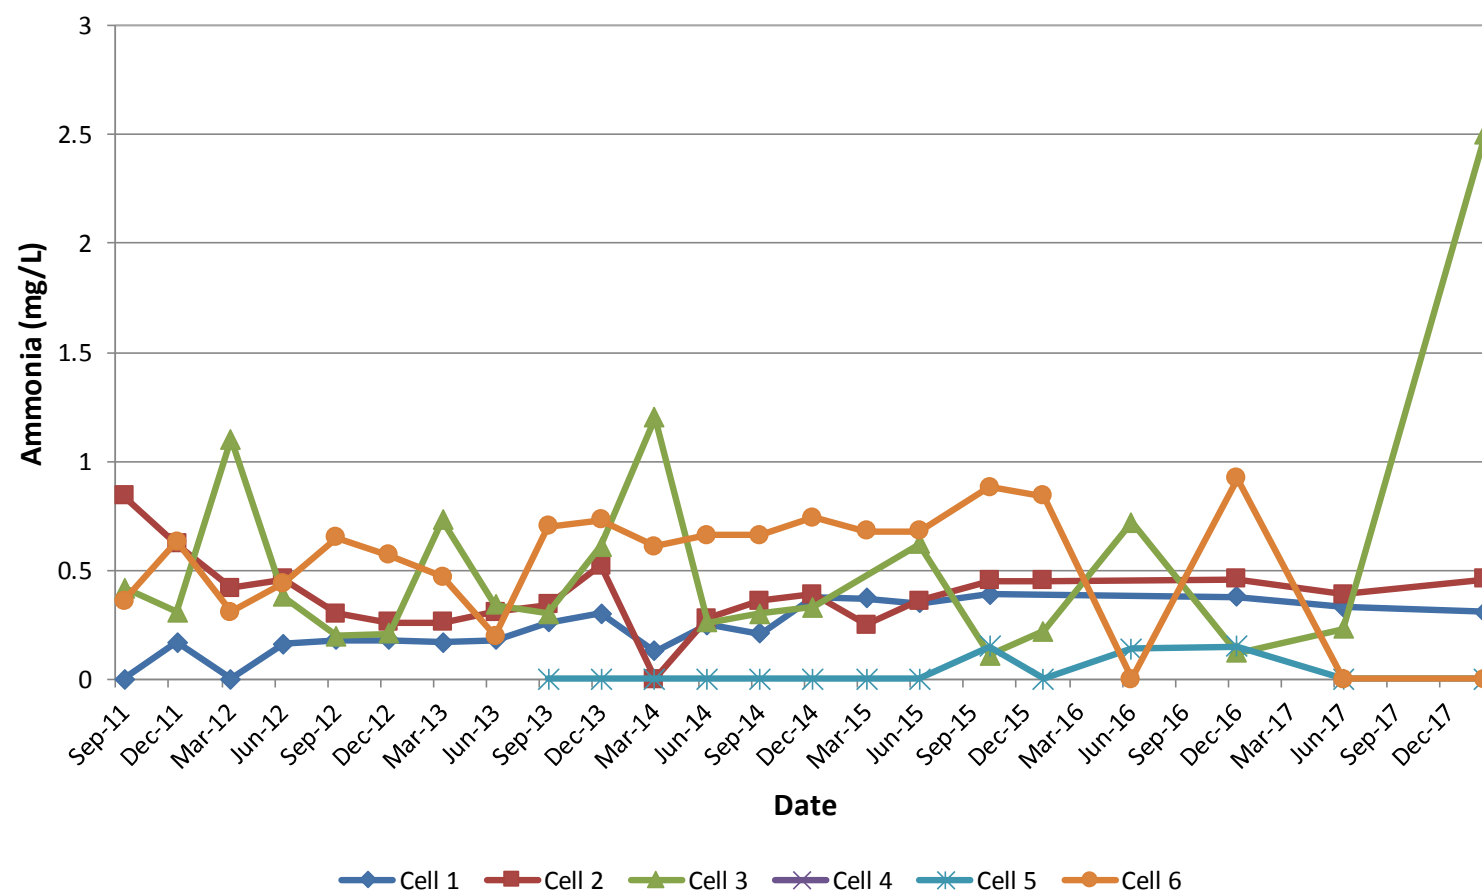
**Figure 4-7 Ammonia**

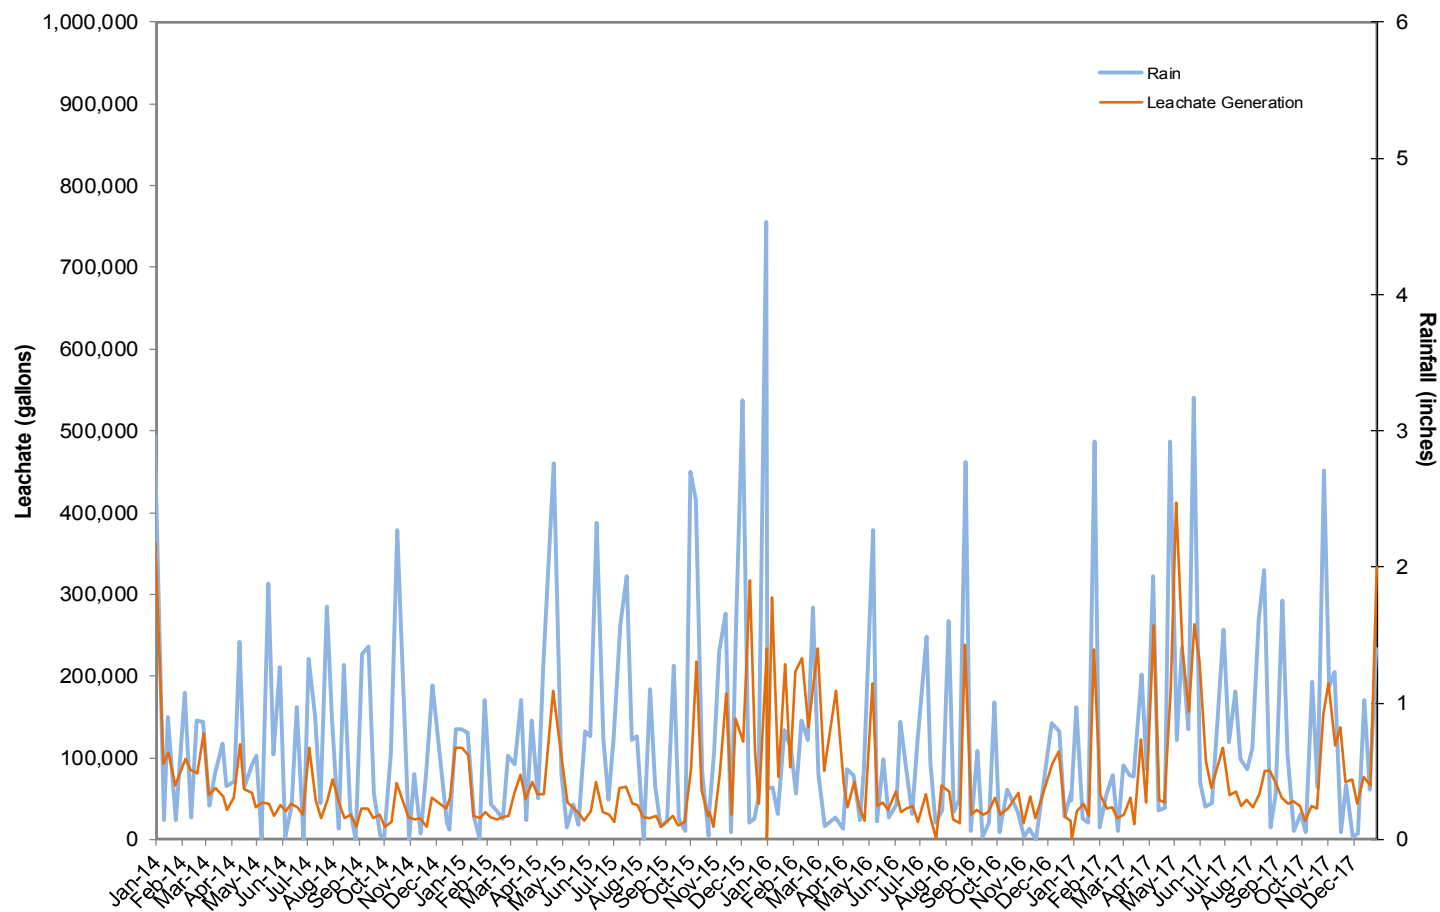
**Figure 4-8 Leachate Generation vs. Rainfall**

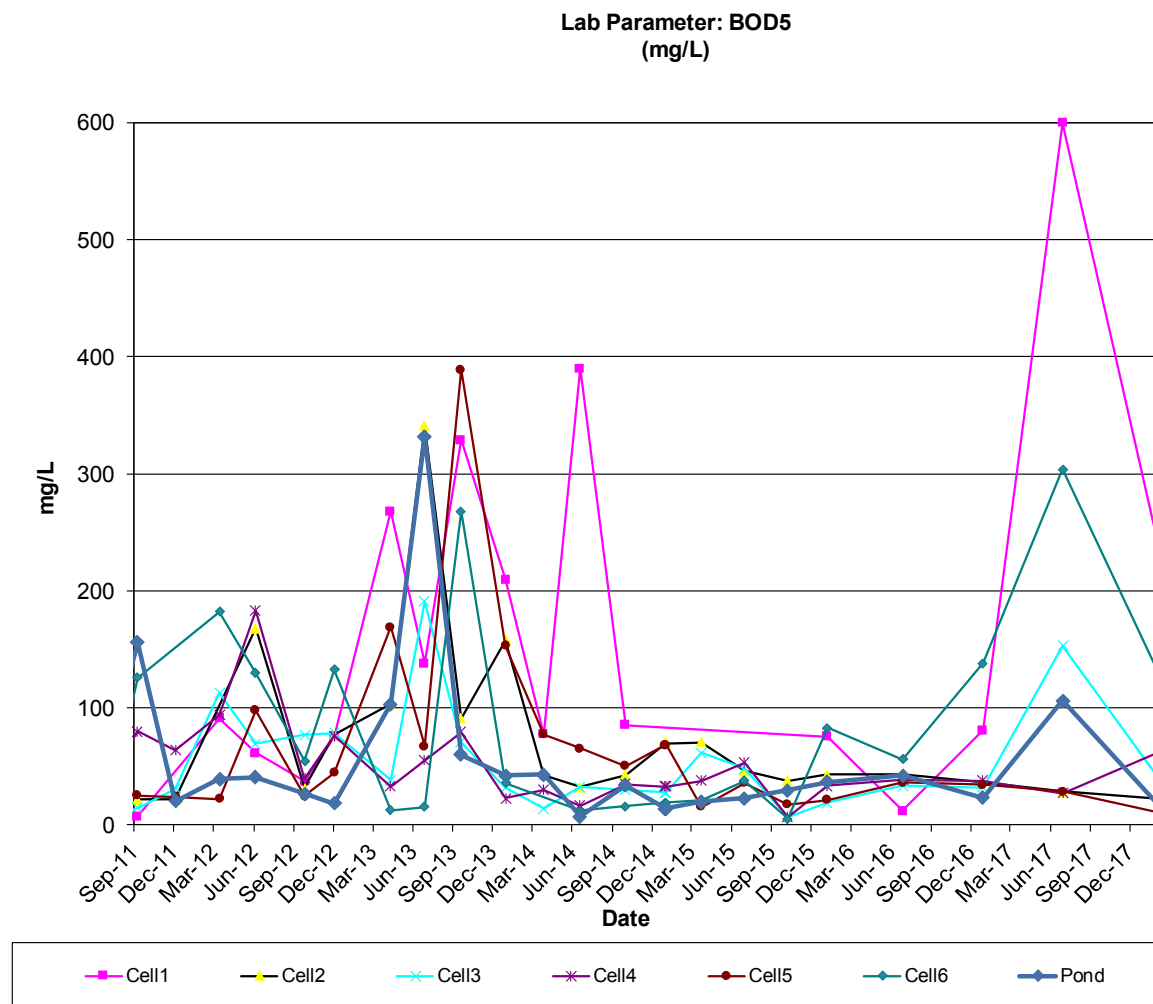
**Figure 4-9 BOD5 of Leachate**

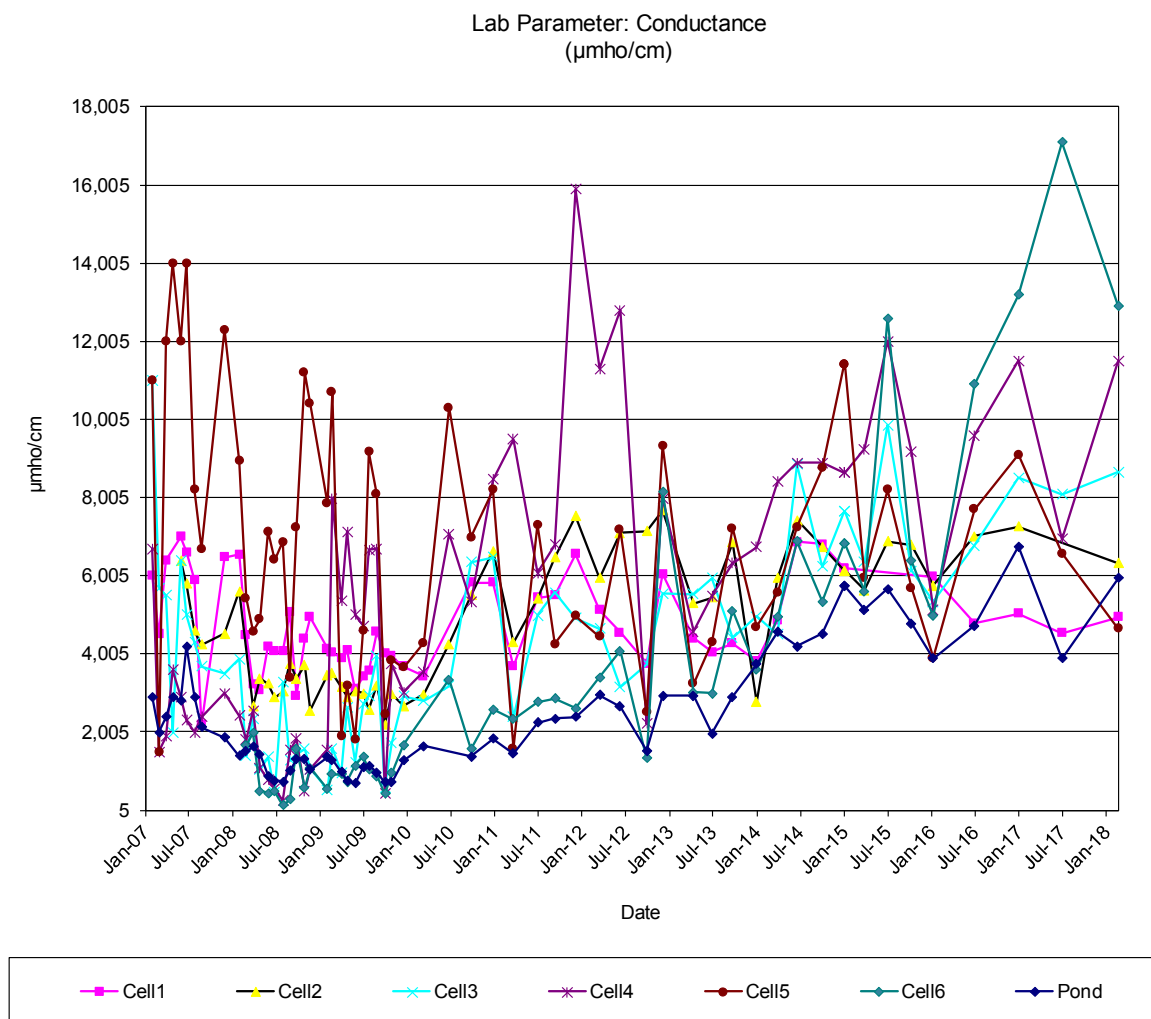
**Figure 4-10 Specific Conductance of Leachate**

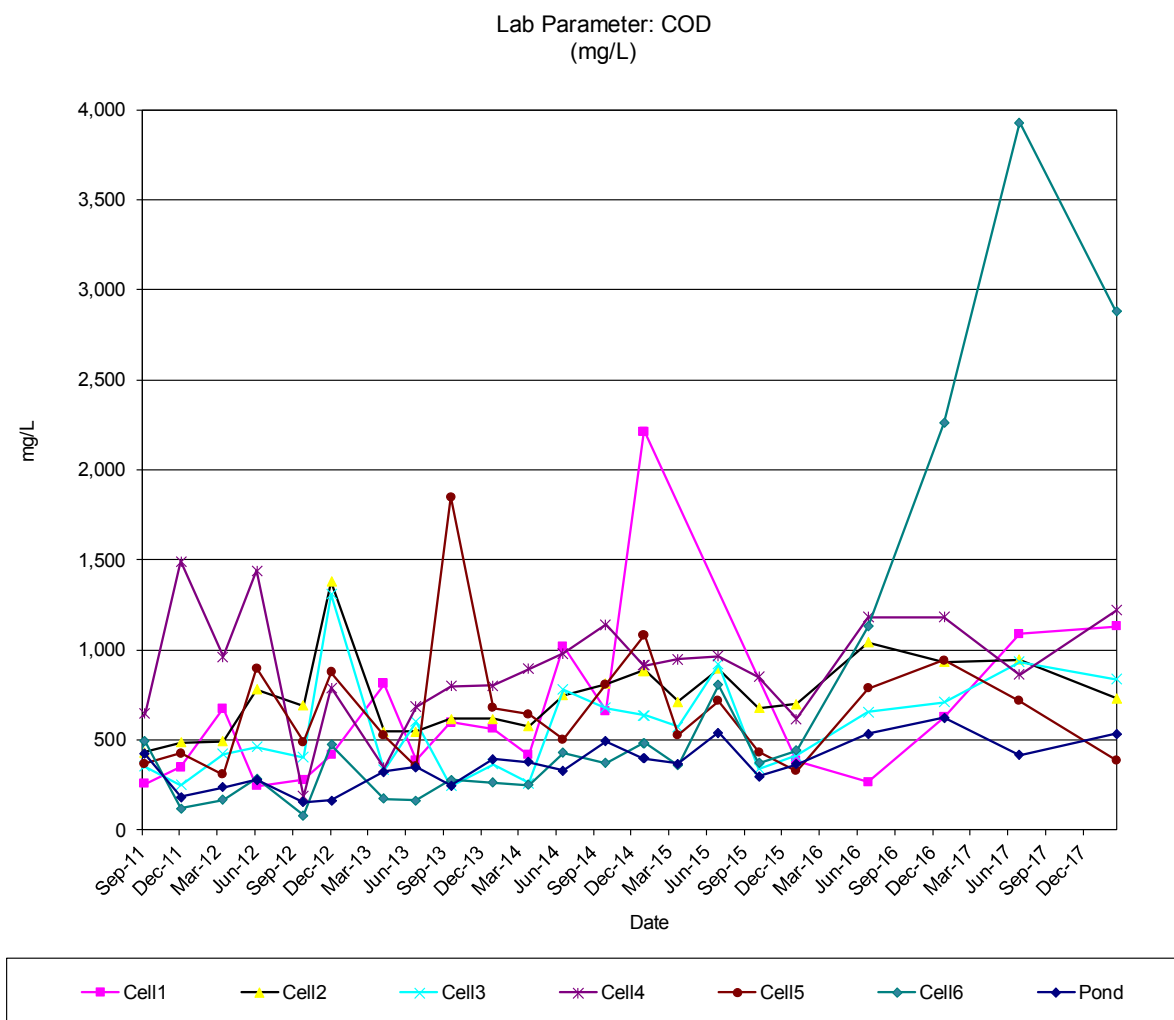
**Figure 4-11 COD of Leachate**

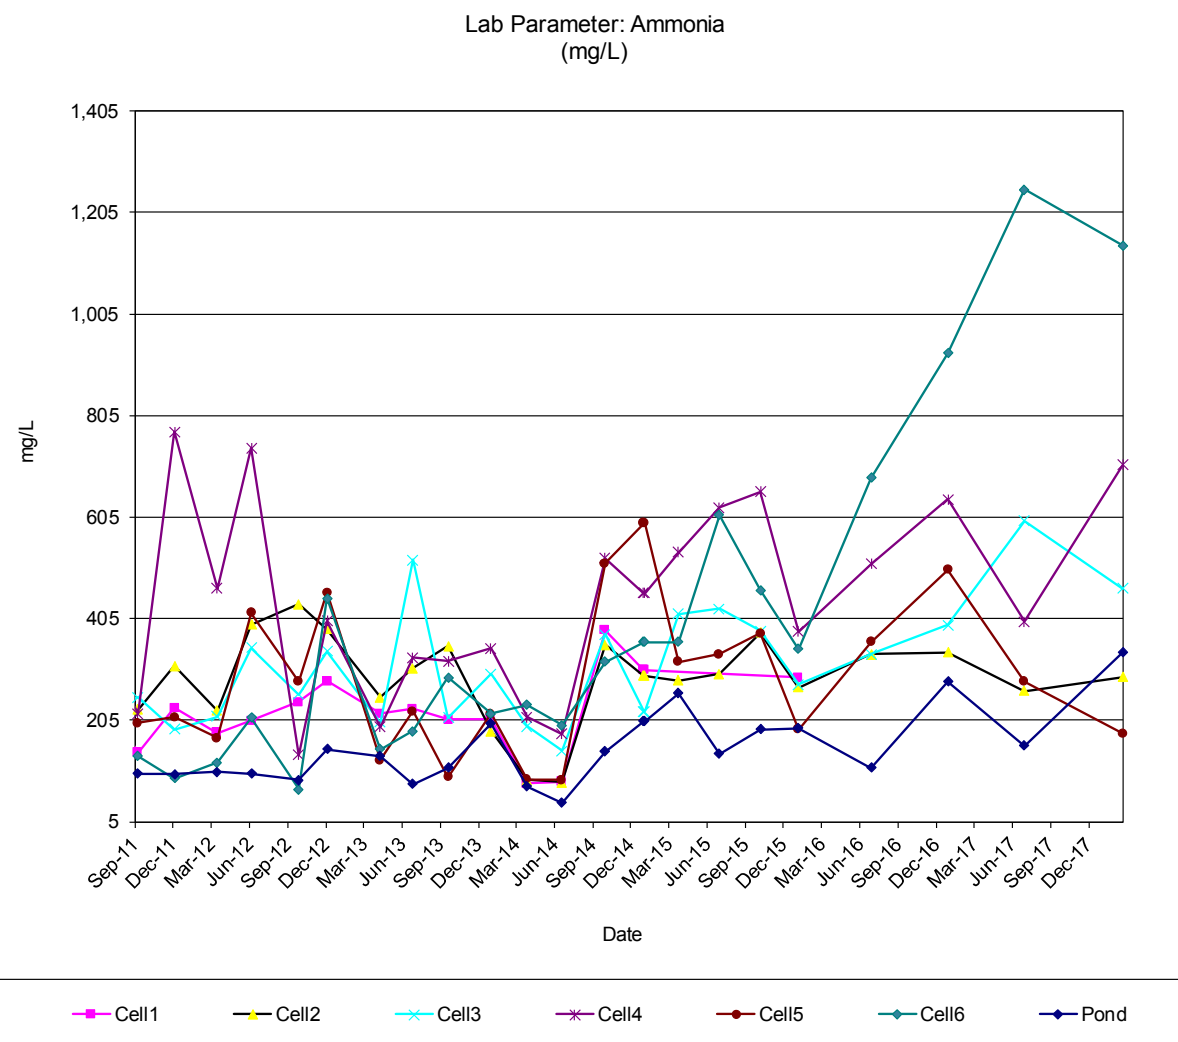
**Figure 4-12 Ammonia of Leachate**

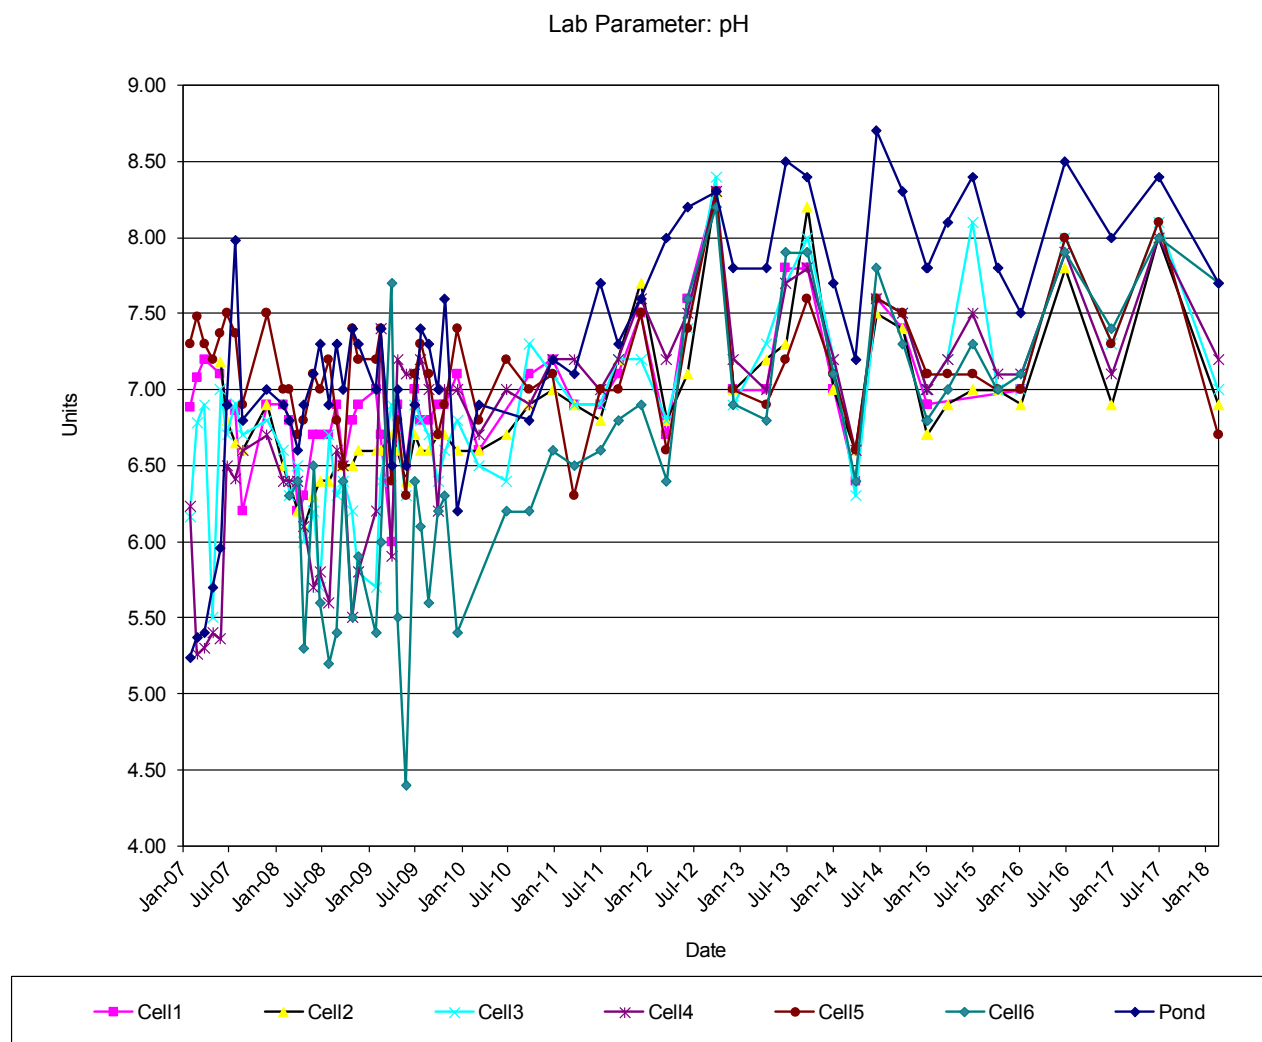
**Figure 4-13 pH of Leachate**

It was also observed that the pH of the leachate in the pond was higher than the leachate in the cells as shown in Figure 4-13. However, the pH trend for the pond follows the leachate pH trend for the cells. It is thought that the concrete liner could possibly contribute to the higher pH in the pond. The liquid in the LDZ of the pond is mostly groundwater based on a comparison of conductance.

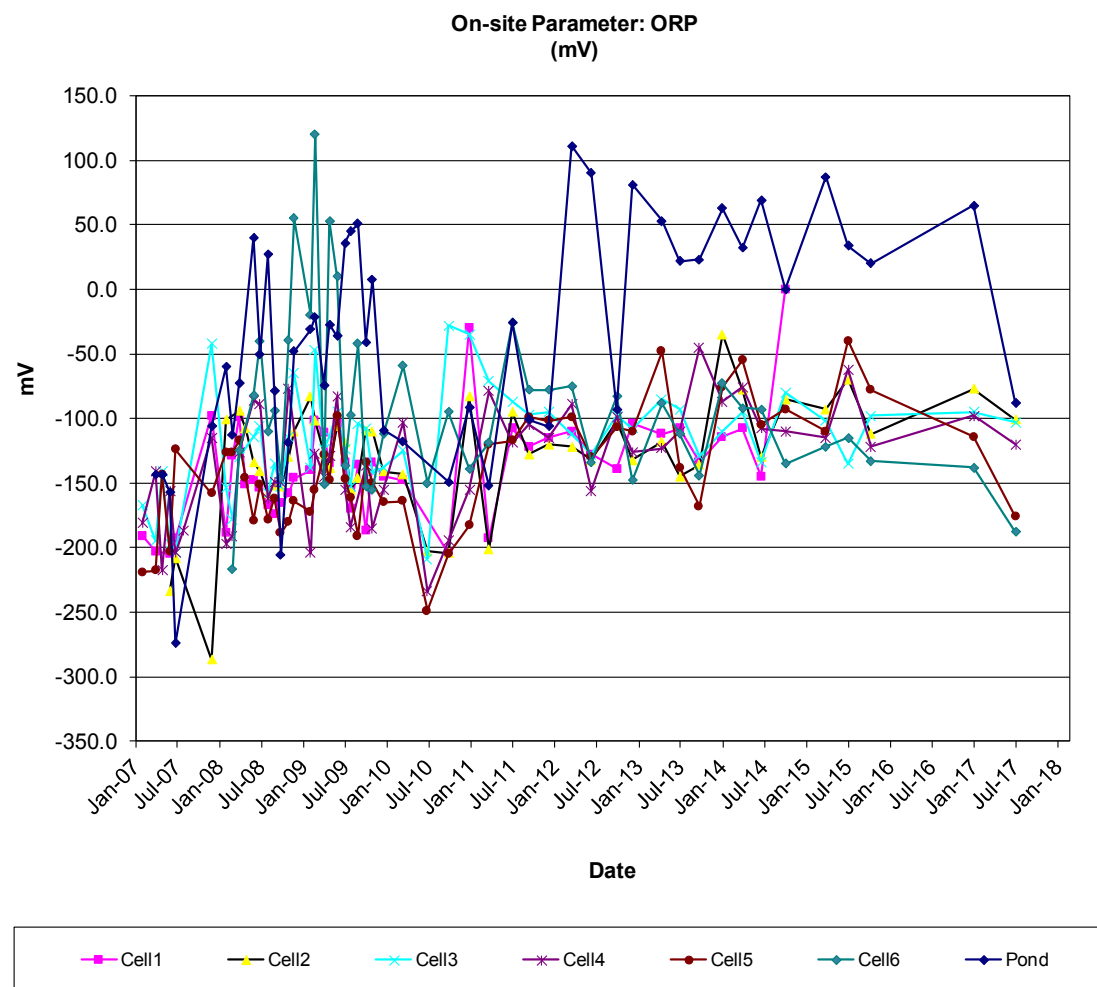
**Figure 4-14 ORP of Leachate**

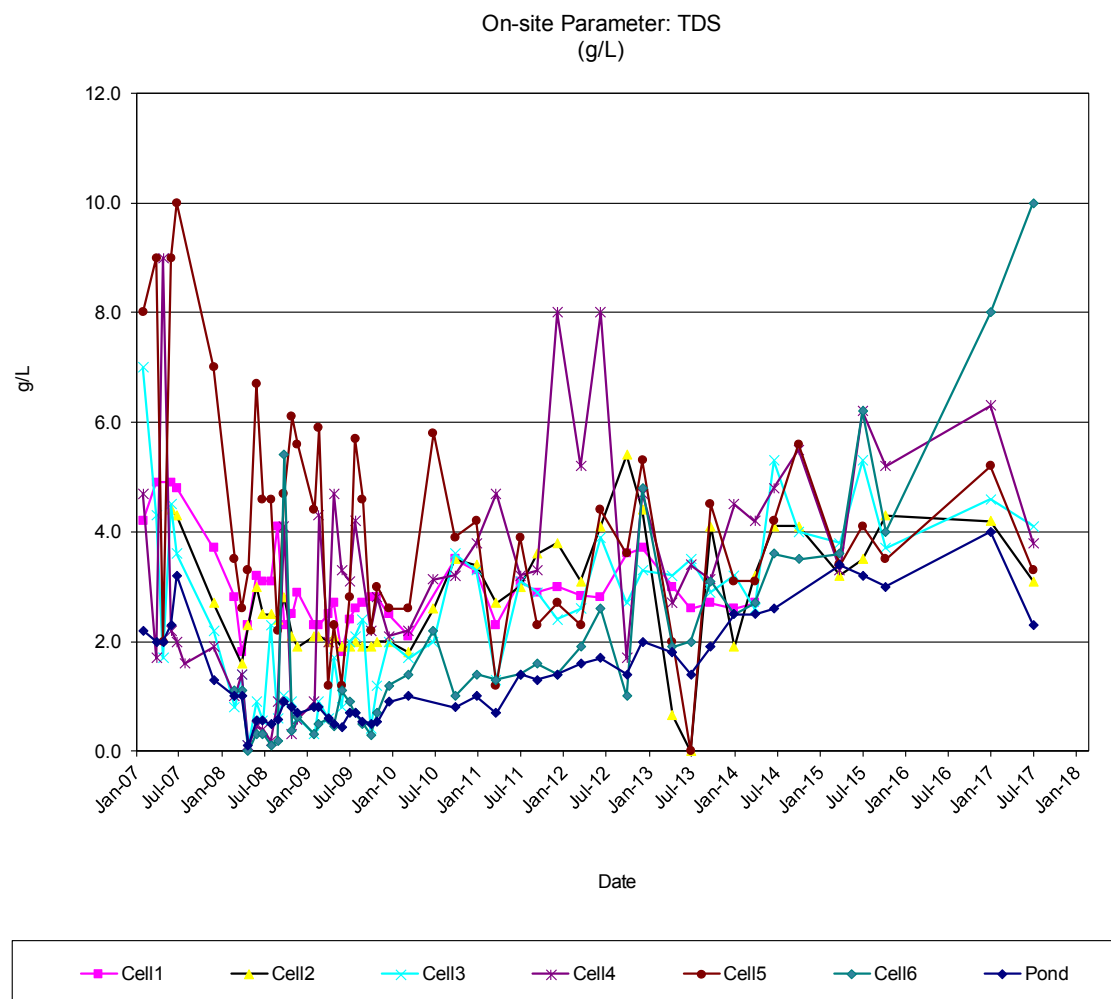
**Figure 4-15 TDS of Leachate**

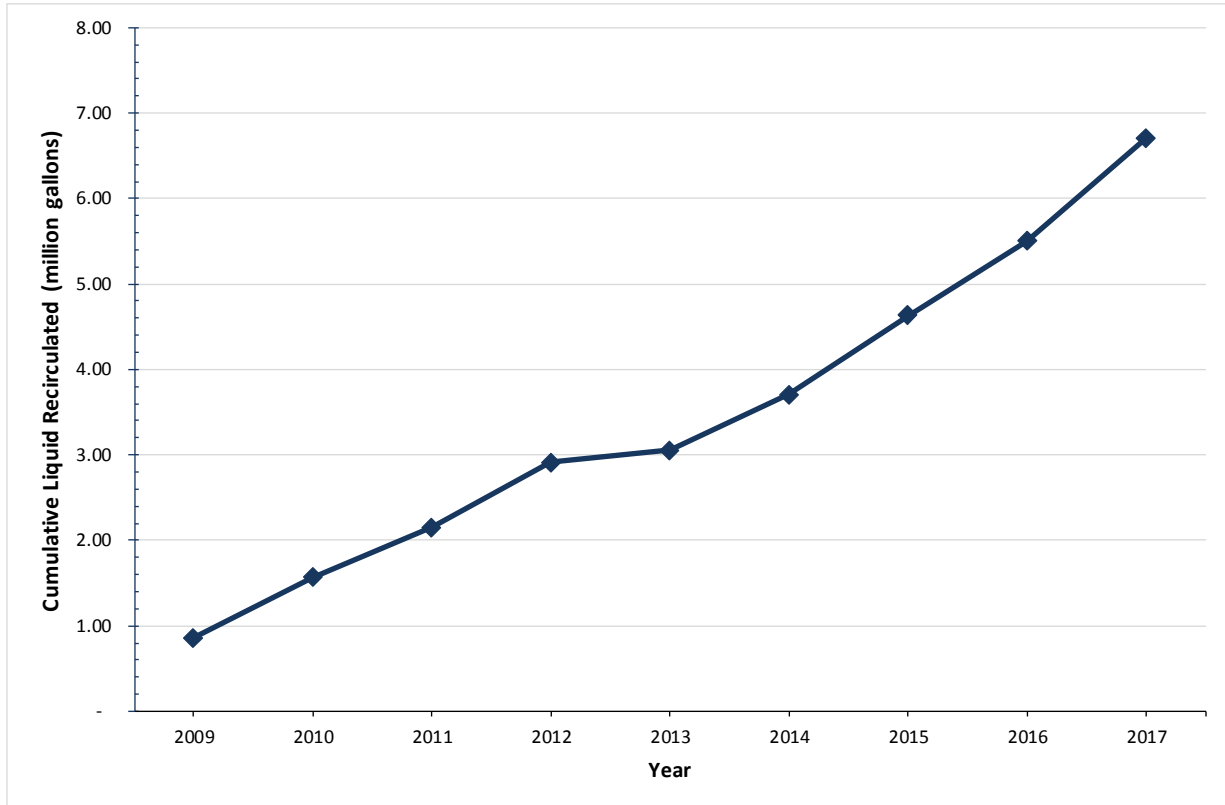
**Figure 4-16** shows the cumulative quantity of leachate recirculated from 2006 through 2017. Approximately 6.7 million gallons of leachate have been recirculated. The annual leachate recirculated is presented in **Table 4-3**.

**Figure 4-16 Cumulative Volume of Leachate Recirculated**

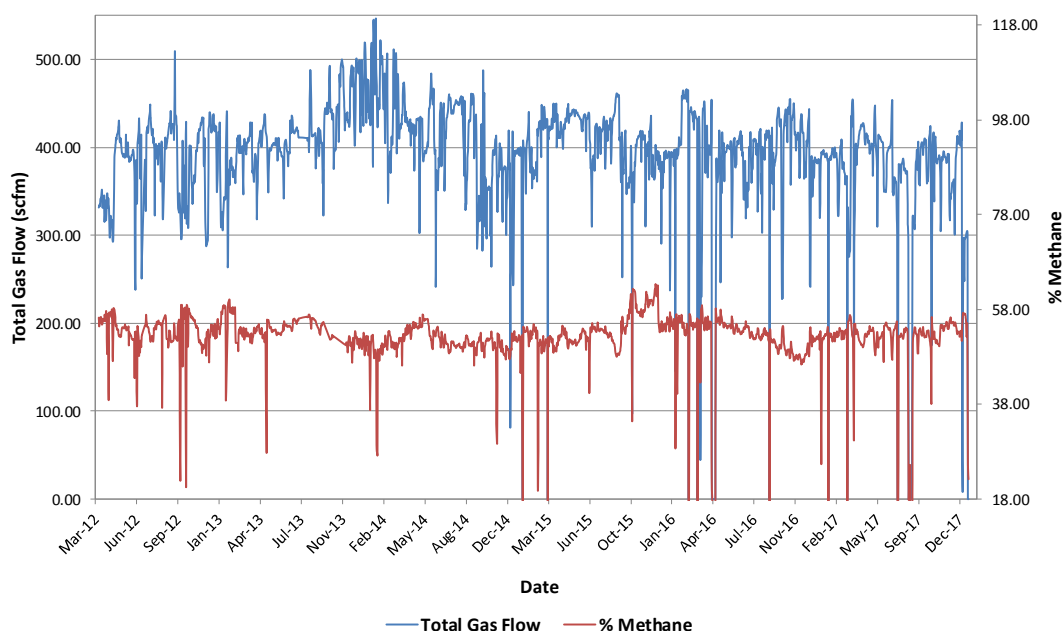
The total gas flow and methane percentage of the gas collected from the landfill is monitored continuously at the LFGTE facility as presented in **Figure 4-17**.

**Figure 4-17 Total Gas Flow and Percent Methane at the LFGTE Facility**

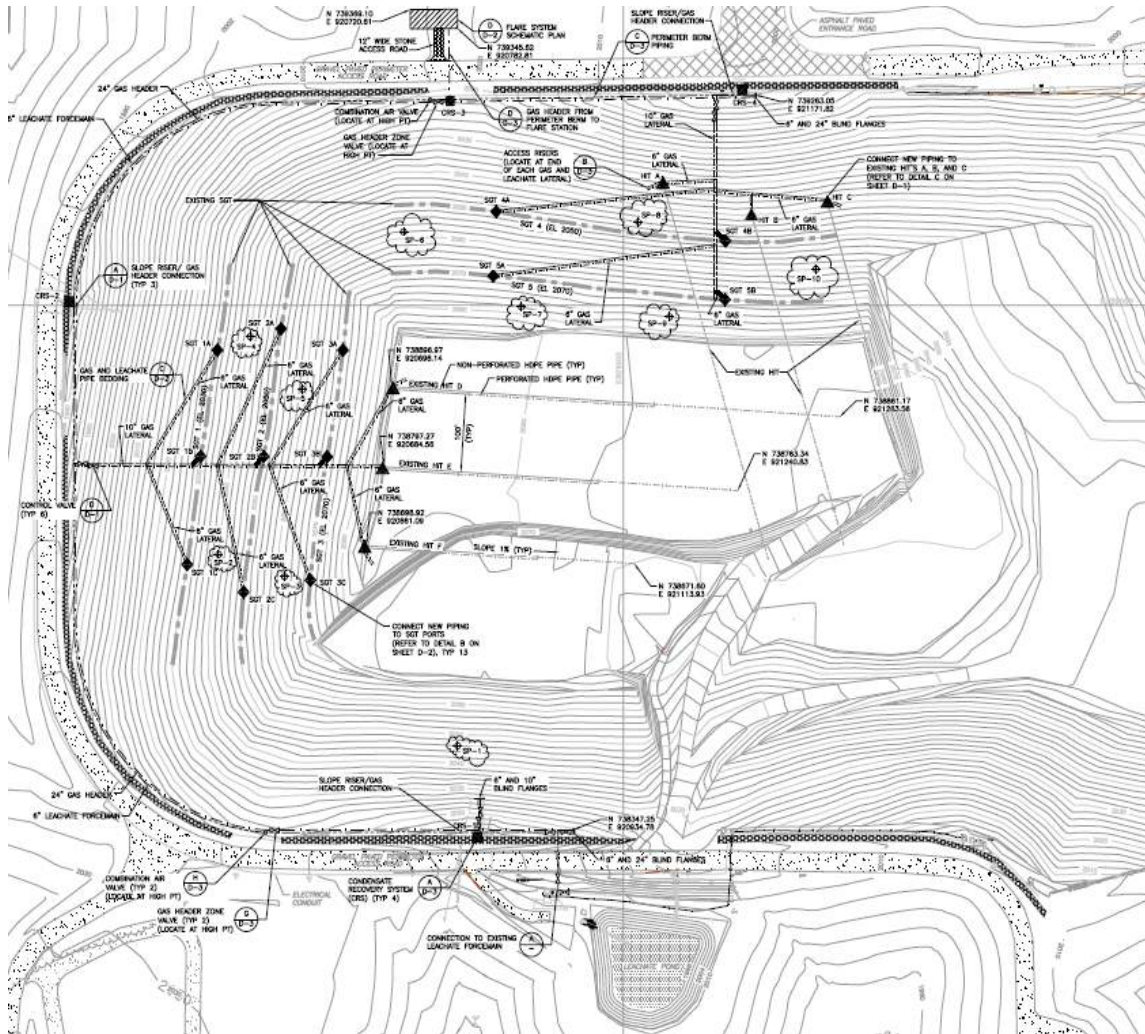
The location of the ten (10) settlement plates installed within the retrofit area is shown in **Figure 4-18**.

**Figure 4-18 Settlement Plates in Cells 1-5**  
(Plate locations are shown circled with cloud outline.)

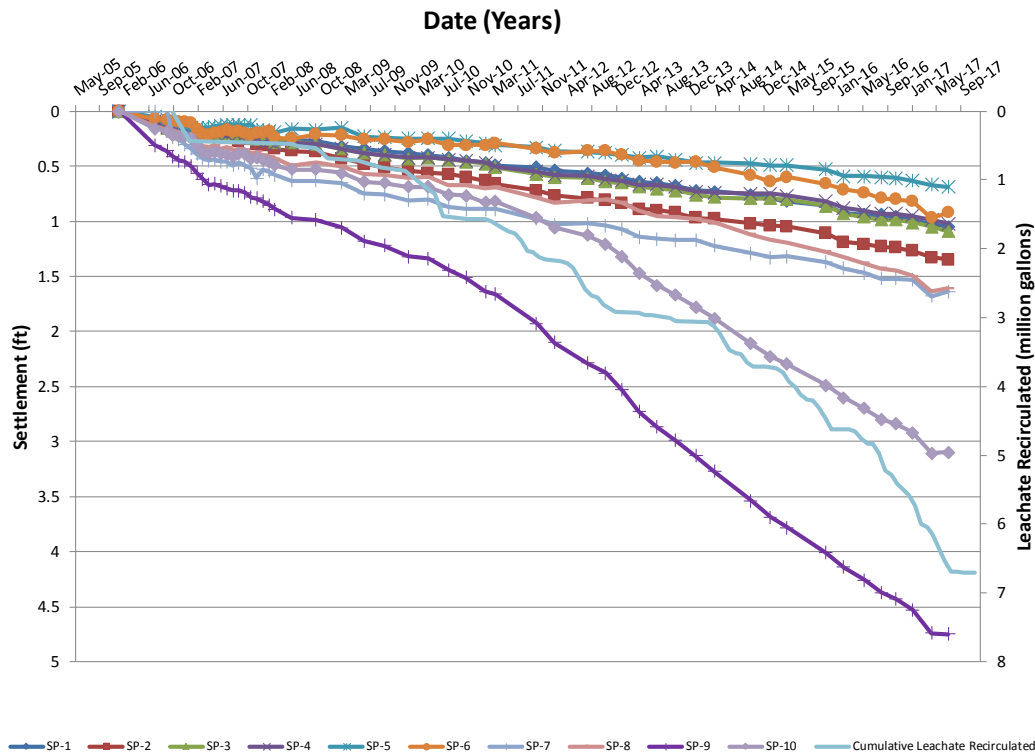
**Figure 4-19** compares the measured settlement in the settlement plates from July 2006 through June 2017 to the quantity of leachate recirculated in Cells 1-6.

**Figure 4-19 Cumulative Settlement**

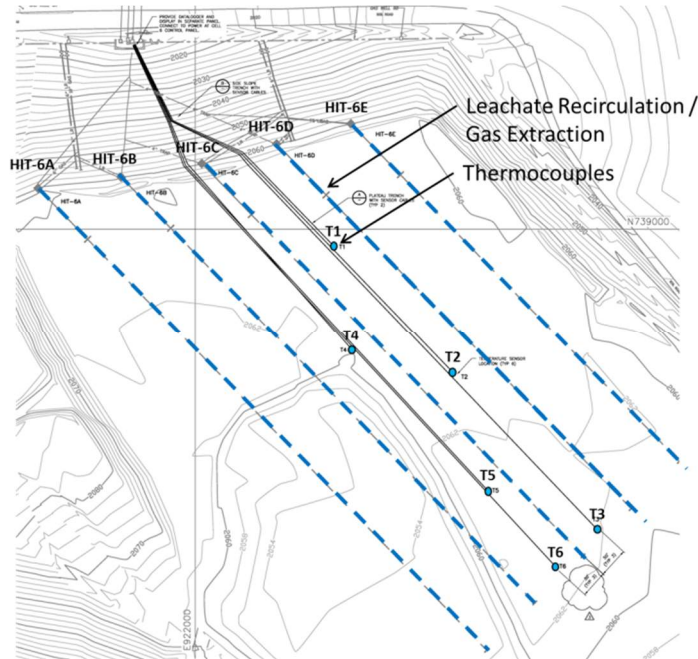
Thermocouples were installed in six (6) locations around Cell 6 HIT in assessing the impacts of leachate temperature during injection as shown in **Figure 4-21**.

**Figure 4-21 Temperature Sensors in Cell 6**

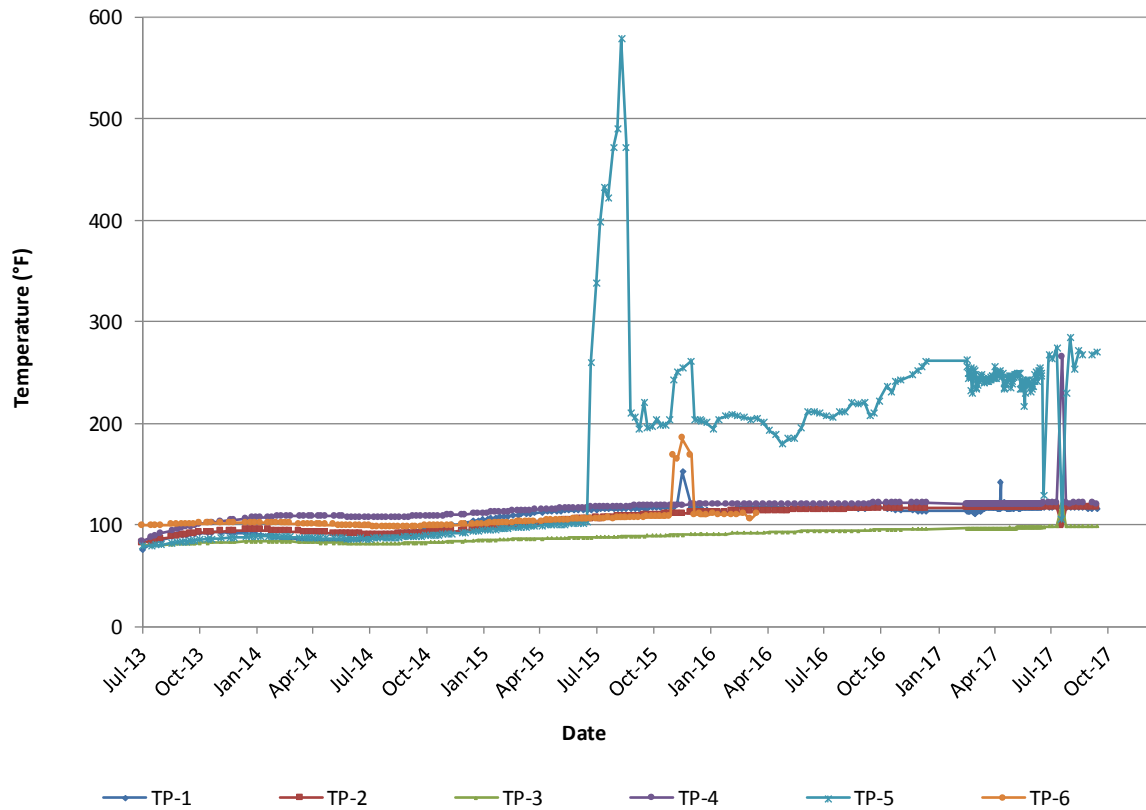
The temperature of waste in Cell 6 is shown in **Figure 4-22**. Thermocouple T6 seems to have failed as of April 2016 as evidenced by erratic jumps from negative to positive temperatures in under a minute. This has continued into 2017. Leachate recirculation in this cell began in June 2014. There are no temperature readings after October 2017 as the datalogger was sent back to the manufacturer for repair.

**Figure 4-22 Waste Temperature Readings in Cell 6**

\*Thermocouple TP-6 has failed as of April 2016.

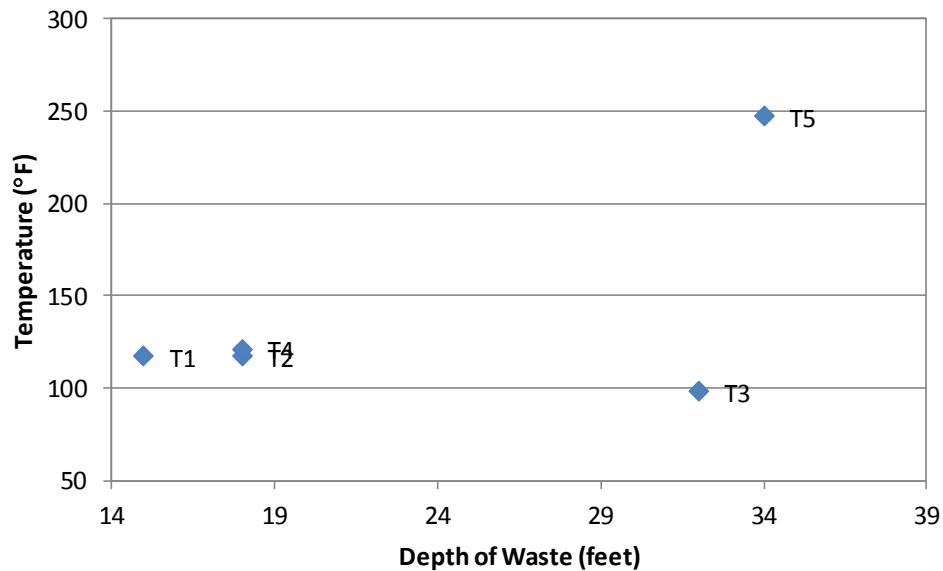
The temperature of waste in Cell 6 compared with the depth of waste is shown in **Figure 4-23**.

**Figure 4-23 Temperature of Waste at Various Depths in Cell 6**

(Note: Waste Depths from July 2017 Topographic Survey and Temperature Readings are from June 2017)

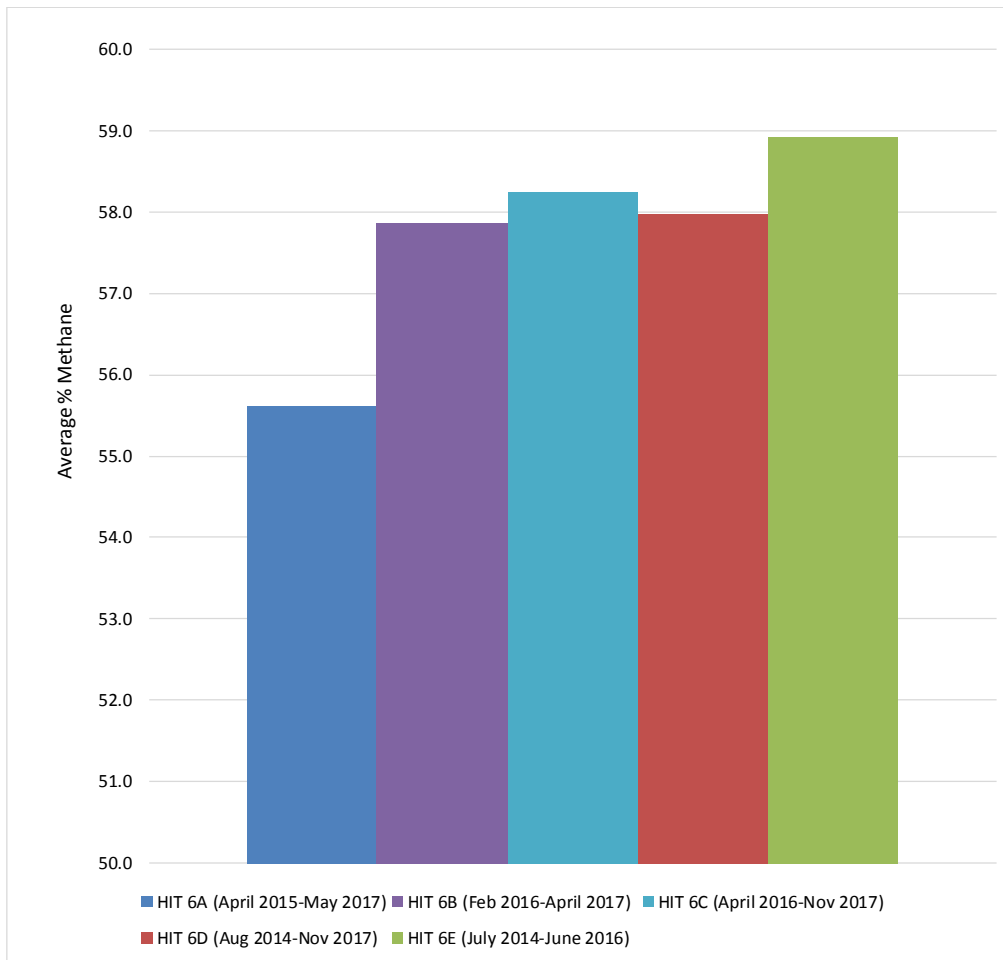
Landfill gas is being collected from HITs 6A, 6D, and 6E and monitoring data has been collected since mid-2014. As no recirculation was done in HITs 6B and 6C during the January-June 2016 period due to weather conditions, landfill gas was collected from these as well. Recirculation has been conducted in HITs 6A, 6B, and 6E in 2017 and landfill gas collected from HITs 6C and 6D. **Figure 4-24** shows the percent methane in each of these HITs and **Figure 4-25** shows the flow rate in standard cubic feet per minute (SCFM).

**Figure 4-24 Average Percent Methane in HITs 6A, 6B, 6C, 6D, and 6E**

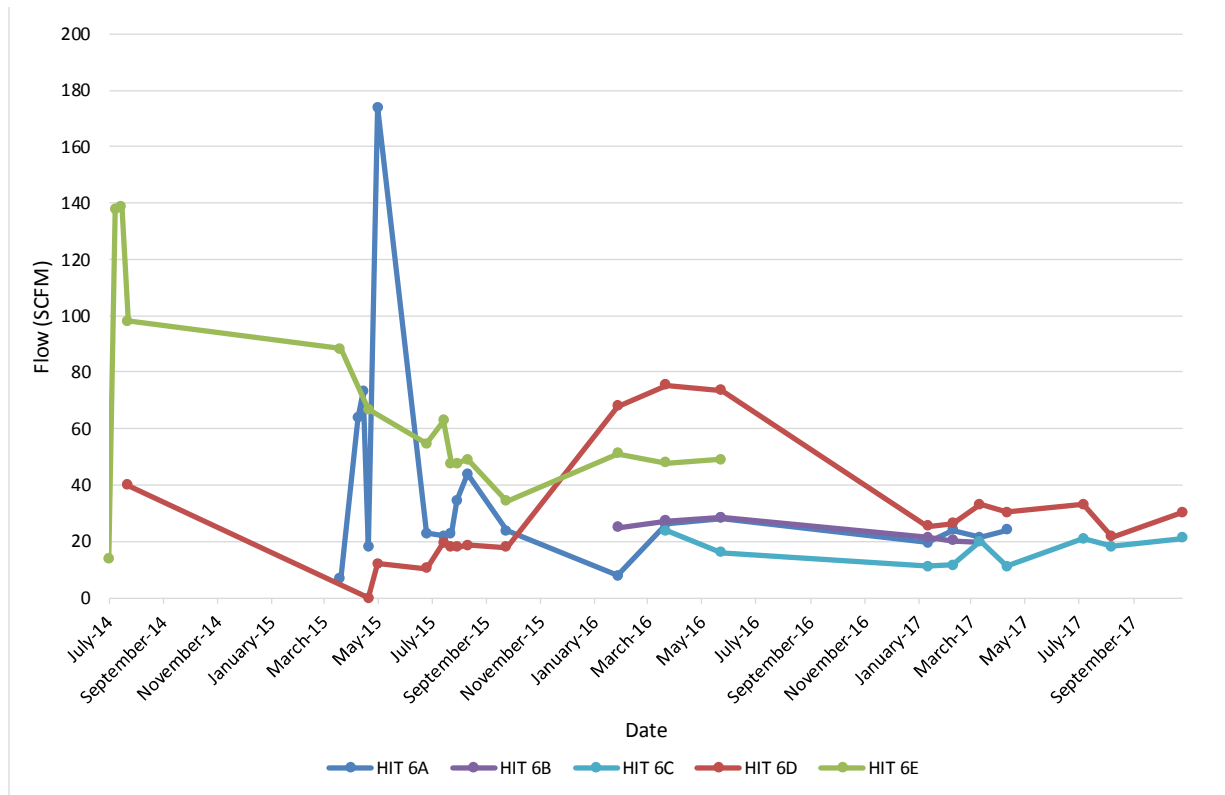
**Figure 4-25 Flow Rate in HITs 6A, 6B, 6C, 6D, and 6E**

(\*Flows were calculated using the differential pressure, vacuum, and orifice plate size for the HITs.)

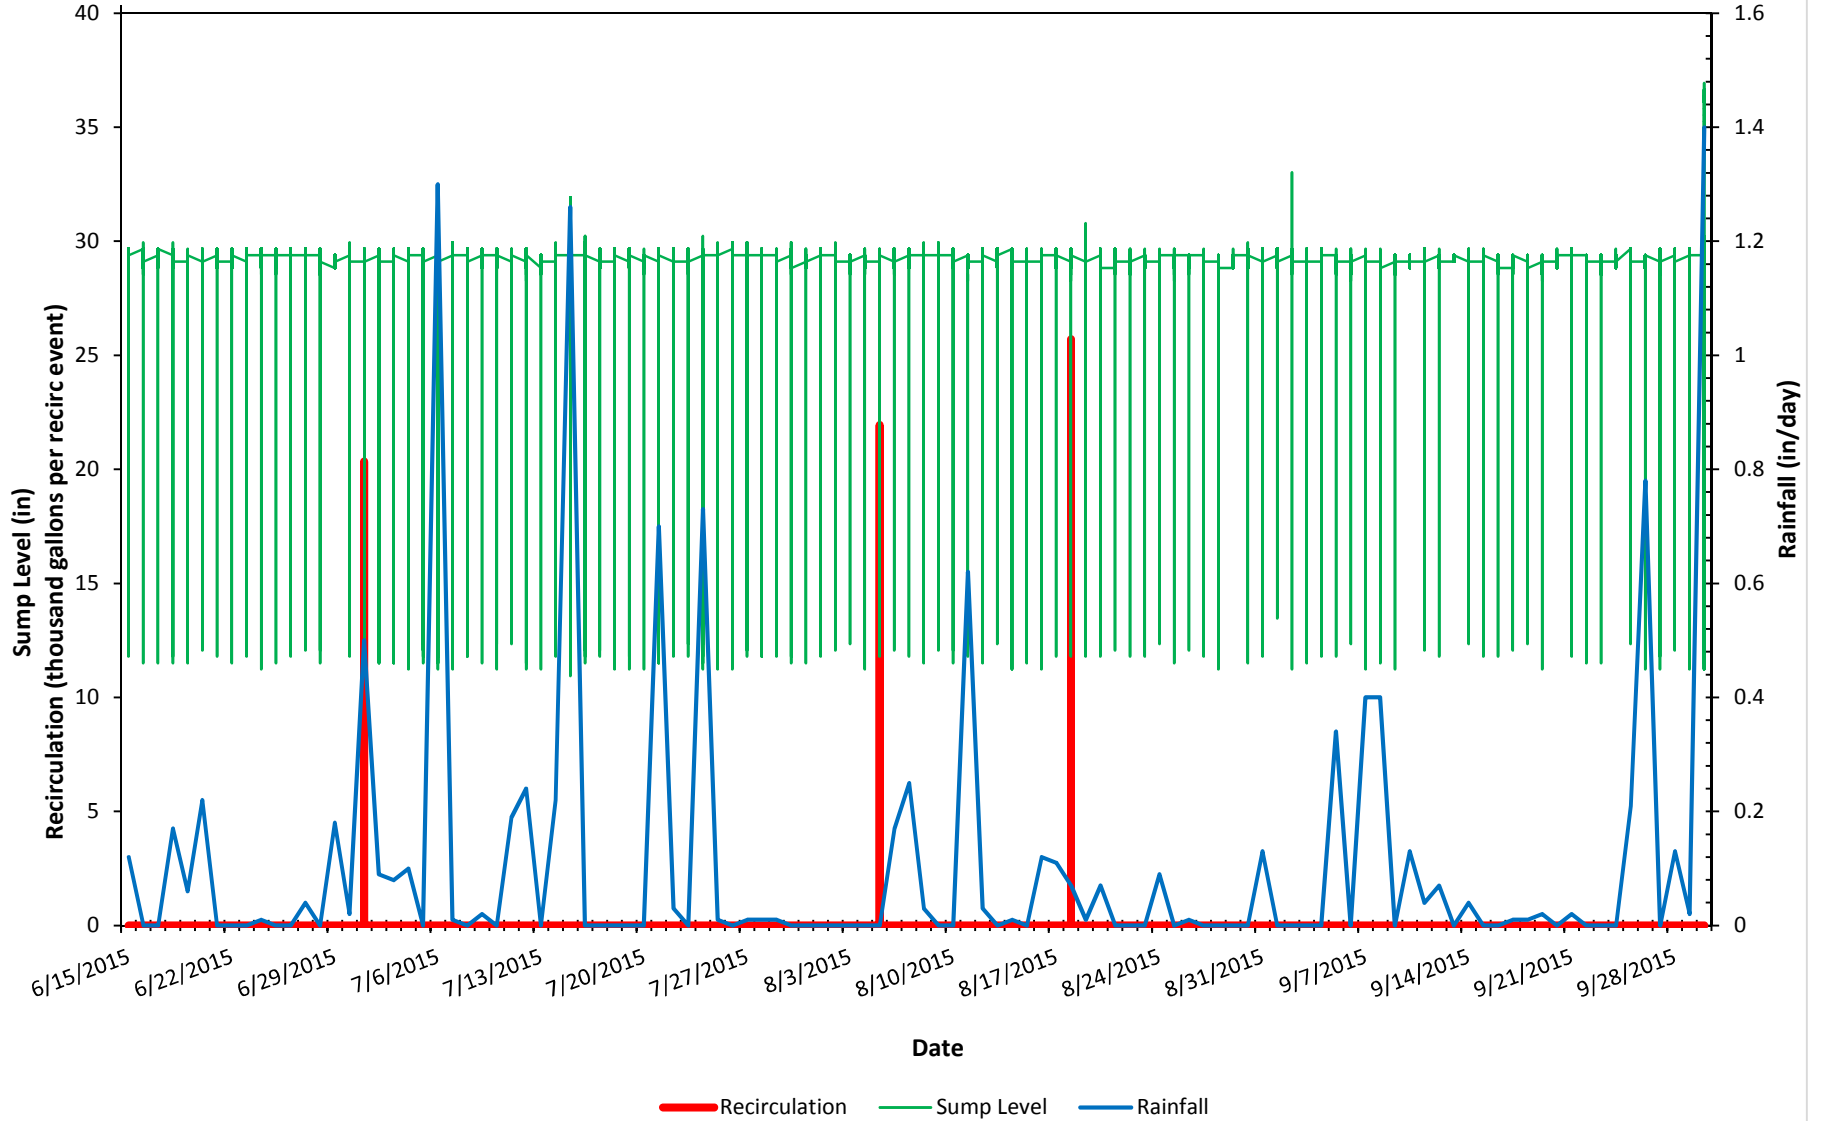
Data has been collected from the Cell 6 pump datalogger to record the sump level. The Cell 6 sump pump is set to turn on at a level of 30 inches and off at a level of 12 inches. **Figure 4-26** shows a graph of the sump levels from June through September 2015 along with the recirculation events and daily rainfall. As no recirculation was done in Cell 6 during the January through June 2016 period, there is no update to this graph from the 2015 year-end report. The datalogger data has been corrupt since June 2016, and the figure was not able to be updated. Some data was able to be extracted for March through April 2017 and is shown in **Figure 4-27**. The sump pump malfunctioned in April 2017 and had to be replaced. The datalogger is in the process of being repaired.

**Figure 4-26 Cell 6 Sump Level, Cell 6 HITs Recirculation Events, and Rainfall**
