2017 Year-End Progress Report

# USEPA PROJECT XL

## Buncombe County Bioreactor Project

### Buncombe County Solid Waste Management Facility

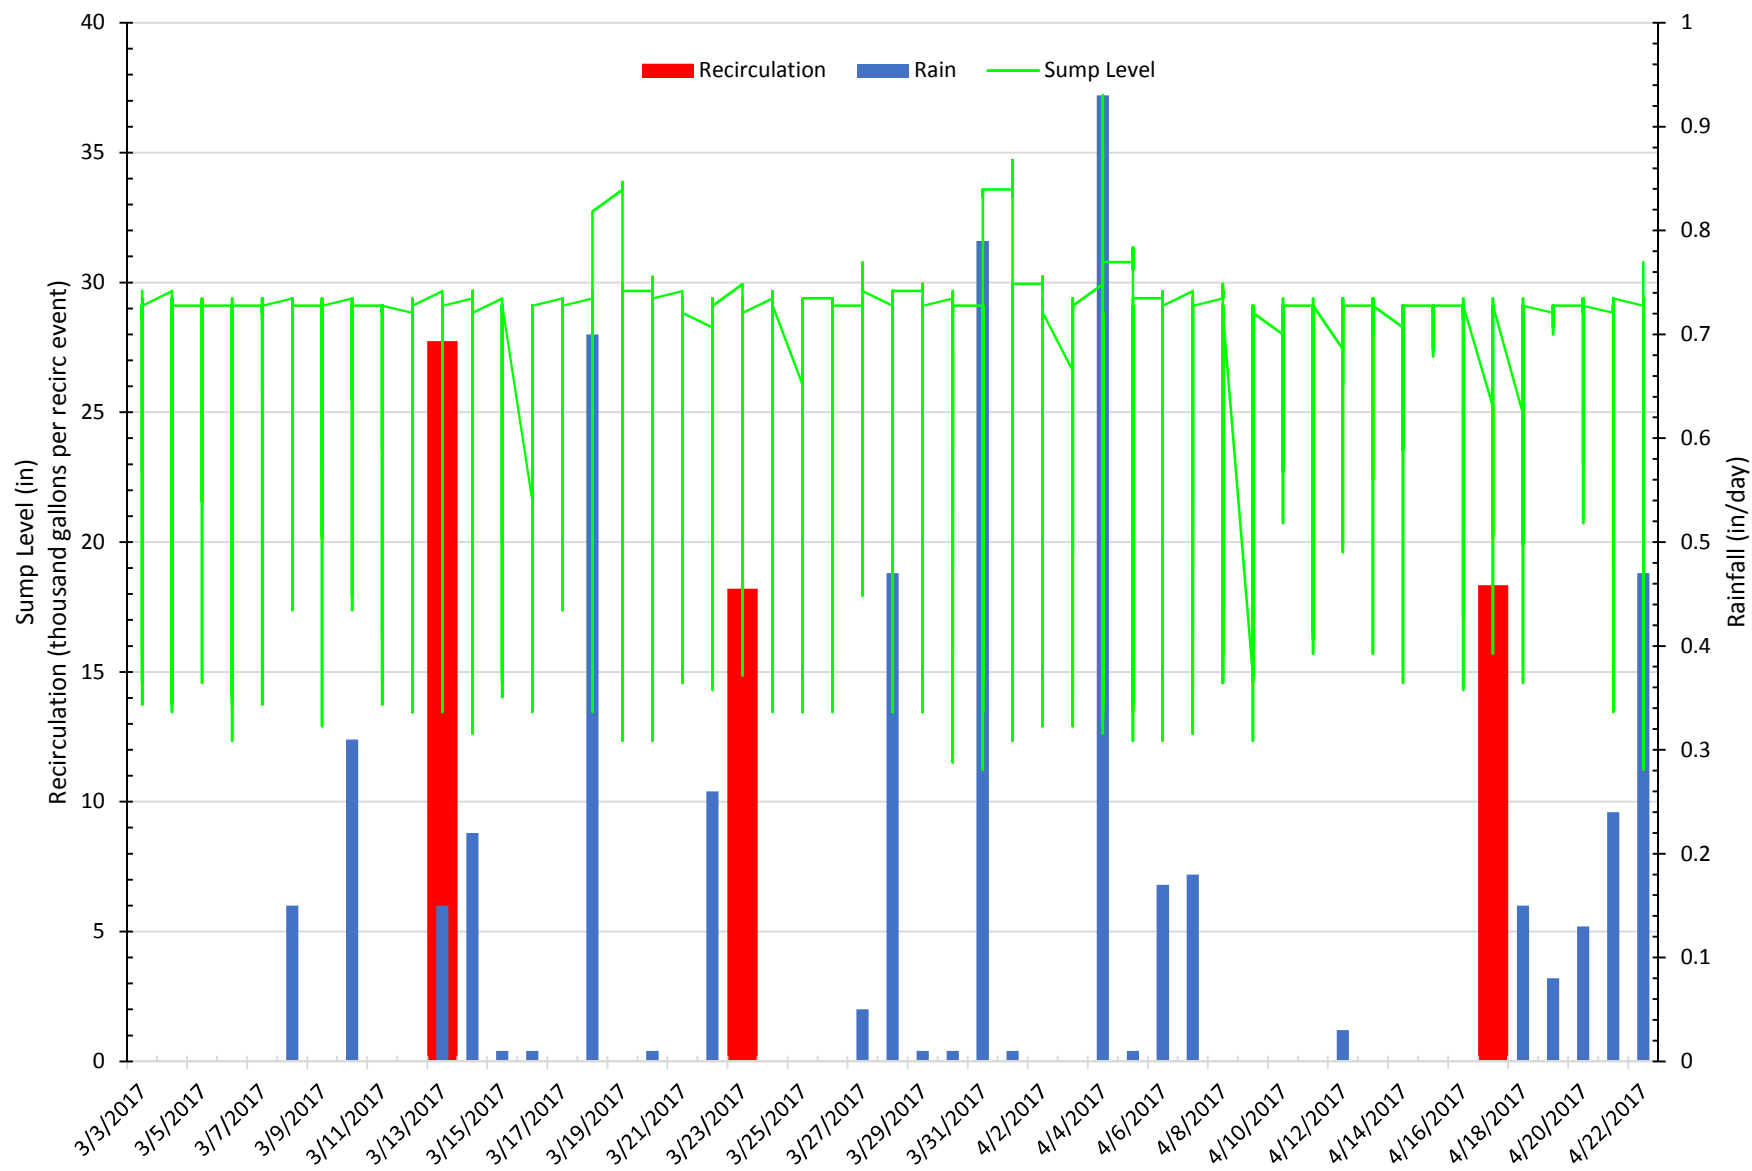
**Figure 4-27 Cell 6 Sump Level, Cell 6 HITs Recirculation Events, and Rainfall (March-April 2017)**

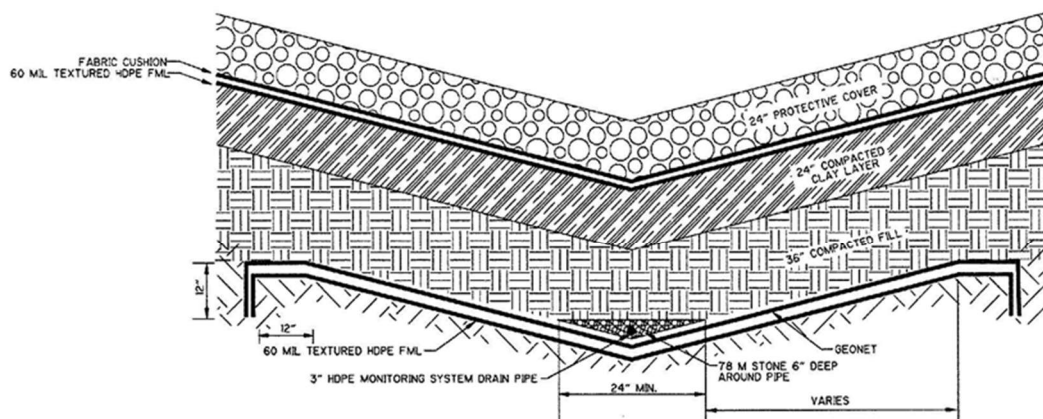
Liquid present in the LDZ could be leachate that has leaked through the base liner system, groundwater or a combination of both. As shown in **Figure 5-1**, the LDZ are open on the sides and therefore are subject to potential groundwater infiltration. This is particularly evident in Cell 1 where it appears that the LDZ is being impacted by an underground spring based on the amount of flow witnessed during sampling events and the high quality of the water. Comparison of test data between the LDZ, leachate and groundwater was made in an effort to determine the source of the liquid.

**Figure 5-1 Leak Detection Zone in Cells 1-6 and Leachate Pond**

The landfill cells and leachate pond are equipped with leak detection zones (LDZ) located beneath the leachate collection system sumps. The LDZ, as shown in **Figure 5-1**, are approximately 1 acre in size and consist of a 60 mil HDPE geomembrane and a 24-inch rock drainage layer located 3-ft below the subgrade of the liner system. The geomembrane is sloped to direct liquid to a collection pipe located directly below the leachate sumps. For Cells 3-6, liquid captured in the LDZ is pumped out through vertical stand pipes located along the perimeter berm. Cells 1 and 2 drain liquid through gravity pipes that protrude from the outer slope of the landfill perimeter access road. The drain pipes are equipped with gate valves that the operator opens to check for liquid. Quantity data is not recorded for Cell 1 as it appears to be impacted by a steady supply of groundwater from an underground spring. Further

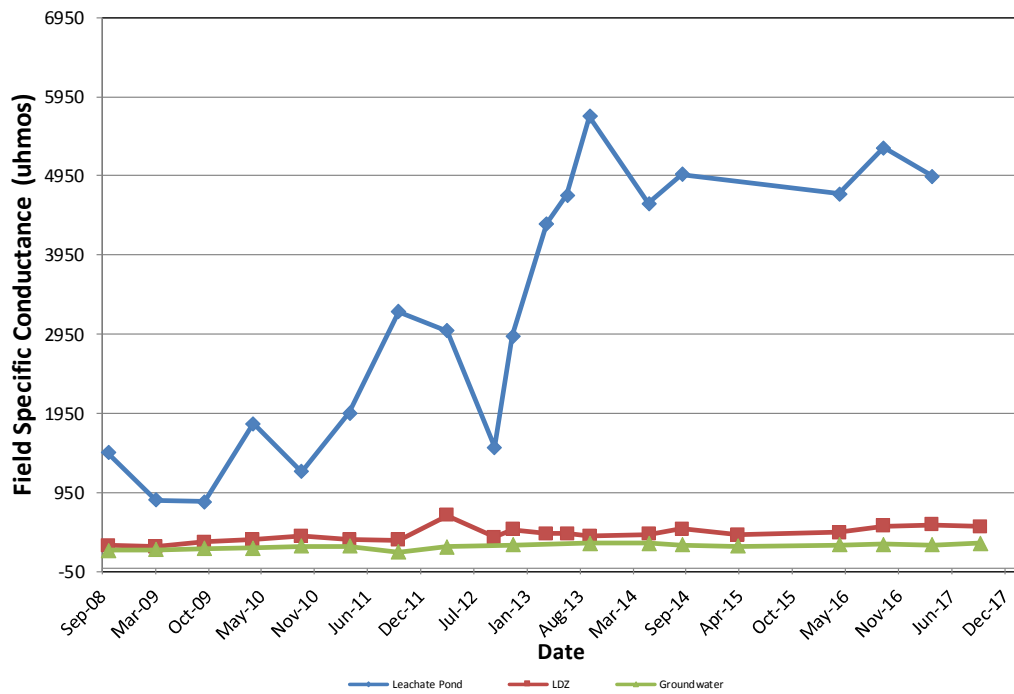
The conductance levels of leachate are much higher than the samples tested for the Cell 1 LDZ. The conductance of leachate is in the range of 800-15,000  $\mu\text{mho}/\text{cm}$  compared to 200-800  $\mu\text{mho}/\text{cm}$  for the LDZ. The LDZ conductance is similar to the levels tested from groundwater well samples in the area as shown in **Figure 5-2**.

**Figure 5-2 Conductance of Leachate, LDZ, and GW Samples**  
(Values are averages of testing results for the six cells and all GW monitoring wells)

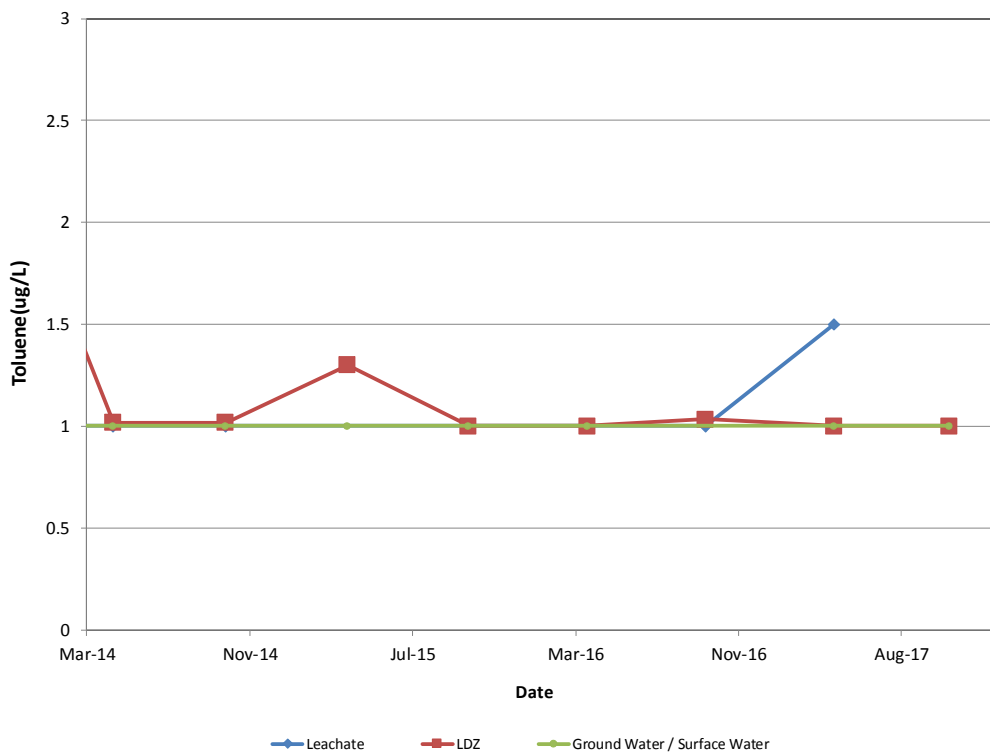
Toluene, which is often present in leachate, was found to be much lower in the LDZ samples, which correlate closely with groundwater testing results as shown in **Figure 5-3**.

**Figure 5-3 Toluene of Leachate, LDZ and GW/SW Samples**  
(Values are averages of testing results for the six cells and all GW/SW monitoring wells)

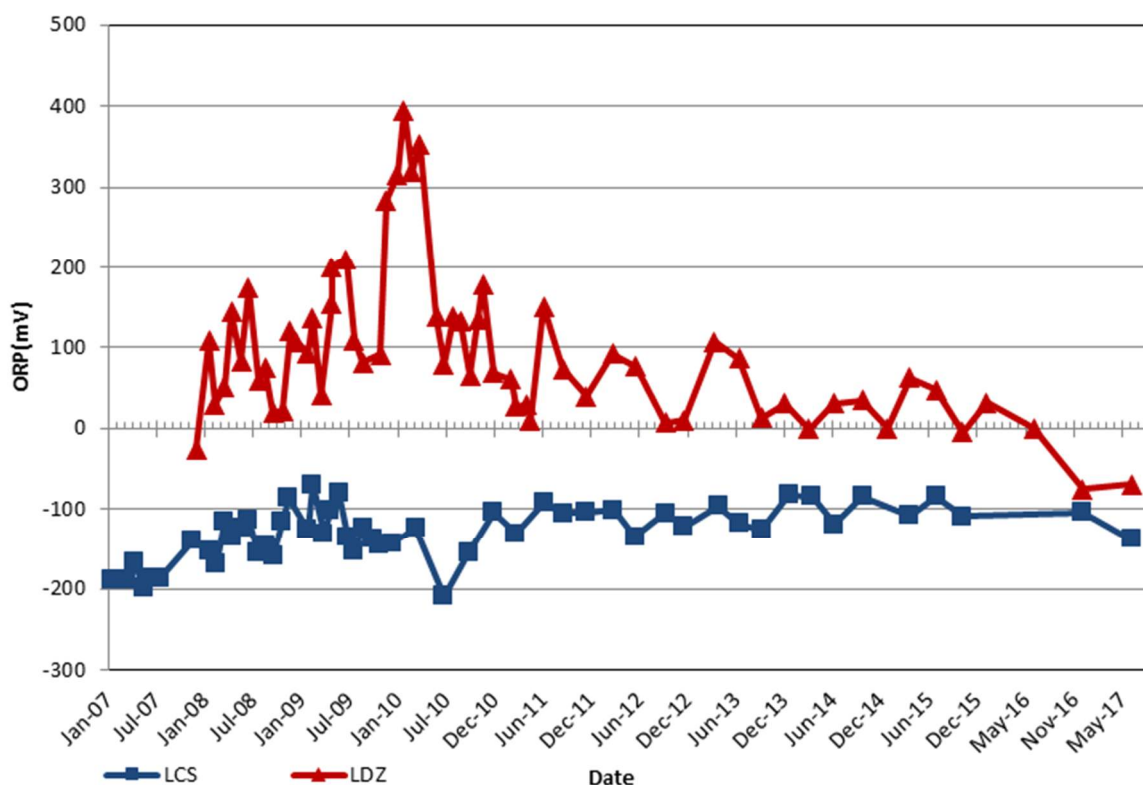
**Figure 5-4** shows the ORP values for the leachate and LDZ samples for all cells. Comparison of ORP values from 2007 to 2015 shows a distinction between leachate and the liquid sampled from the LDZ. However, the most recent data does not show a distinction. No data is available for 2018 as the Horiba water quality meter used for onsite ORP testing is no longer working. Buncombe County is research alternatives to purchase a new meter.

**Figure 5-4 ORP of LCS and LDZ**  
(Values are averages of testing results for the six Cells)

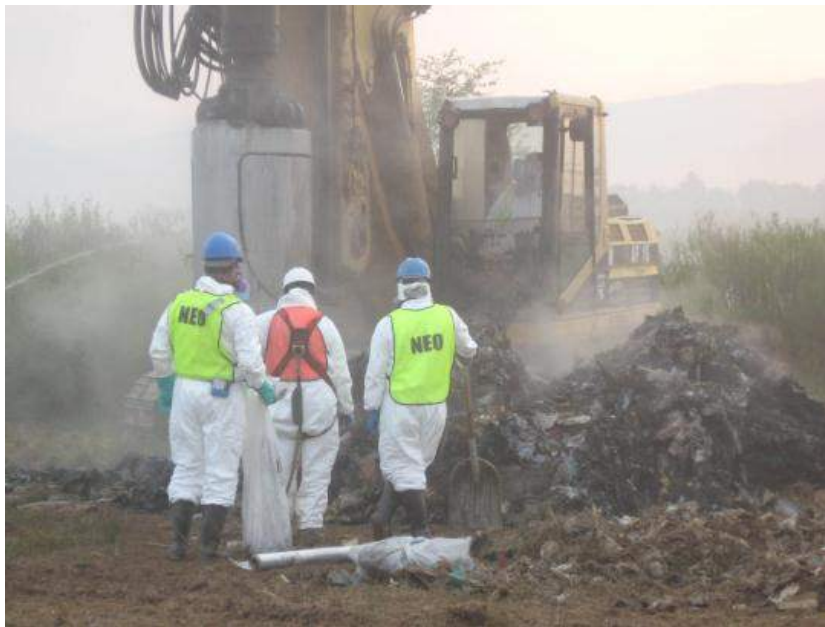
The waste from these five boreholes was observed to be noticeably wetter than the waste for the other boreholes. Steam emanating from the waste of VW-24 was indicative of the elevated temperatures. The waste from this borehole appeared to be well decomposed.

**Figure 5-5 Exhumed Waste from Drilling of Vertical Well 24**

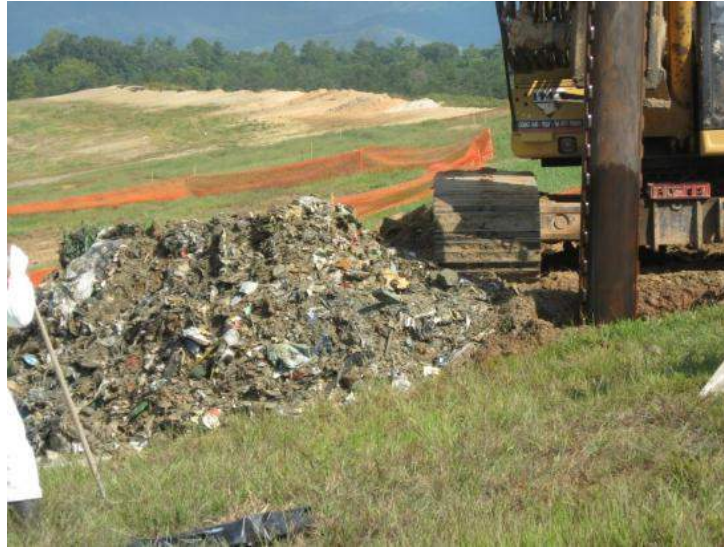
**Figure 5-6 Exhumed Waste from Drilling of Vertical Well 13**

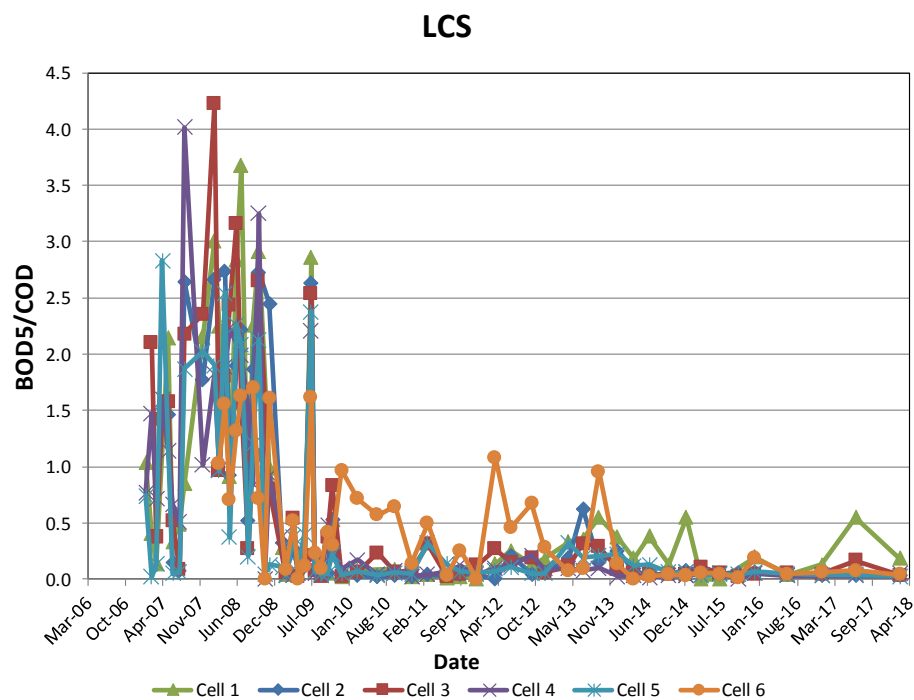
The BOD<sub>5</sub>/COD ratio of the landfill leachate has dropped steadily since 2007 indicating that stabilization of the organic waste fraction is occurring as shown in **Figure 5-7**.

**Figure 5-7 BOD<sub>5</sub>/COD Ratio of LCS in Cells 1-6**

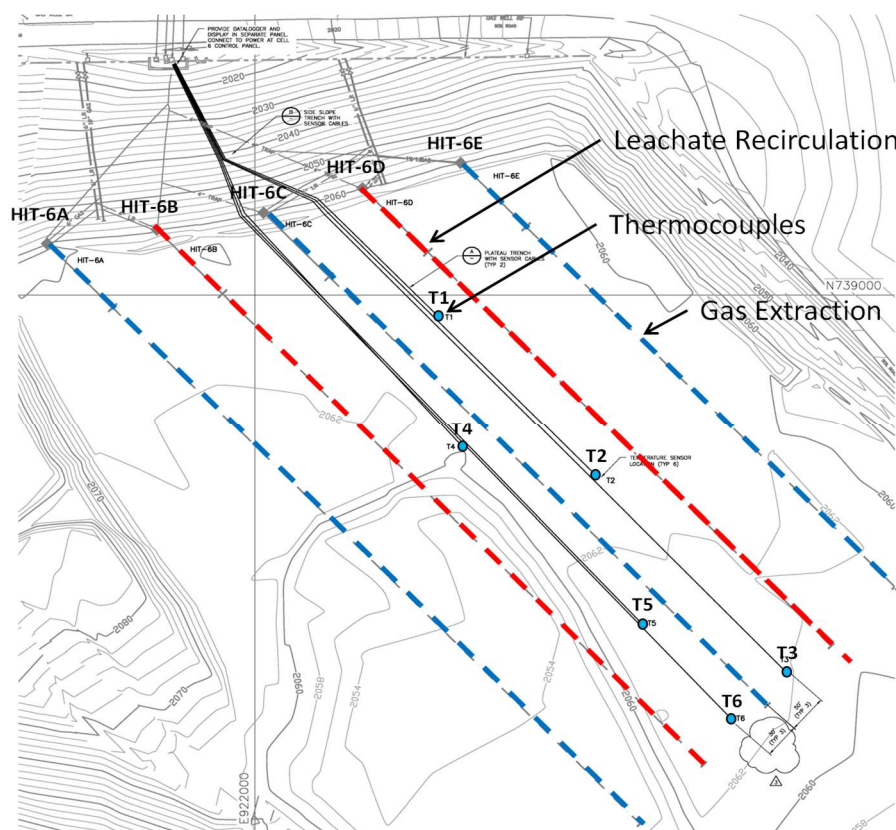
Figure 6-1 An Option Discussed at the Stakeholders' Meeting for Cell 6 HIT Operation

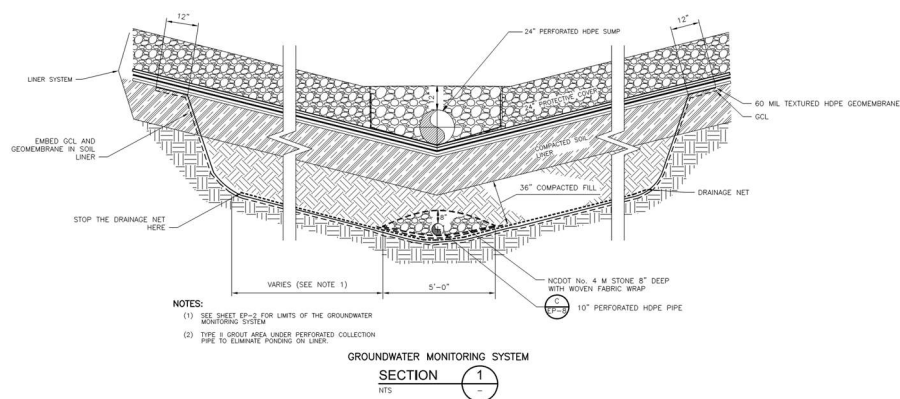
For Cells 7-10, it is recommended that the design of the LDZ be revised to eliminate the 3-foot separation between the LDZ and the bottom of the base liner system, as this will greatly reduce the potential for groundwater infiltration. This is shown in **Figure 7-1**.

**Figure 7-1: Revised LDZ Design**

While liquids have been observed in the leak detection zones in nearly all of the landfill cells, testing of the liquids indicate it is groundwater. For Cells 7-10, it is recommended that the design of the leak detection zone (LDZ) be revised to eliminate the 3-foot separation between the LDZ and the bottom of the base liner system, as this will greatly reduce the potential for groundwater infiltration.
