BUNCOMBE COUNTY NORTH CAROLINA 2019 MID-YEAR BIOREACTOR PROGRESS REPORT

Buncombe County Landfill
81 Panther Branch Road
Alexander, NC 28701

The following Mid-Year Bioreactor Progress Report summarizes the data collected through July 2019 for the Buncombe County Solid Waste Management Facility (Facility) as part of the United States Environmental Protection Agency's (USEPA's) Project XL Program.

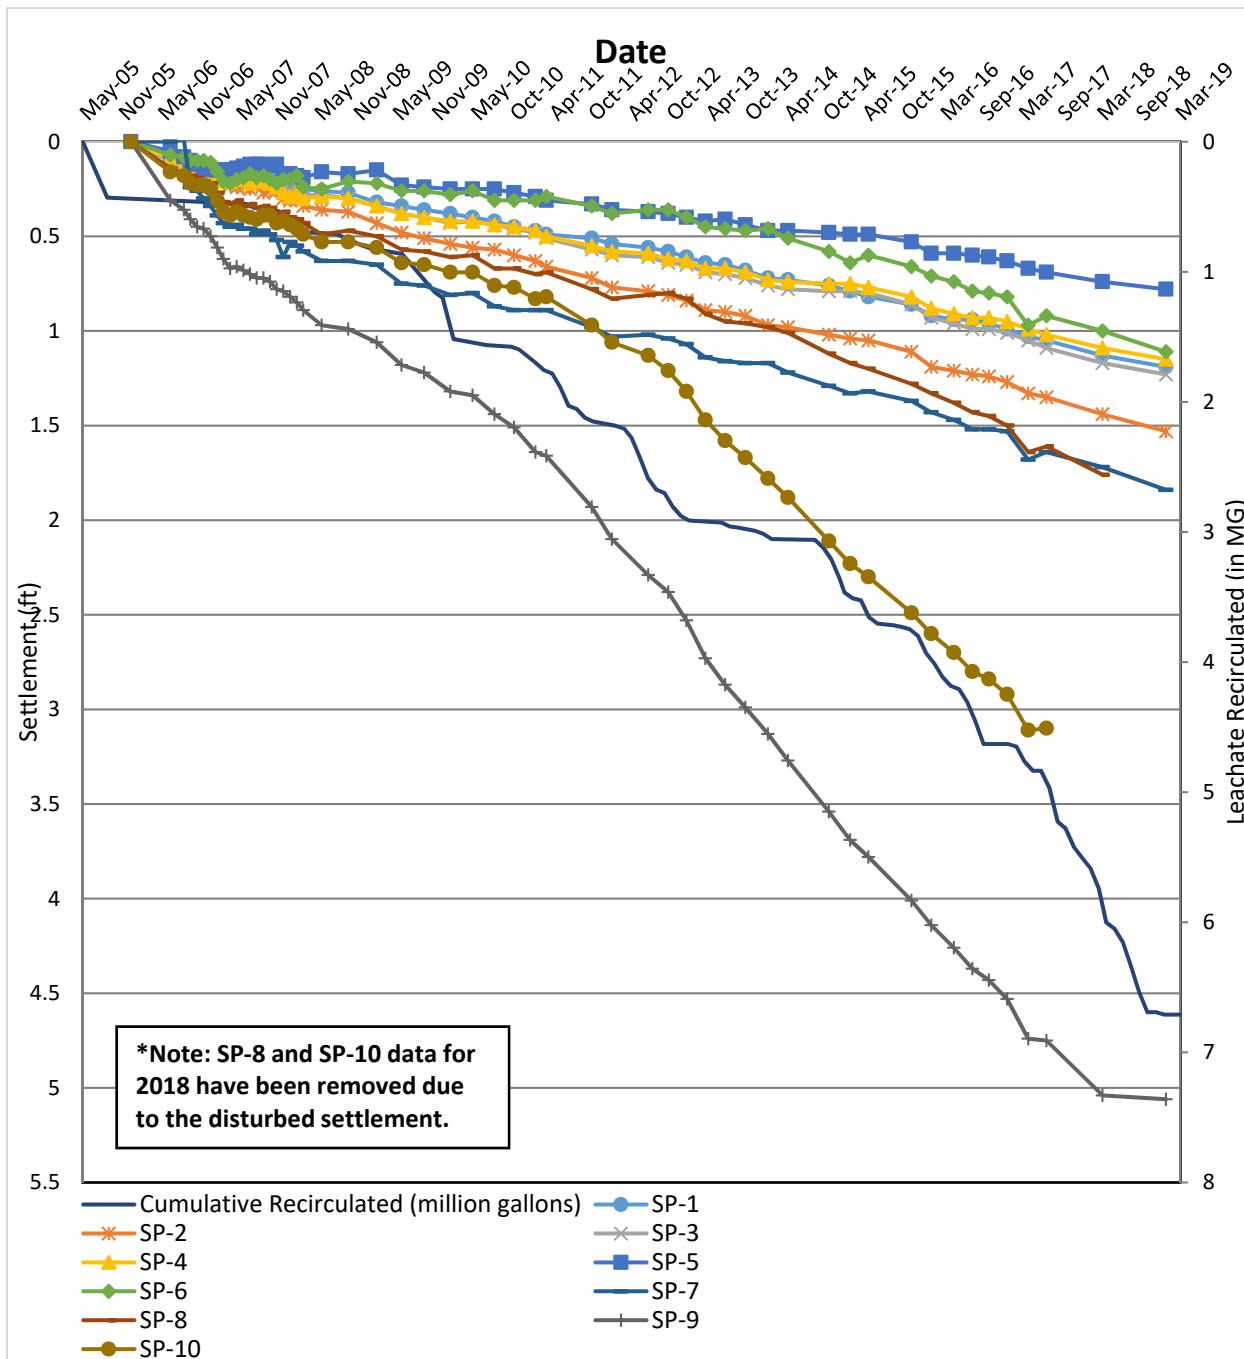
Figure 1. Cumulative Settlement (2006 – January 2019)

Ten Settlement plates were installed throughout the entire footprint of the MSW landfill. An average settlement of 1.84 ft. as shown in Figure 1 has occurred in Cells 1-5. There is a correlation between leachate recirculation locations relating to the settlement of the waste. Additionally, noticeable settlement areas have gained an advantage from stormwater that is captured on the flatter elevations that percolates through the waste.

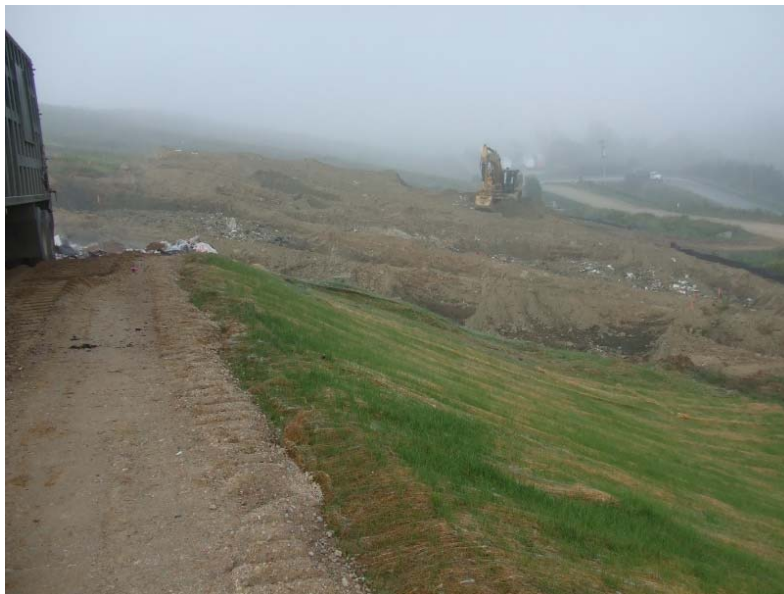
Figure 2. Access road to side slope disposal area

Buncombe County staff built the access road for the commercial haulers to access the sideslope disposal area, Figure 2. Utilizing our own Solid Waste Department's staff to build the access road and prepare the site for sideslope disposal saved the Solid Waste Department significant funds. Figure 3 & Figure 4 show the active disposal area prepared by staff. Additionally, Solid Waste staff completed all the excavation required around the bioreactor leachate injection/gas extraction lines, Figure 5.

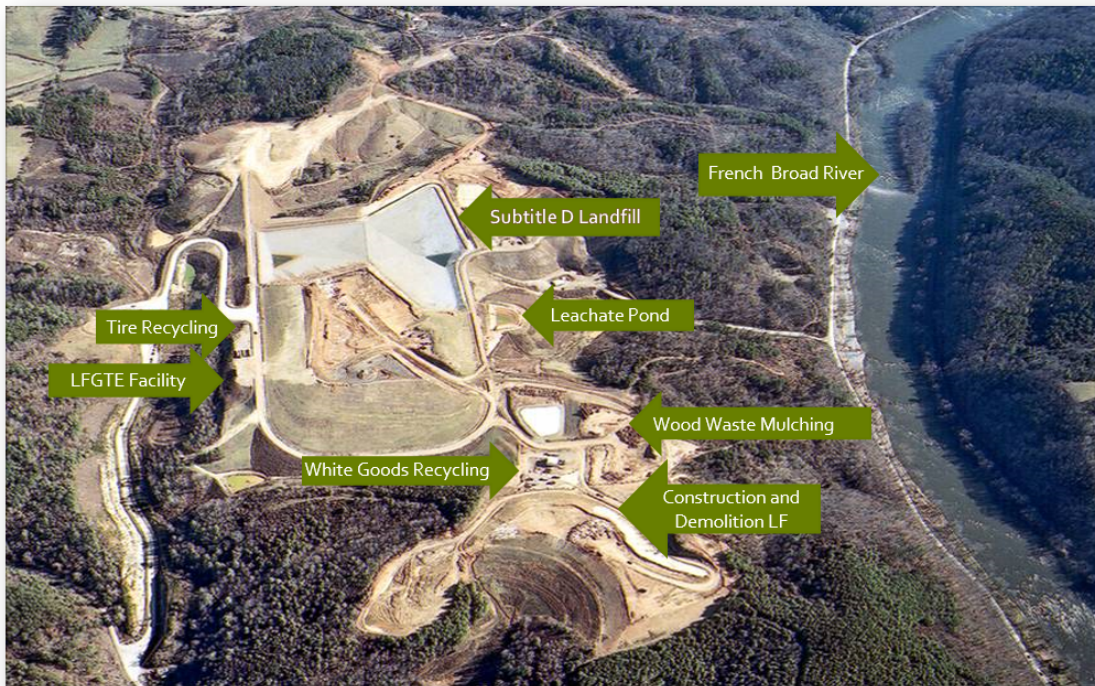
Figure 6. Buncombe County Solid Waste Management Facility

landfill, wood waste mulching facility, a residential drop-off, a household hazardous waste (HHW) facility, and a white good and tires recycling facility. See Figure 6 for the overall site layout.

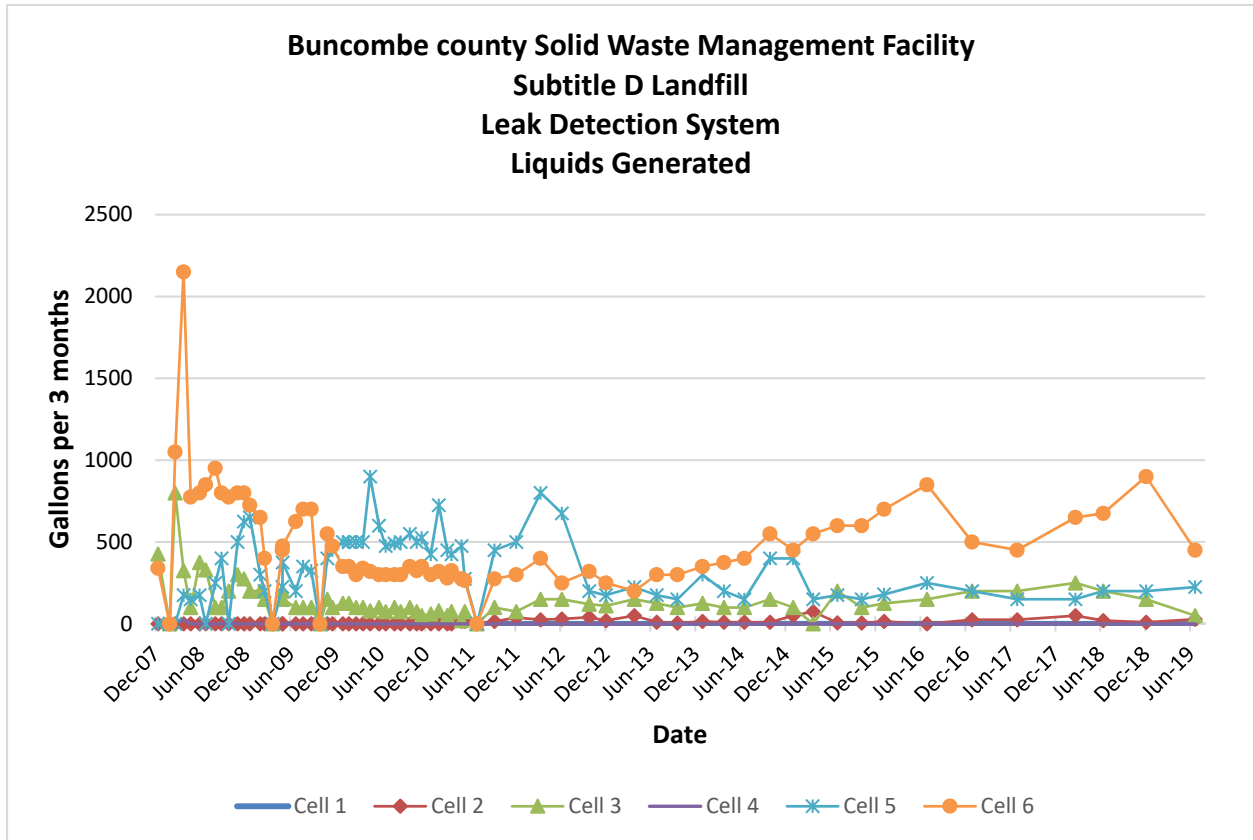
Figure 13. Liquids Generated (2007- June 2019)

Quarterly and semi-annual quantities of liquids collected from LDZ are shown in Figure 13 and Figure 14. Figure 15 through Figure 20 shows qualitative data from liquid testing such as pH, conductance, ORP, BOD5, COD, and ammonia parameters.

*Note: Leak Detection Volumes was done quarterly until 2016.

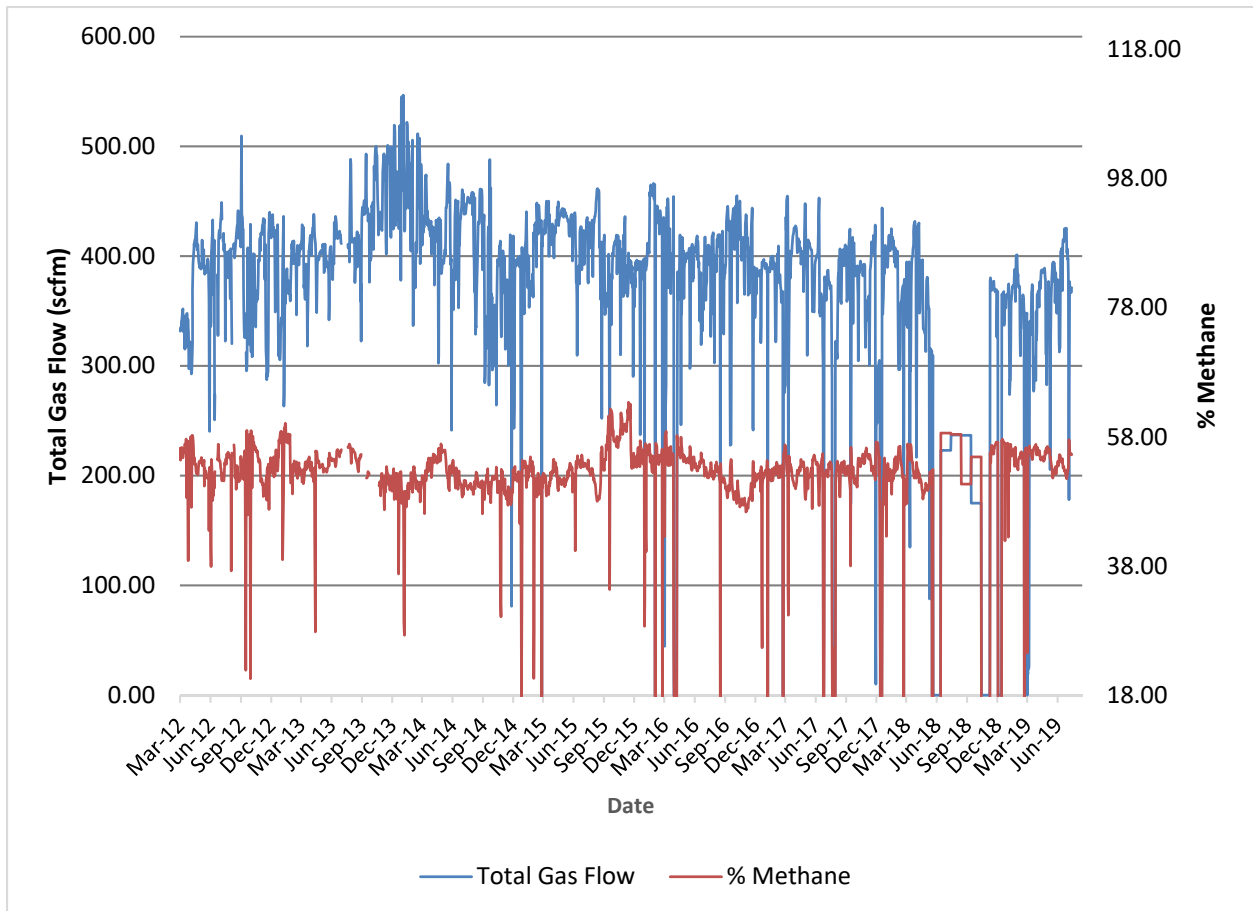
Figure 29. Total Gas Flow and Percent Methane at the LFGTE Facility

The total gas flow and methane percentage of the gas collected from the landfill is monitored continuously at the LFGTE facility as presented in Figure 29.

*Due to malfunctioning data logging equipment, monthly averages of methane and gas flow are represented in this graph for July 2018 through October 2018.
